BEST PRACTICES FOR BICYCLE TRAIL PAVEMENT CONSTRUCTION AND MAINTENANCE IN ILLINOIS

Research Report FHWA-ICT-12-009

**Developing Best Practices for Bicycle Trail
Pavement Construction and Maintenance in Illinois**

June 2012

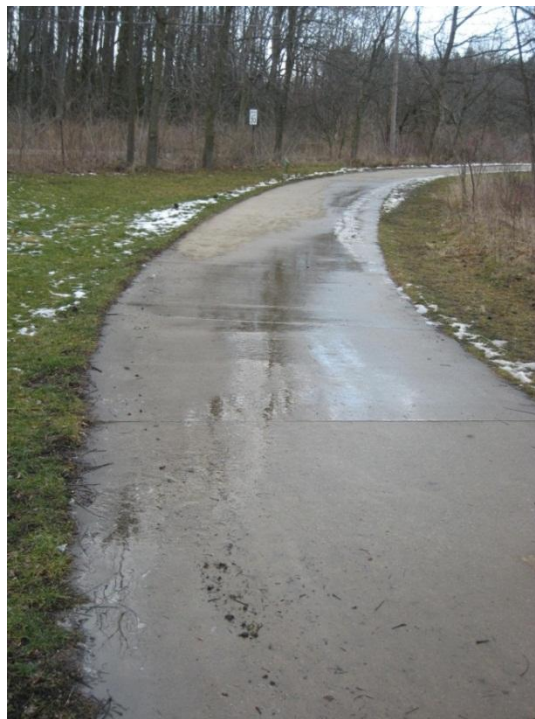
Figure D.4. Lack of trail drainage.

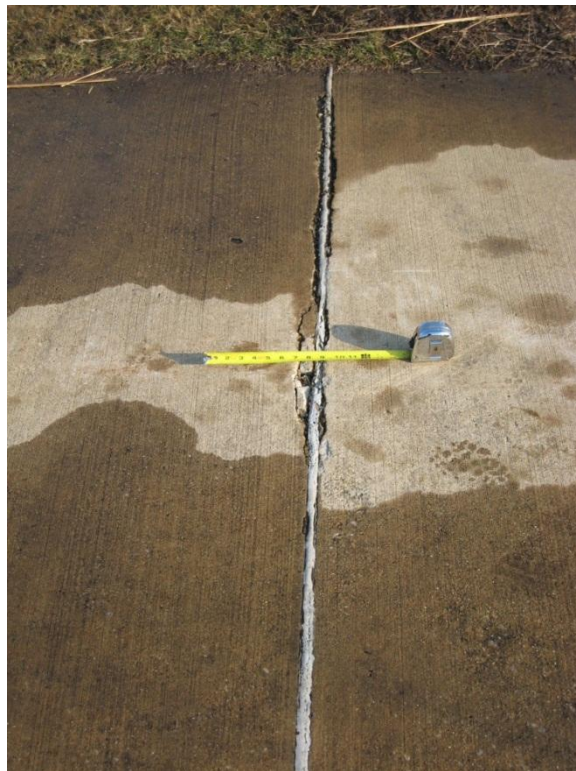
Figure D.6. Joint deterioration due to failing sealant.

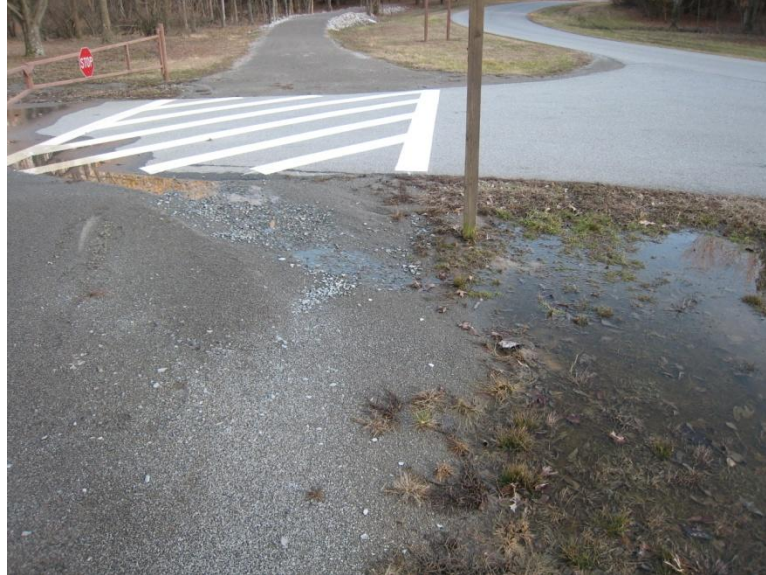
Figure D.20. Additional drainage elements needed in some locations.

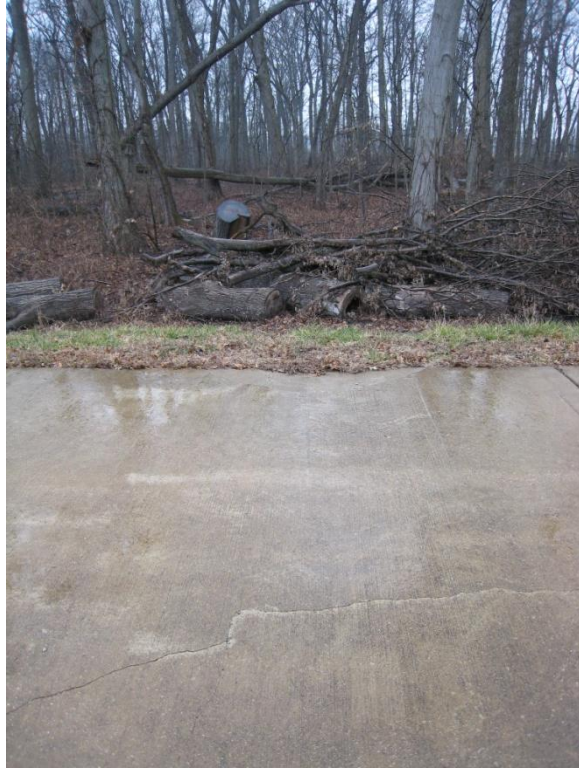
Figure D.25. Slab shattered by tree removal equipment.

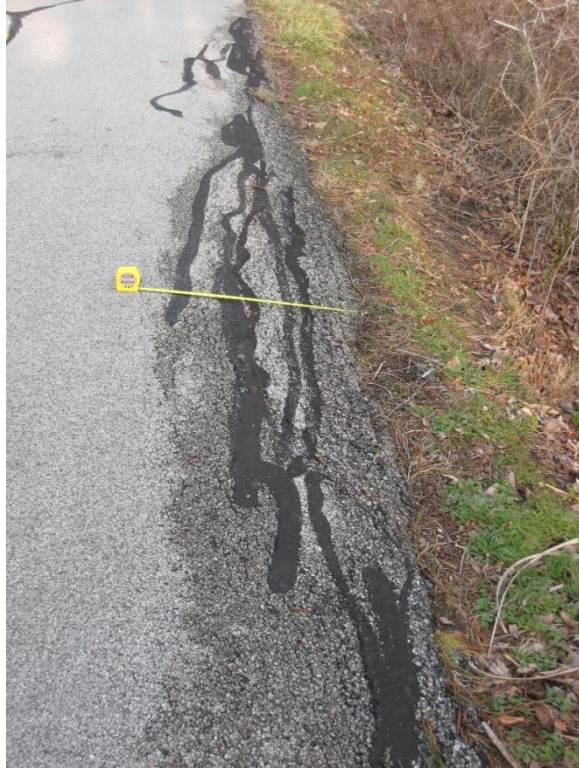
Figure D.32. Area of edge cracking and fall-off.
