National Trail Surfaces Study

Final Report

February 2014

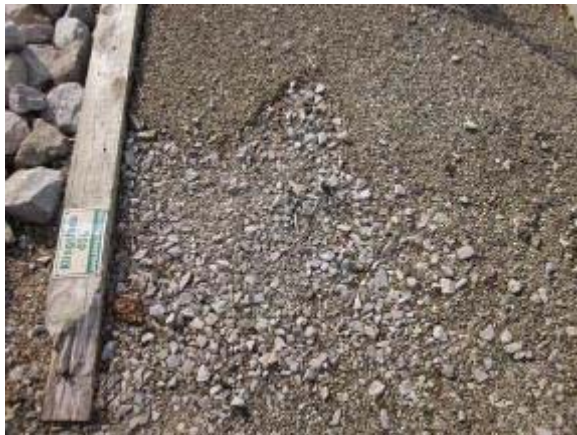
Photo 14 Klingstone loose fines coming to surface. March 17, 2009.

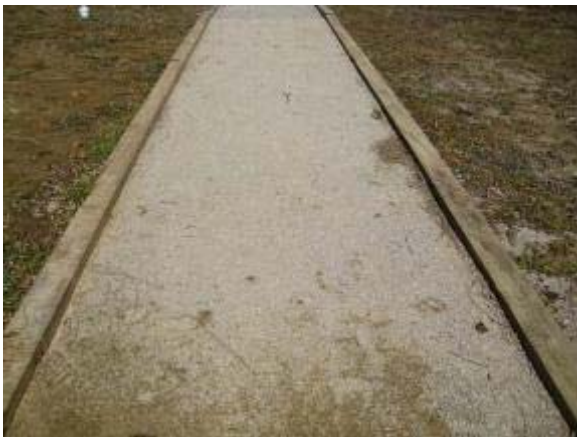
Photo 35 Soiltac Powder Mix-In almost a year after installation. March 13, 2008.

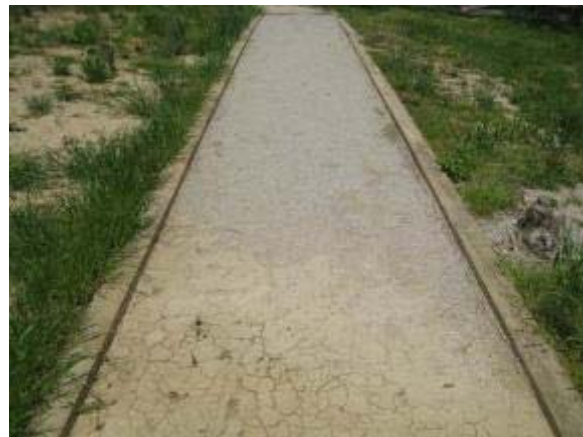
Photo 36 Soiltac Powder Mix-In trail segment maintained its condition a year after installation. March 13, 2008.

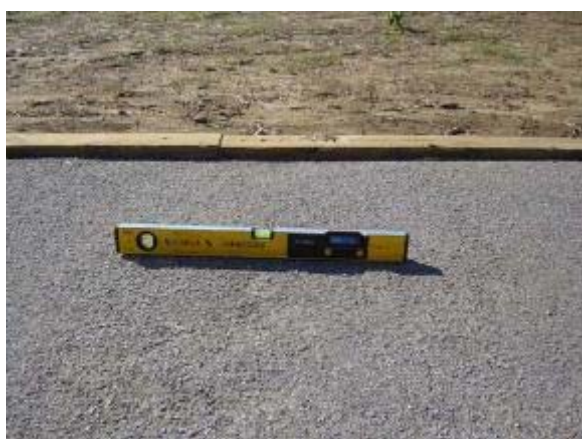
Photo 76 Stabilizer surface shows an indentation from
the surface testing. July 6, 2007.

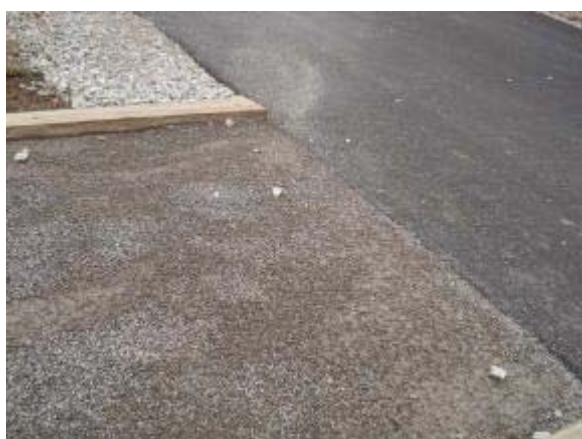
Photo 78 Stabilizer trail segment shows loose fines at
top of surface. October 19, 2007.

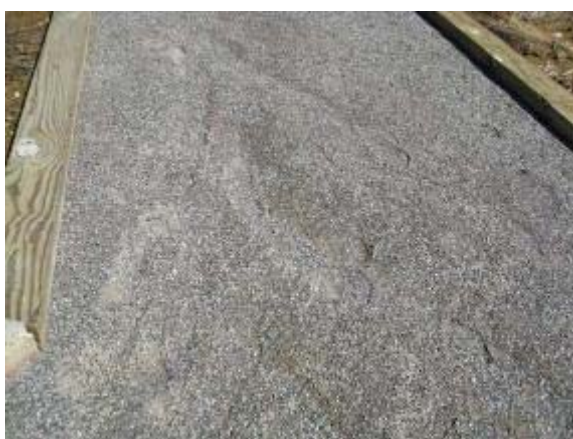
Photo 79 Stabilizer trail segment shows loose fines at
top of surface. October 19, 2007.

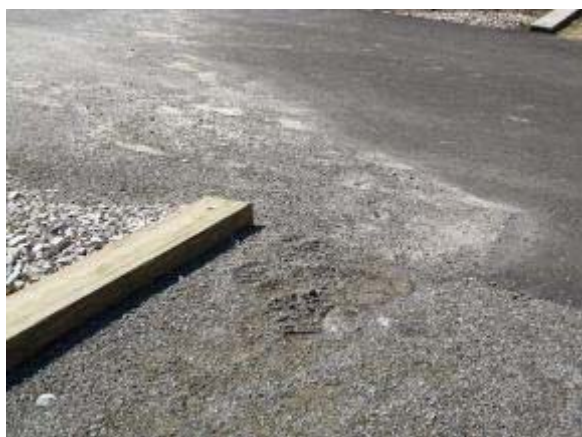
Photo 80 Stabilizer trail segment has runoff from heavy
rainfall. March 13, 2008.

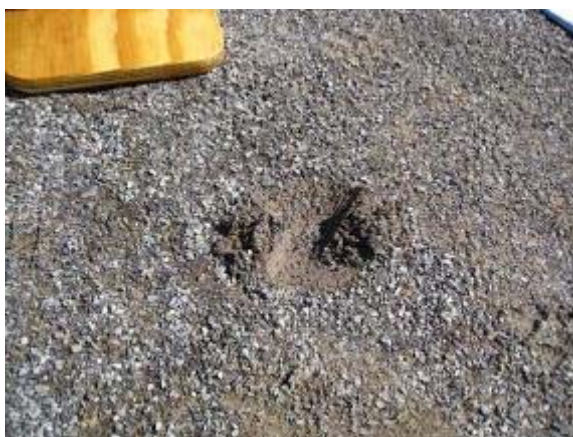
Photo 81 Stabilizer trail segment shows loose fines from heavy rainfall. March 13, 2008.

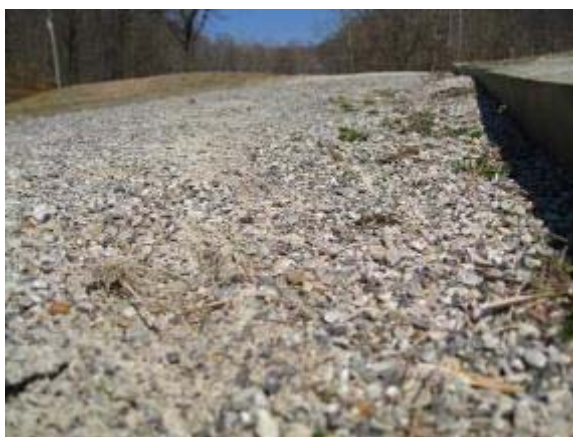
Photo 85 Stabilizer trail segment shows gullies created in surface from runoff. March 17, 2009.

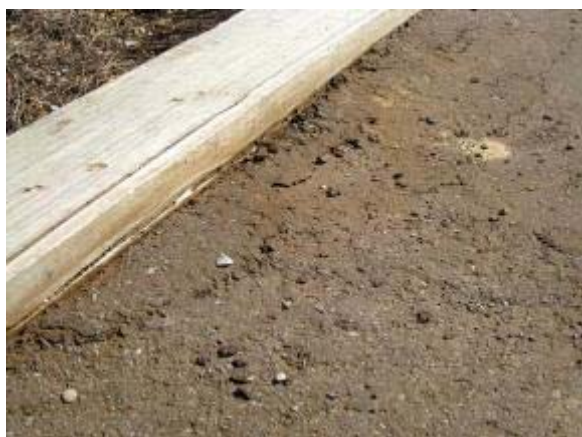
Photo 97 StaLok trail segment maintained itself through first round of testing. October 19, 2007.

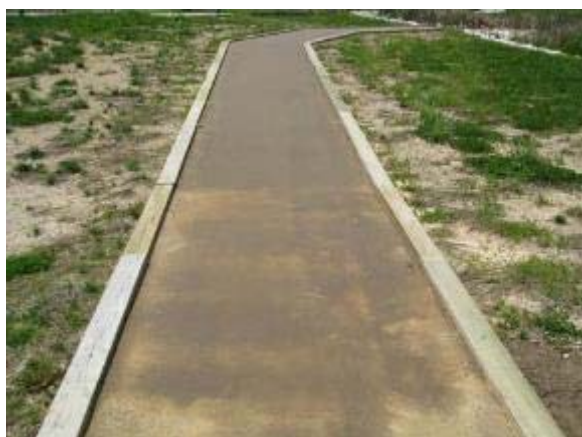
Photo 99 StaLok trail segment was noted for repairing itself. March 13, 2008.

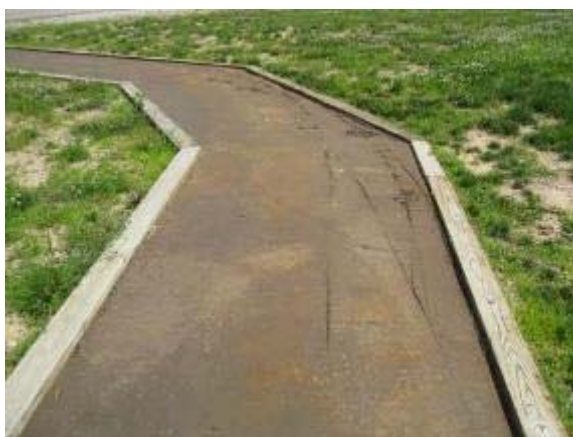
Photo 100 StaLok trail segment was noted for showing indentations and then repairing itself. May 6, 2008.

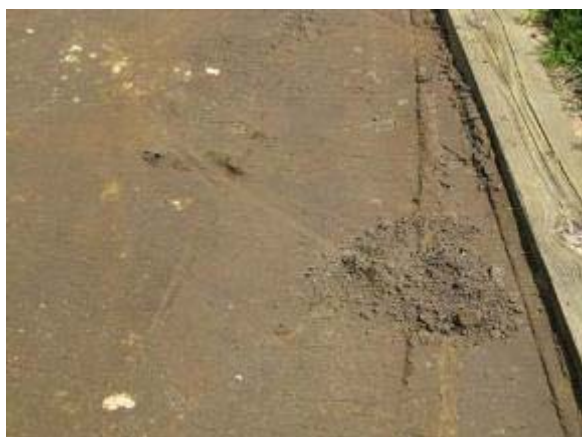
Photo 101 StaLok trail segment with wheelchair marks would repair itself. June 12, 2008.

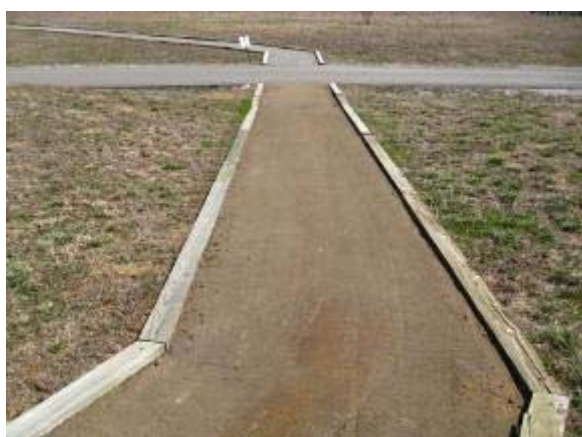
Photo 103 StaLok trail segment previously shown with marks had repaired itself. March 17, 2009.

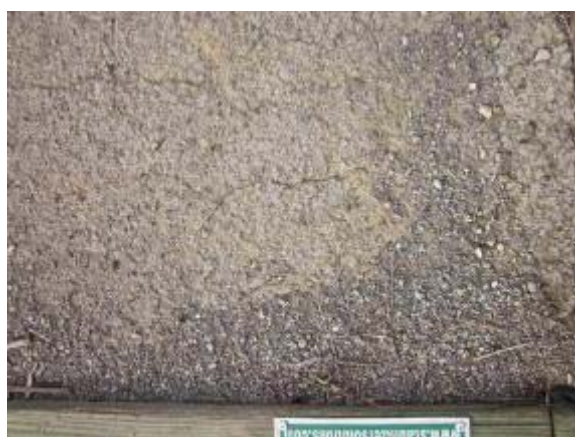
Photo 104 StaLok trail segment previously shown with marks had repaired itself. March 17, 2009.

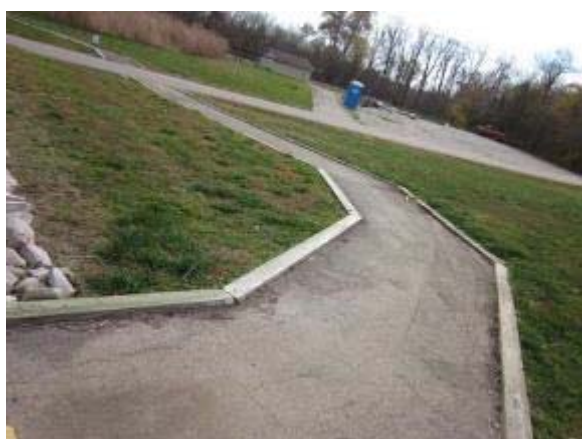
Photo 105 StaLok trail segment shows cracking next to timber edging. November 2, 2011.

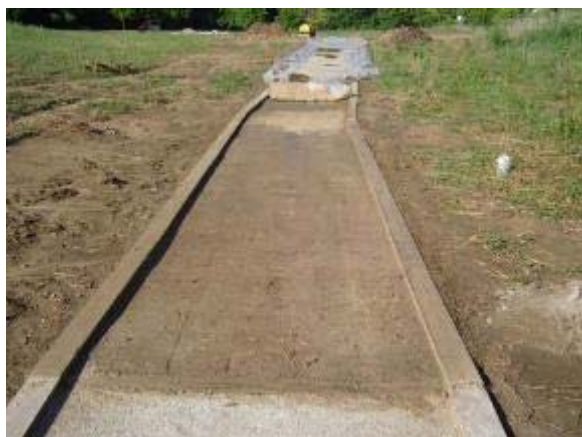
Photo 109 Polypavement is applied to a base of compacted native soils and mixed into an additional 2 inches of tilled soil. July 3, 2007.

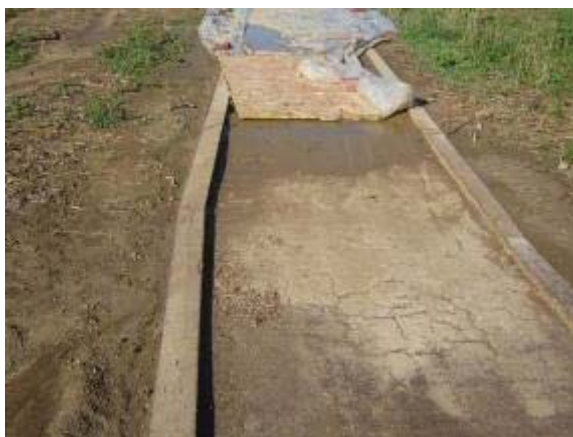
The trail segment is composed of the stabilizer, Polypavement and is 5 feet wide by 30 feet long. The segment contains timber edging. The Polypavement is applied to a base of compacted native soils and is then mixed into an additional 2 inches of tilled soil. The surface started to show signs of cracking, sinking

and softening after the first round of tests when the temperature was still mild and warm (June – August; 100 degree temps). After uncharacteristically heavy rainfall, the surface became the same texture as mud. Upon drying up, the surface remained cracked and was heaving along the full width of the trail. The material just under the surface of the segment, contains cracks and heaving and stayed wet and therefore soft under foot. NCA continued to test the surface to ensure consistency in data collection, despite the initial impression that the Polypavement application was not maintaining itself. It appeared that the top layer of the surface was all that was left of the stabilizer and the remaining surface had returned to its natural soil state. The assumption is that this surface, because of its natural soil base, never got the opportunity to set up properly because it was installed in wetlands where the soil naturally maintains more moisture.

Photo 110 Polypavement trail segment started to show signs of cracking and softening after the first round of tests. July 6, 2007.

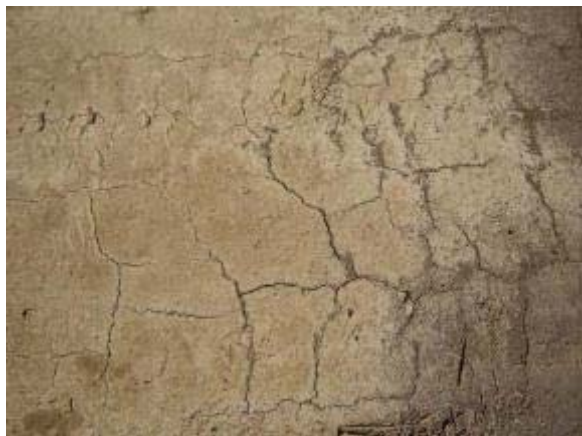
Photo 111 Polypavement trail segment started to show signs of cracking and softening after the first round of tests. July 6, 2007.

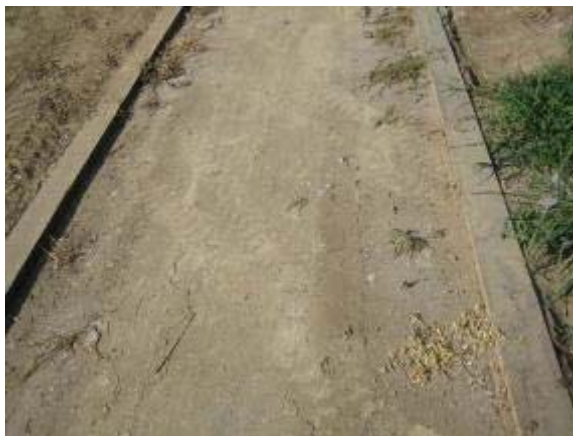
Photo 112 Polypavement trail segment shows cracking. July 6, 2007.

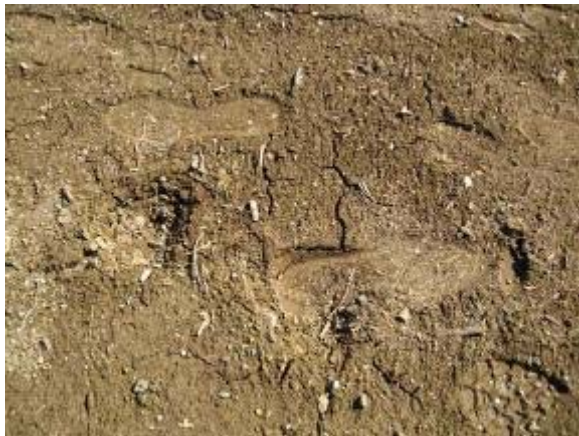
Photo 115 Polypavement trail segment would dry with cracks and heaving after heavy rail. March 13, 2008.

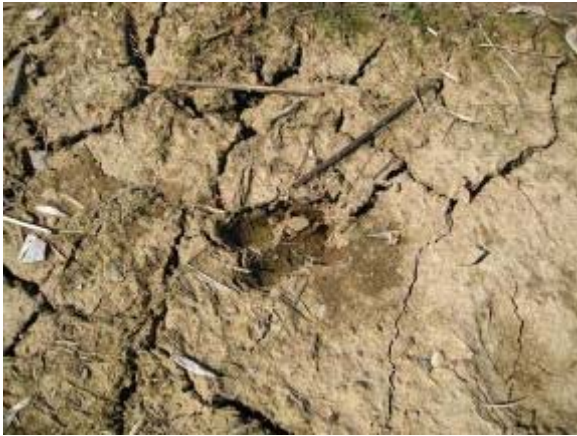
Photo 119 Polypavement trail segment almost two years after installation shows top layer of stabilizer and remaining surface returned to its natural soil base. March 17, 2009.

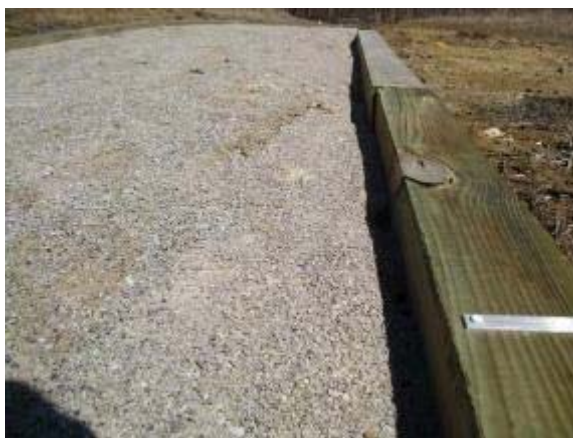
Photo 135 Quarter Inch Minus Limestone trail segment maintained itself in dry temperatures. October 19, 2007.

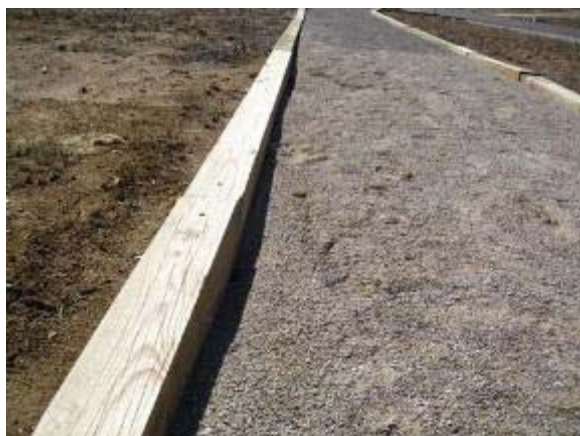
Photo 136 Quarter Inch Minus Limestone trail segment was loose under foot after heavy rainfall. March 13, 2008.

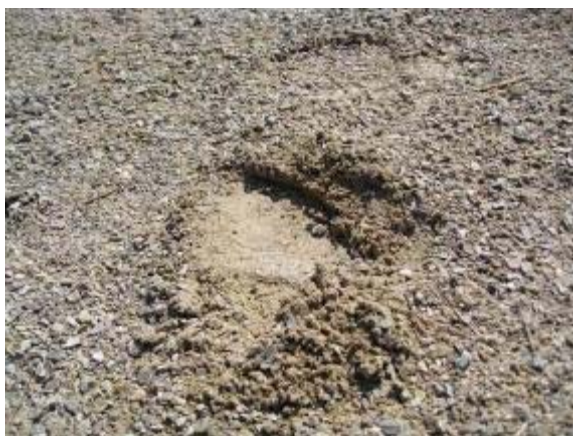
Photo 137 Quarter Inch Minus Limestone trail segment developed an erosion ditch. March 13, 2008.
