CUSTOMER SUCCESS STORY

WIRELESS MONITORING PREVENTS PRODUCTION LOSS

INDUSTRY | Automotive – Rubber

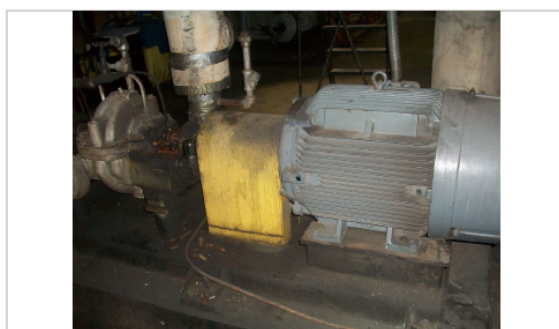
Asset Photo

Analysis Comment: The vibration data and cross channel phase analysis indicates misalignment at the coupling.

Failure Mode: Misalignment

1230-UTI-STM-WTR-BFP-P01-#1 BOILER FEED WATER PUMP

Repair Recommendation: Perform a precision alignment and replace the elastomer coupling insert. Align the key ways 180 degrees apart. Set the coupling gap to the manufactures recommended distance for the coupling being installed. Properly lubricate the coupling if applicable.
