CUSTOMER SUCCESS STORY

CONTINUOUS MONITORING SAVES TIME AND MONEY

INDUSTRY | Chemical Processing

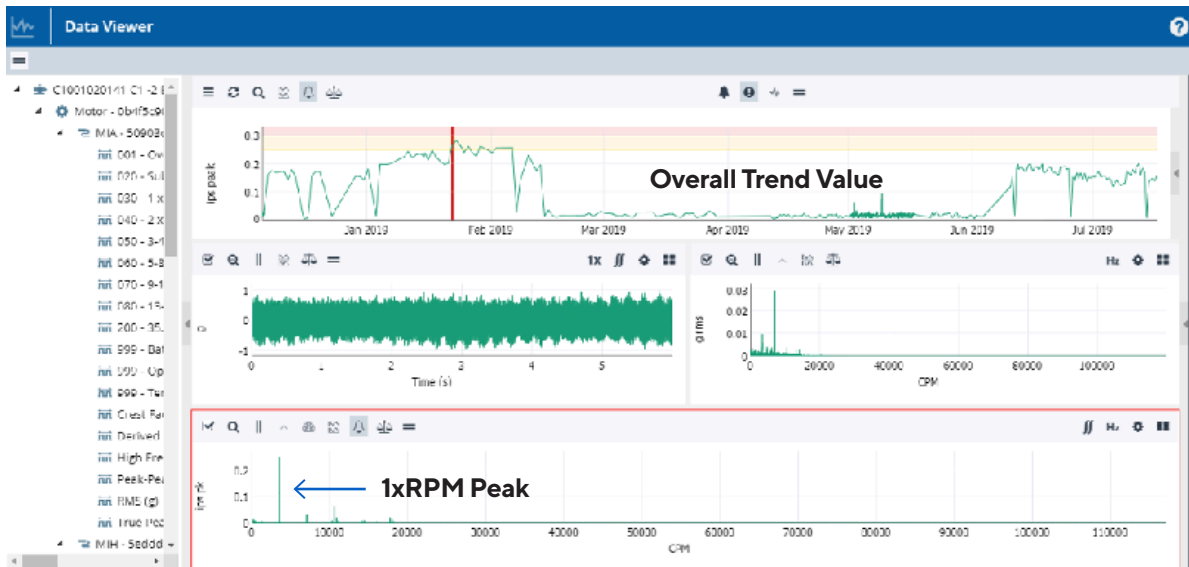
Our wireless system detected an increase in energy at 1xRPM and overall data that exceeded the alarm threshold thus sending an alarm to the Allied Analyst. The Allied Analyst then leveraged the SmartCBM™ reliability tool suite to determine the cause.

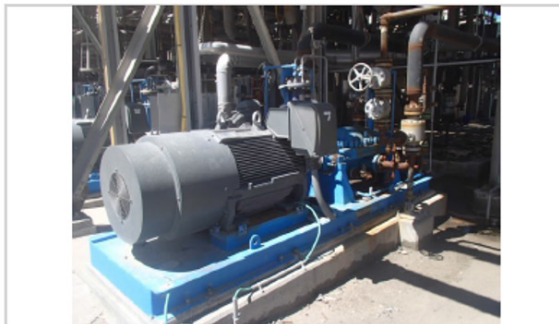
C1001020141 #2 Boiler Feed Water Pump (1-3)

A full review of the data indicated that the coupling had locked up at startup. The analyst created a fault entry report for the customer and communicated to everyone that was impacted. The report clearly outlined the assessment and the repair recommendation. Further inspection revealed that product had clogged the entire baghouse and 'bridged' over 50% of the 'dumps', causing a turbulent flow issue. The facility was shutdown to complete the repair, which took less than 15 minutes.

- Analysis Comment:**
- Increasing vibration on motor at one times operational speed.
 - This signature is commonly associated with coupling misalignment and/or damage.

- 1. Ensure all mounting hardware is intact with proper torque.
- 2. Inspect coupling for wear/damage and verify alignment is within 0.002".
- 3. Complete any additional repairs as found.
- 4. Contact Allied for a post repair quality check when repairs are complete.

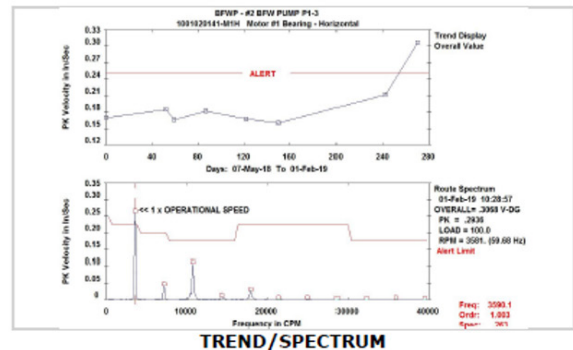
Fault entry report capturing analysis and repair recommendation for client
