Troubleshooting Why LIV & App Onboarding Fails

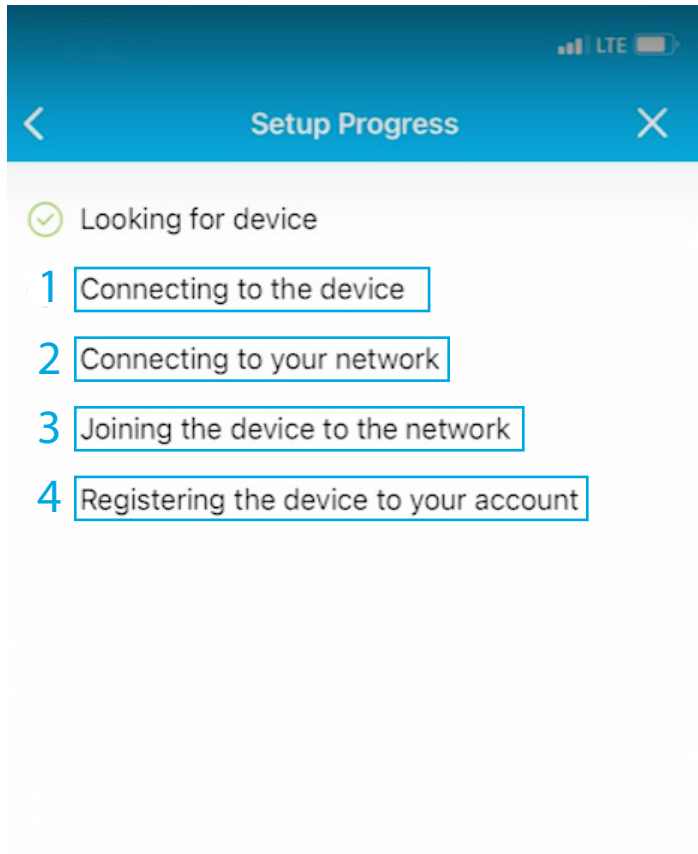
1. If the device fails at this step, try to get closer to the Wi-Fi router and try again. If it continuously fails at this step, it may be a faulty Hub.
2. When a device fails at this step, it traditionally means the Wi-Fi network is not a 2.4 GHz network or it may not be enabled.
3. If continuously failing at this step, it is suggested to do a Wi-Fi speed test as the connection may not be suitable for LIV or any other smart home device.
4. Contact Thermacell Support and they will help get the customer registered manually if it continues to fail here after multiple attempts.
