Exposure of a dense PTFE Membrane in a GBR Procedure: Proposal of a Treatment Protocol

Italian Society of Osseointegration

Dr. Fabrizio Belleggia DDS, Specialist in Oral Surgery, Private Practice, Rome, Italy. fabriziobelleggia@virgilio.it

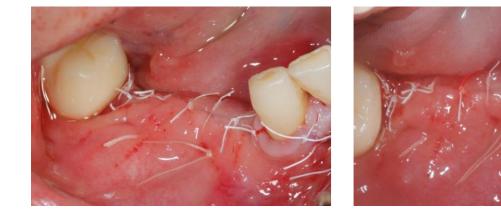
Horizontal mattress and single PTFE sutures.

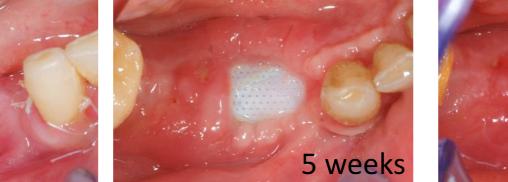
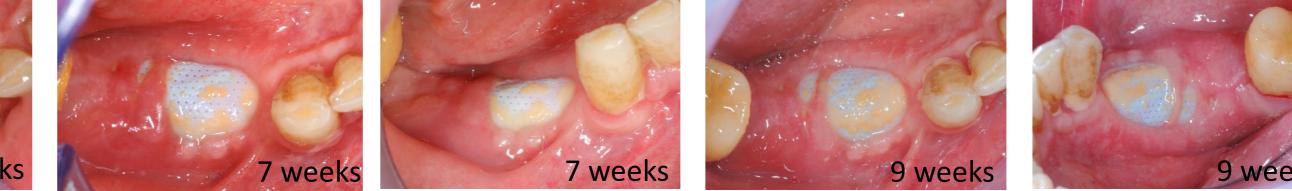
Suture removal after 2Soweeks.fr

Some weeks after suture removal, the membrane exposure happened. It was not removed until the mesio-distal limits of the exposure were far from the edges of the membrane.

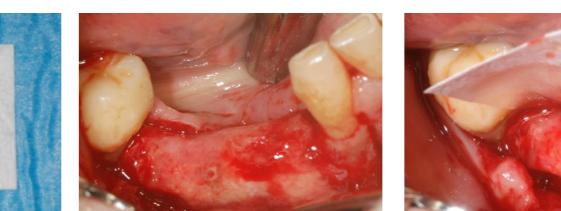
connective tissue layer. No sign of infection or suppuration was detected.

After 10 weeks the membrane was removed. The graft underneath the membrane was covered by a thin

A Cytoplast RTM 2030 collagen membrane, stabilized with tacks, covered the immature graft.

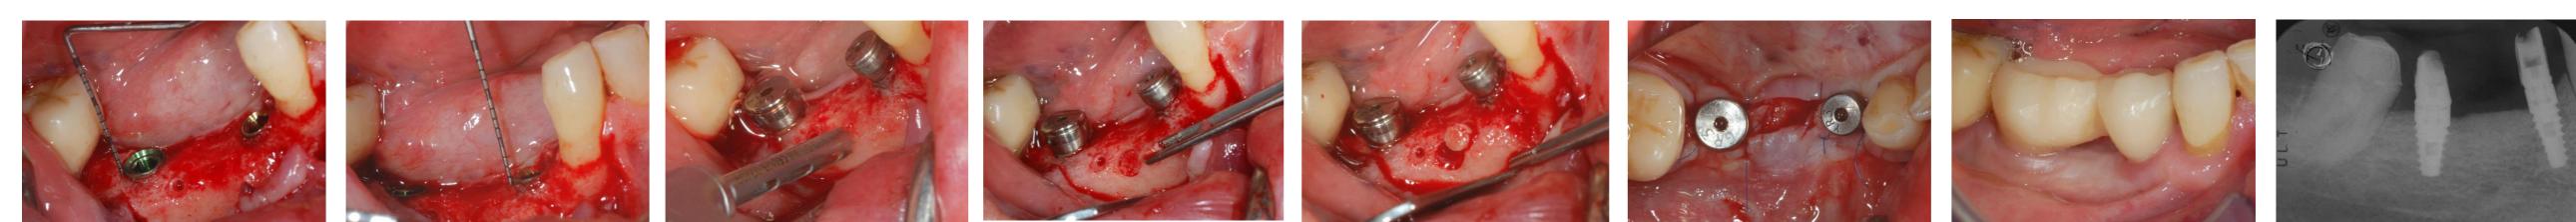
The neck of the implants with Laser-Lok channels were positioned above the bone crest for connective tissue integration. The width of keratinized tissue allowed healing abutment application for unsubmerged healing. After a 3-month healing period, provisional abutment and provisional restoration were connected for progressive loading.
