Guide to Sustainable Mountain Trails – *Sketchbook*

Fundamentals of Mountain Trail Sustainability

- ◆ On September 12th, major flooding occurred in the foothills northwest of Denver, CO.
- ◆ 13.15” of rain fell during the storm in Allenspark, CO.
- ◆ Main roads following mountain rivers washed away cutting off access to the RMNP. Trail Ridge Road which climbs to 11,000’ was the only intact access.

Rocky Mountain National Park – Trail Recovery Plan

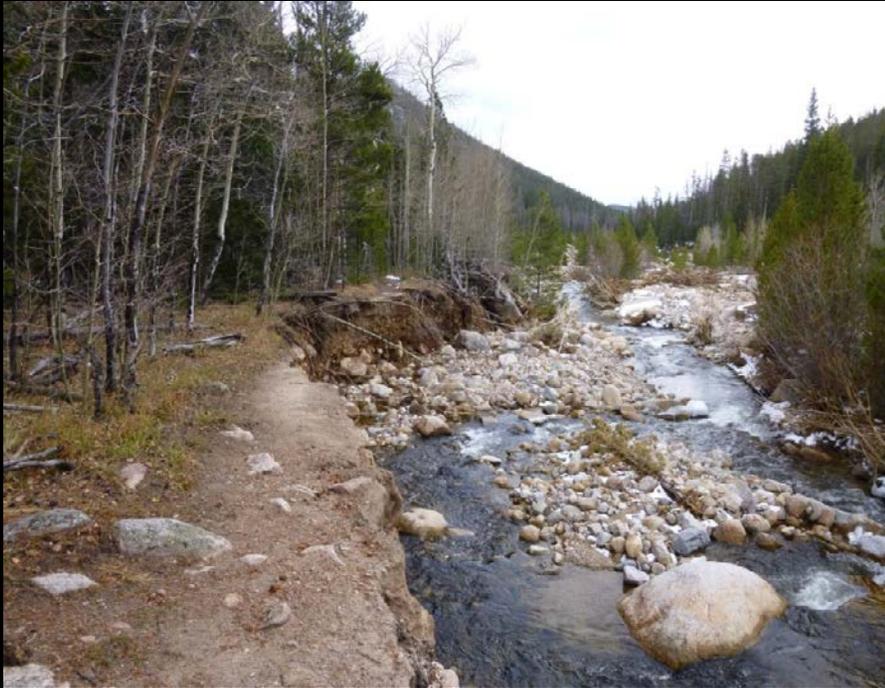
Bank Failure on the Lawn Lake Trail

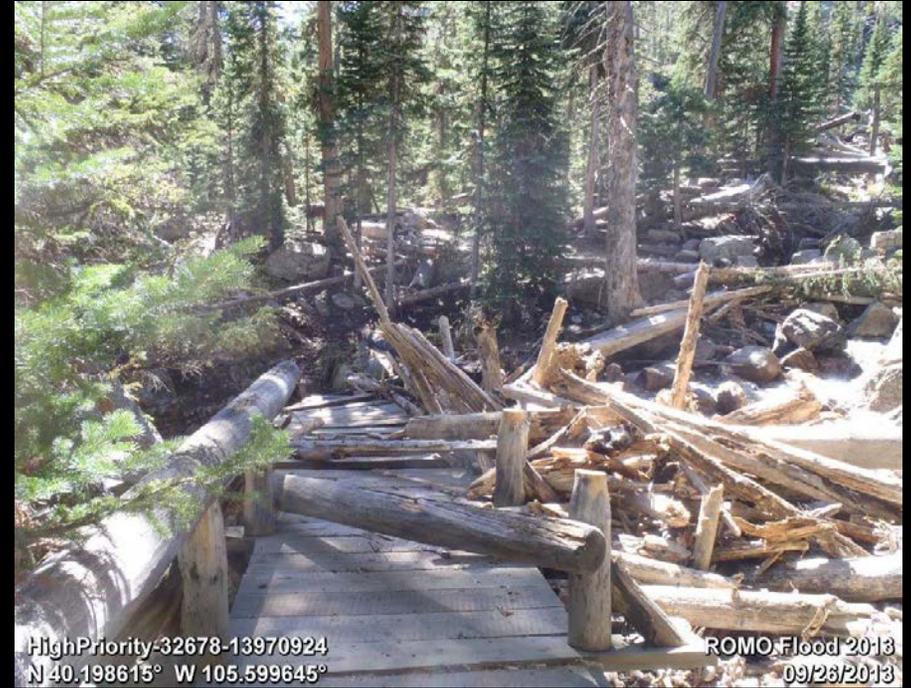
Bridge damage on the Ouzel Falls Trail

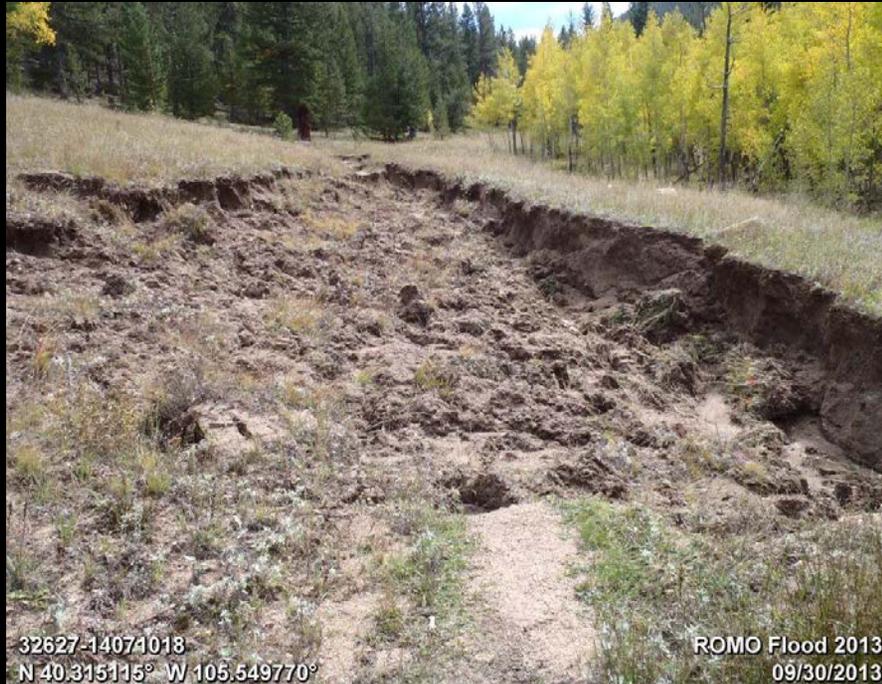
Collapsed Tread on the Aspen Brook Trail

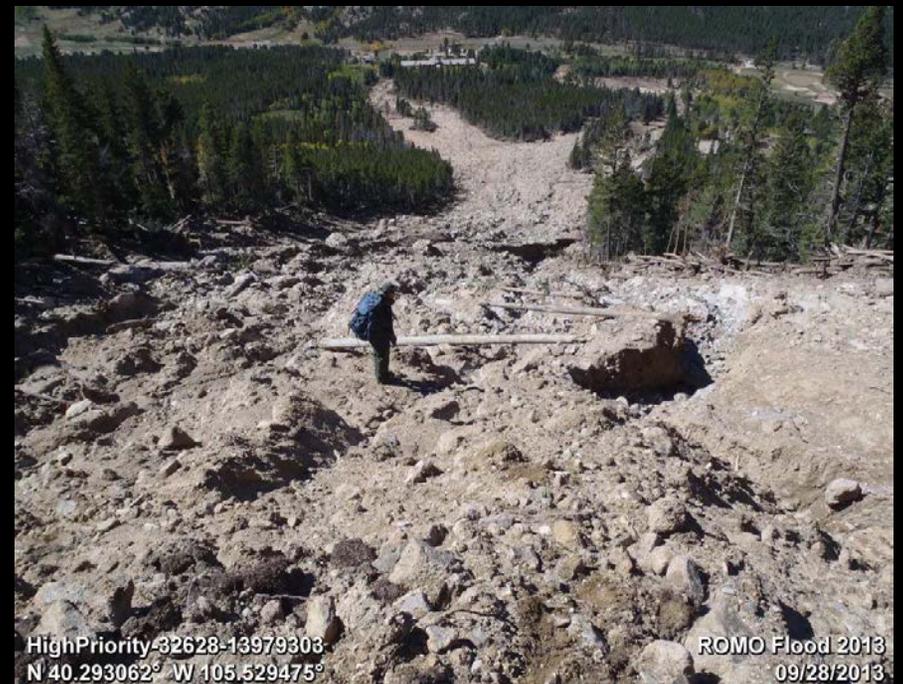
Landslide at the Twin Sisters Trail

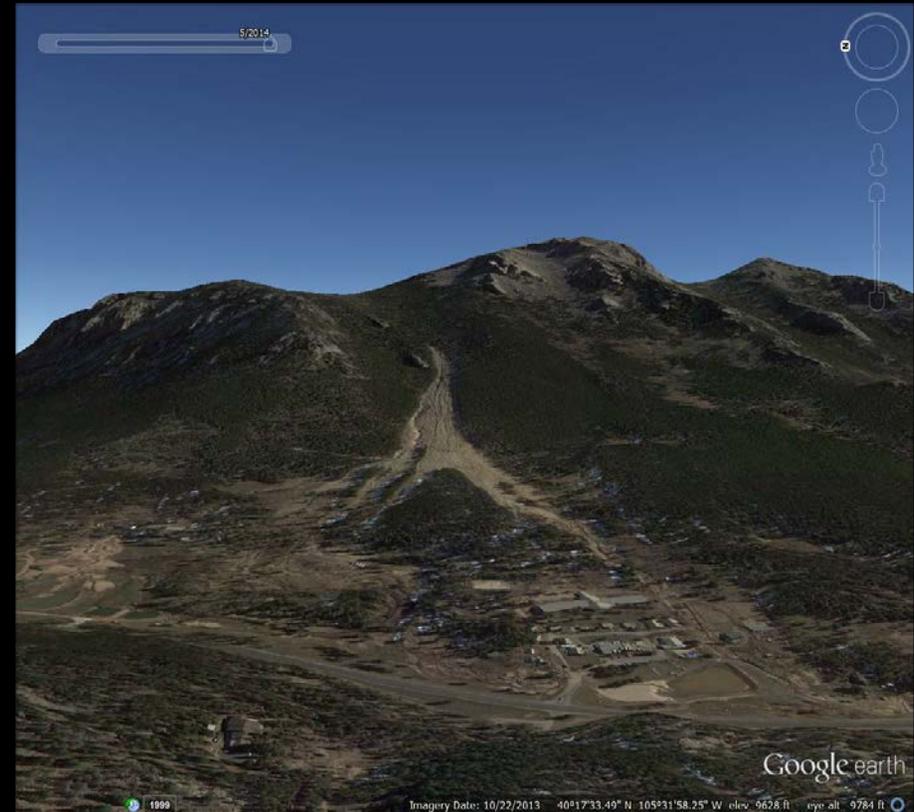
Post-Great Flood of 2013 Google Earth Image

- ◆ A major landslide removed approximately 2,110 LF of trail and five switchbacks.
- ◆ Social Trails are occurring along both sides of the slide – an unacceptable occurrence.
- ◆ Small landslides are occurring to the south of the existing slide. Mitigation likely required, to be determined.

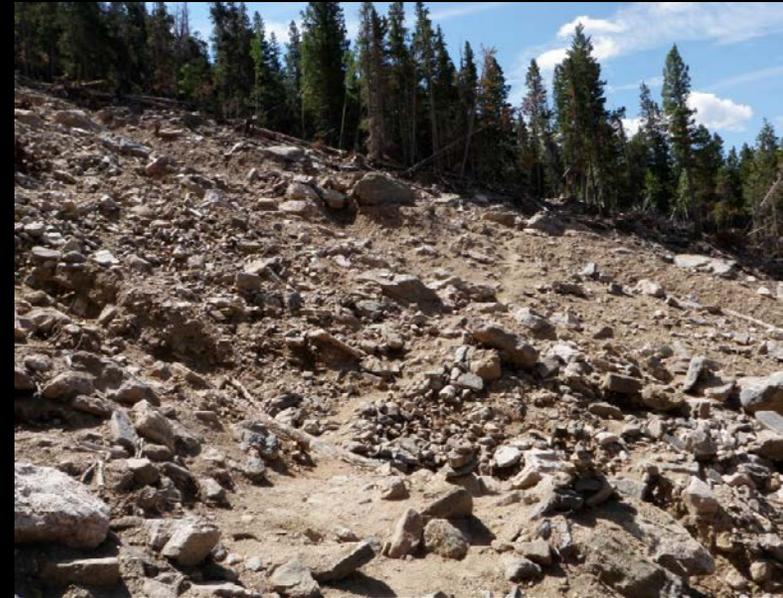
Twin Sisters Slide (Looking South)

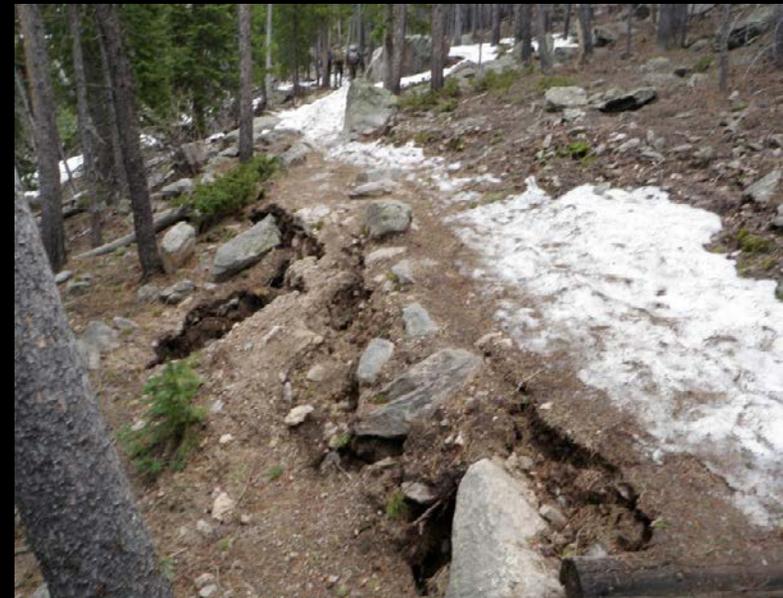
Evidence of Unstable Slopes

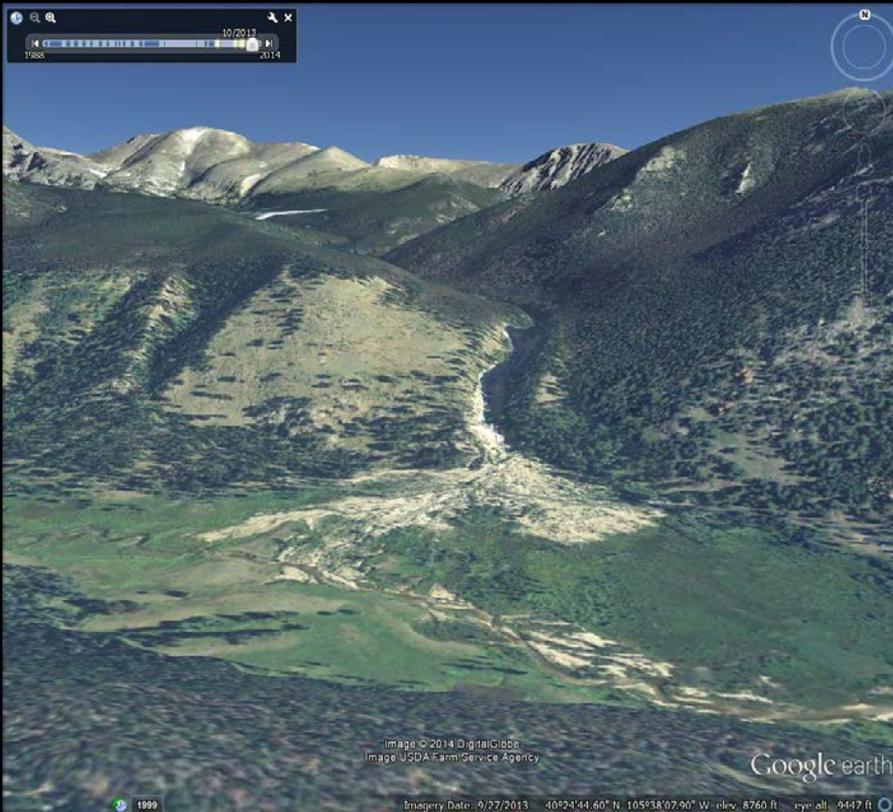
Before Great Flood of 2013

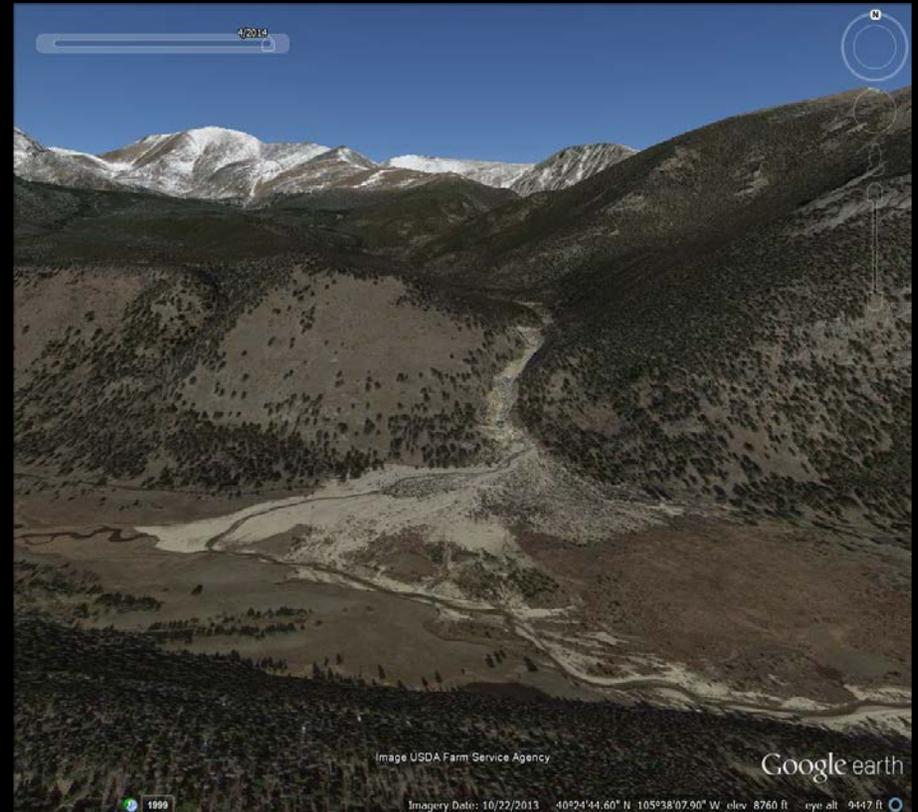
After Great Flood of 2013

- ◆ Roaring River jumped its banks and moved the channel to the west.
- ◆ Western section of trail completely demolished.
- ◆ Eastern section of trail **almost** completely destroyed.

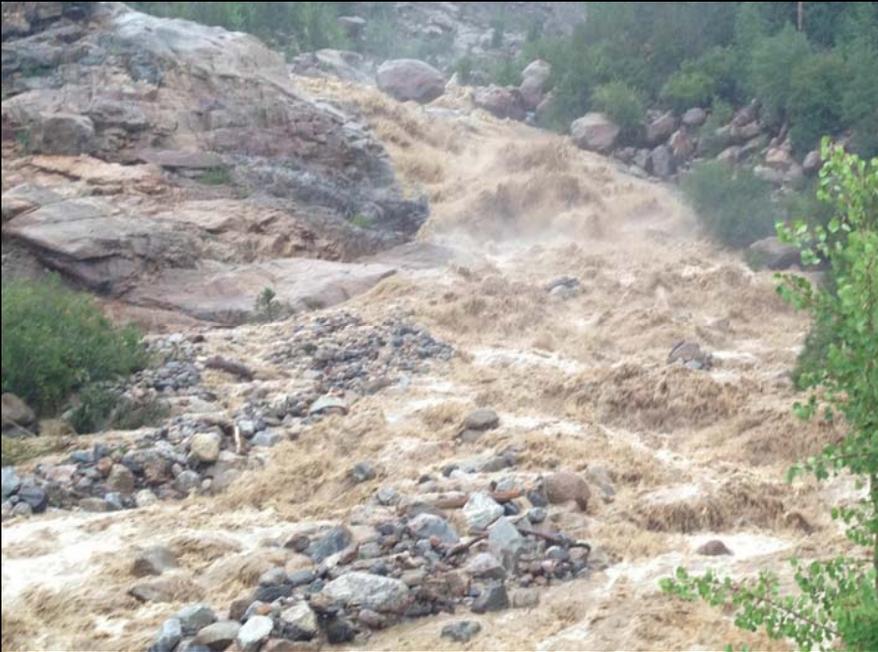
During Flood – Water Raging

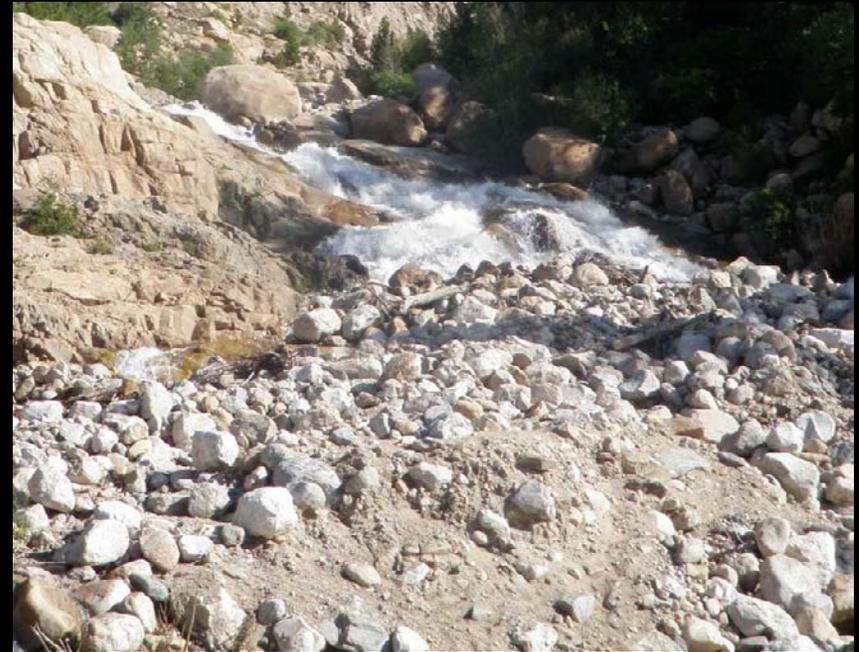
Typical Condition Immediately Post-Flood

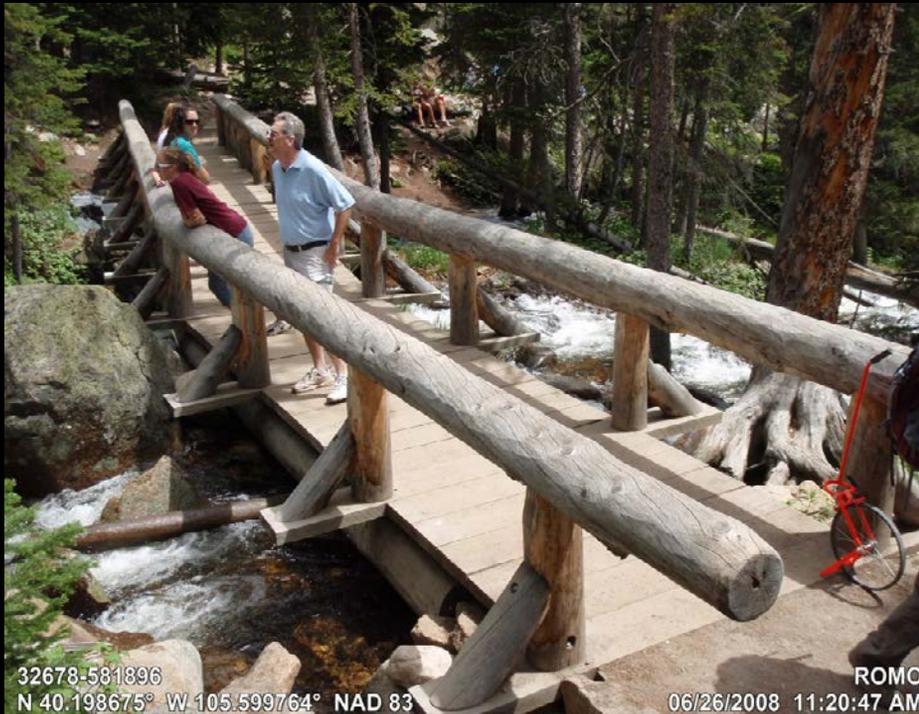
Before the Great Flood of 2013

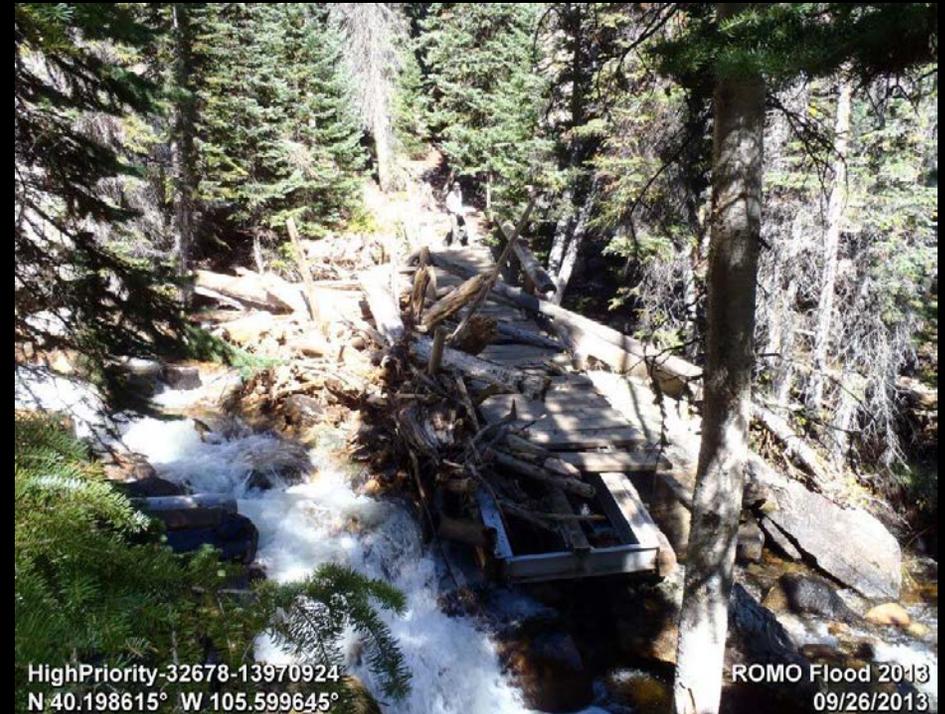
After the Flood of 2013

- ◆ Flooding in Ouzel Creek destroyed a multiple use bridge cutting off access to a popular loop hike.
- ◆ Social Trail leading to “unofficial” overlook receives much more use due to destruction of lower (original) viewing area.
