**U.S. Geological Survey, Virginia Tech Field Unit
FINAL RESEARCH REPORT**

**Improving the Sustainability of the Appalachian Trail: Trail and
Recreation Site Conditions and Management**

Final Report, May 2020

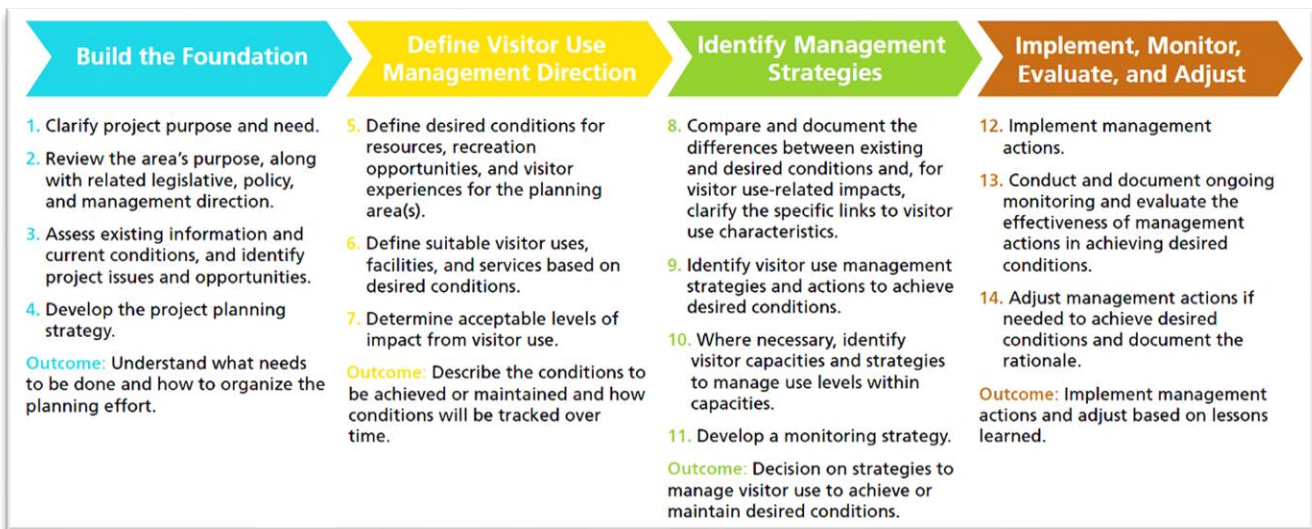
Figure 3. The Visitor Use Management (VUM) framework recommended by the IVUMC for adaptively managing visitor use and carrying capacities in protected natural areas.

can be used for comparison to future assessments to document longitudinal change and for establishing resource condition thresholds (standards) as part of carrying capacity and Visitor Use Management decision-making (Figure 3).

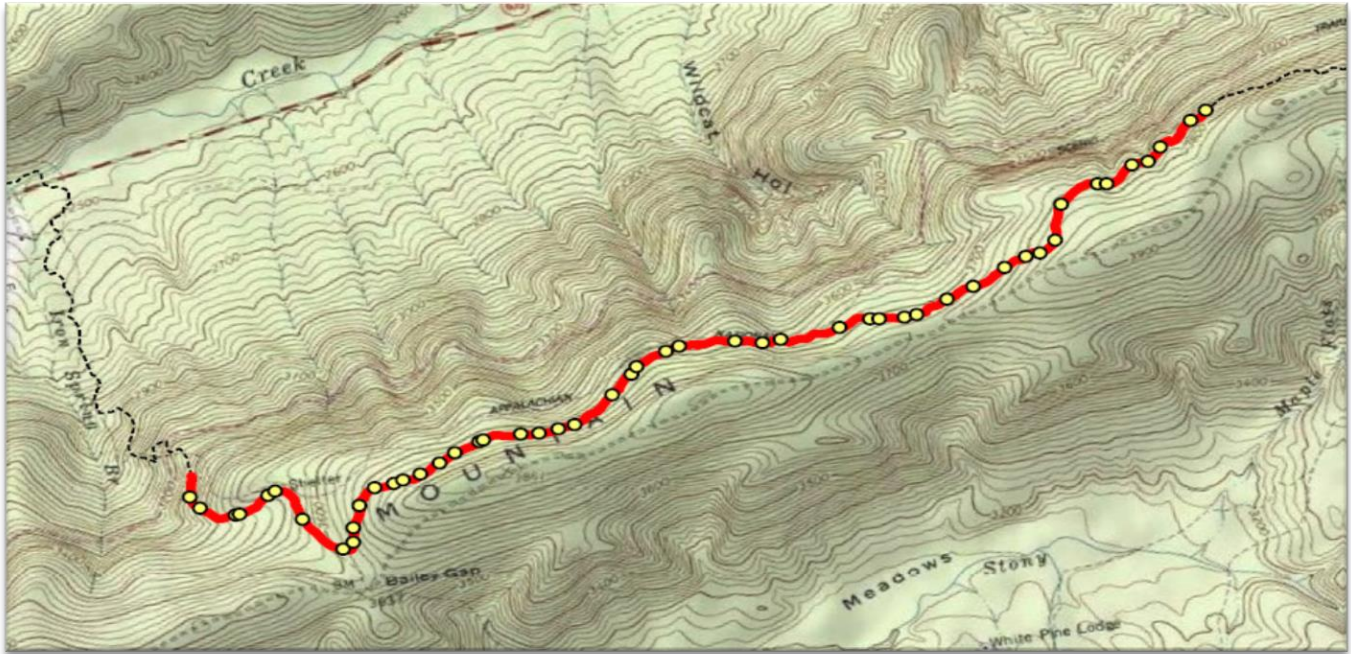
Figure 6. Map showing the locations of 50 sample points determined by second-stage GRTS sampling where AT tread conditions were assessed at temporary trail transects.

A second stage of GRTS sampling was then conducted for each of the 63 5 km segments to determine the sample locations where A.T. tread conditions were assessed. Within each sampled segment, the GRTS sample point list was again referenced to select the first 50 points, providing a second spatially-balanced representative sample (Figure 6). Field staff navigated to each of these points with a Trimble Geo7X GPS unit and established a temporary trail transect oriented perpendicular to the tread. The distances between these varied but on average they occurred every 328 ft (100 m) and no closer than 26 ft (8 m). A total of 3,150 A.T. trail transects were established and assessed over the three seasons of A.T. fieldwork.

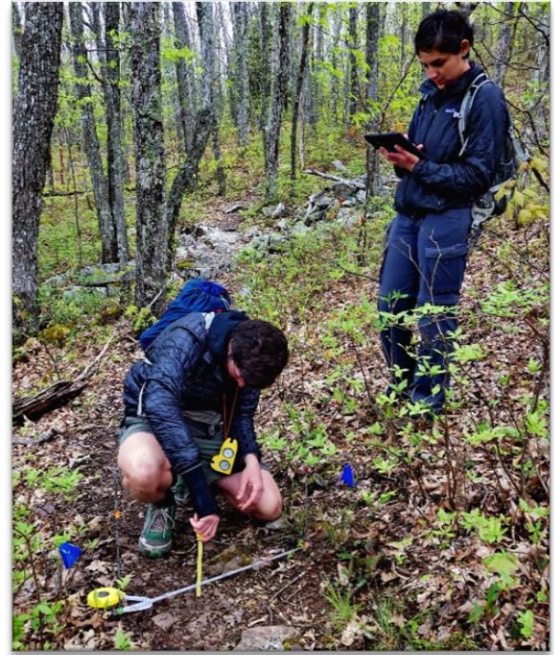
Trail Slope Alignment (TSA)	Degradation Potential	Trail Profile
<i>Fall-aligned Trails</i>		
0-22°	Very High – tread drainage rarely possible; erosion, widening, & muddiness probable	
23-45°	High – tread drainage is often difficult; erosion, widening, & muddiness are likely	
<i>Side-hill Trails</i>		
46-68°	Low – tread drainage is possible; low potential for problems	
69-90°	Very Low – tread drainage is easy; very low potential for problems

A variety of inventory indicators were assessed to support statistical relational analyses, including trail grade, trail slope alignment angle (Figure 8), and tread construction and maintenance practices. Watershed attributes, vegetation and soil type, and other indicators were also assessed at the site or derived from GIS analyses. Trail grade at the transect was measured to the nearest degree using a clinometer sighted between one field crew member on the transect and another on the trail 3m uphill. Similarly, the landform grade was measured between the transect and a point 9.8 ft (3 m) uphill along the fall-line (the path water would follow if poured on a slope). Trail slope alignment was measured as the smallest difference in compass bearing between the trail and the prevailing landform aspect. Soil texture was determined by feel with a ribbon test at the beginning of each segment and when the survey crew observed changes in soil appearance thereafter (see Appendix 2). Tread type was recorded from the following categories: soil/organic muck,

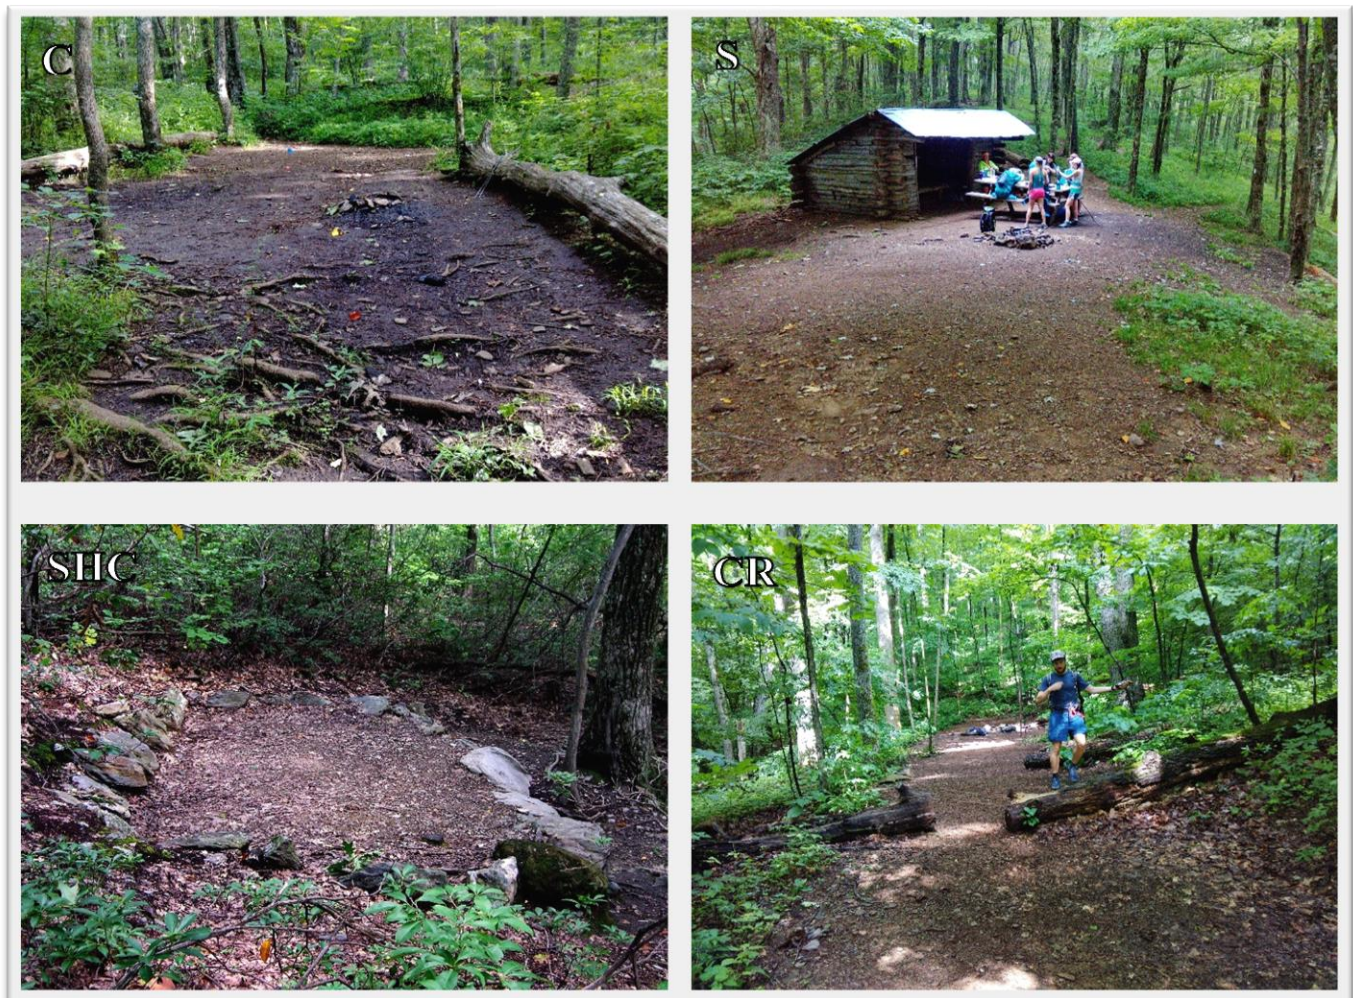
Figure 10. Photos illustrating four campsite types: C - Campsite, S - Shelter, SHC - Side-Hill Campsite, and CR - Campsite on Road.

Campsite type refers to the following categories: campsite (C), shelter site (S), side-hill campsite (SHC), and campsites on roads (CR) (Figure 10). Side-hill sites are located in sloping terrain and constructed with cut-and-fill excavations to create level campsites with a small expansion-resistant “footprint.” Campsites on roads are those created by visitors or trail managers along former (closed) forest roads. Tree canopy cover was estimated using the six groundcover categories as the percentage of the site shaded by the tree canopy when the sun is directly overhead. Offsite woody vegetation density and offsite topographic roughness (ruggedness due to rocks) were recorded in three categories (low, medium, high), referencing the extent to which vegetation density or landscape roughness in offsite areas would constrain campsite expansion. Site expansion potential was rated using three categories (poor, moderate, high), also referencing the extent to which features in immediate offsite areas would constrain campsite expansion, including slope, rockiness, vegetation density, and/or drainage (Eagleston and Marion 2017).

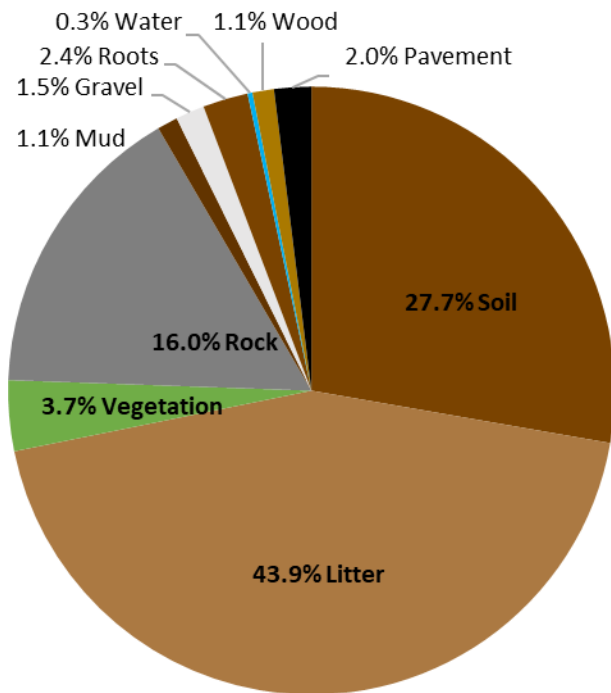
Figure 12. Pie chart illustrating the relative proportions of AT tread surface cover.

Muddiness, averaging 1.1% of the surveyed tread surface, increased from south to north, ranging from 0.1% in SORO to 2.3% in NERO (Table 6). Wood, which reflects the presence of boardwalks or bog bridging to respond to muddiness, or water bars to mitigate soil loss, was also more common in the north, increasing from 0.2% in SORO to 2.0% in NERO. Finally, standing or running water averaged just 0.3% of treads but ranged from 0.0% in SORO to 0.6% in NERO. A pie chart illustrating the proportions of these tread surface categories is included as Figure 12.

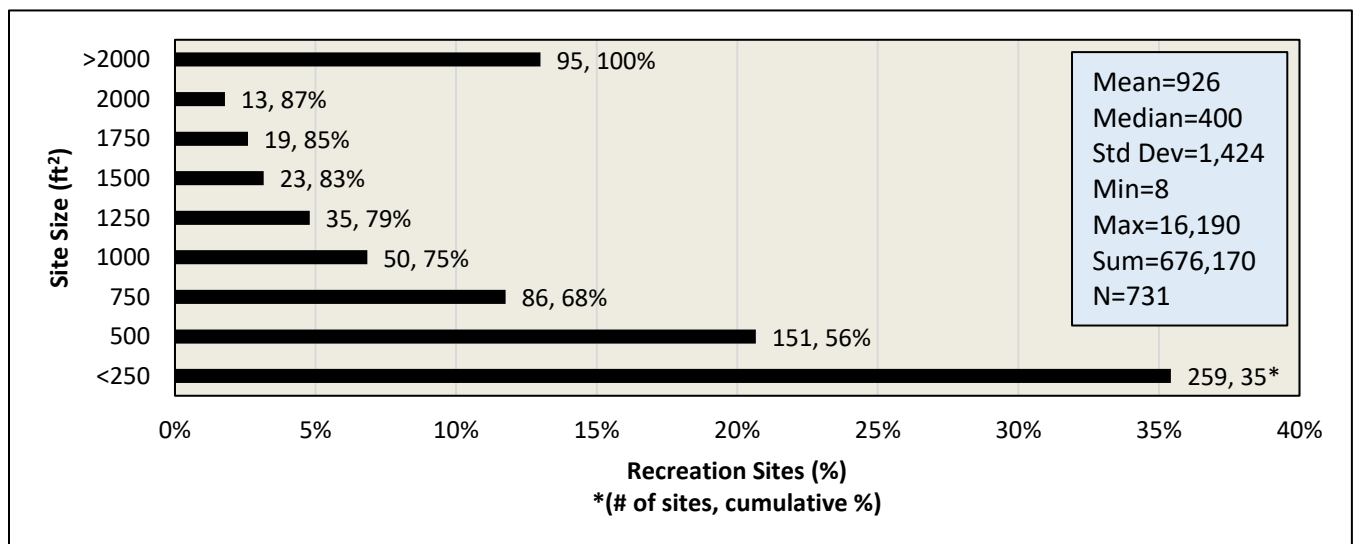
Figure 25. Frequency distribution and descriptive statistics for recreation site size.

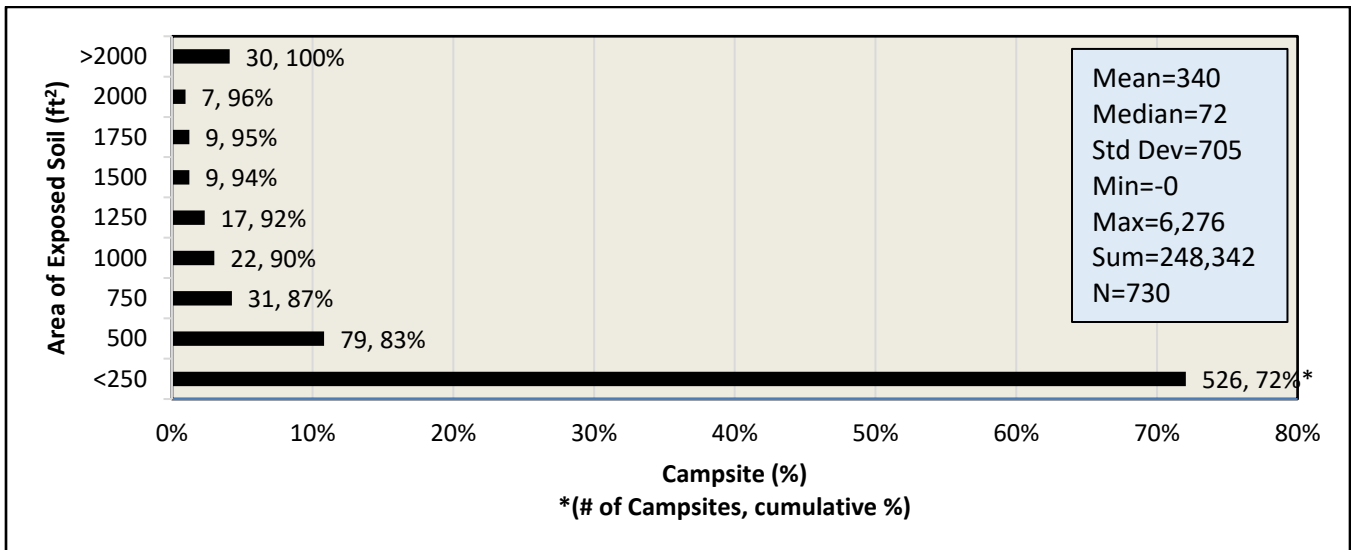
Figure 27. Frequency distribution and descriptive statistics for area of exposed soil.

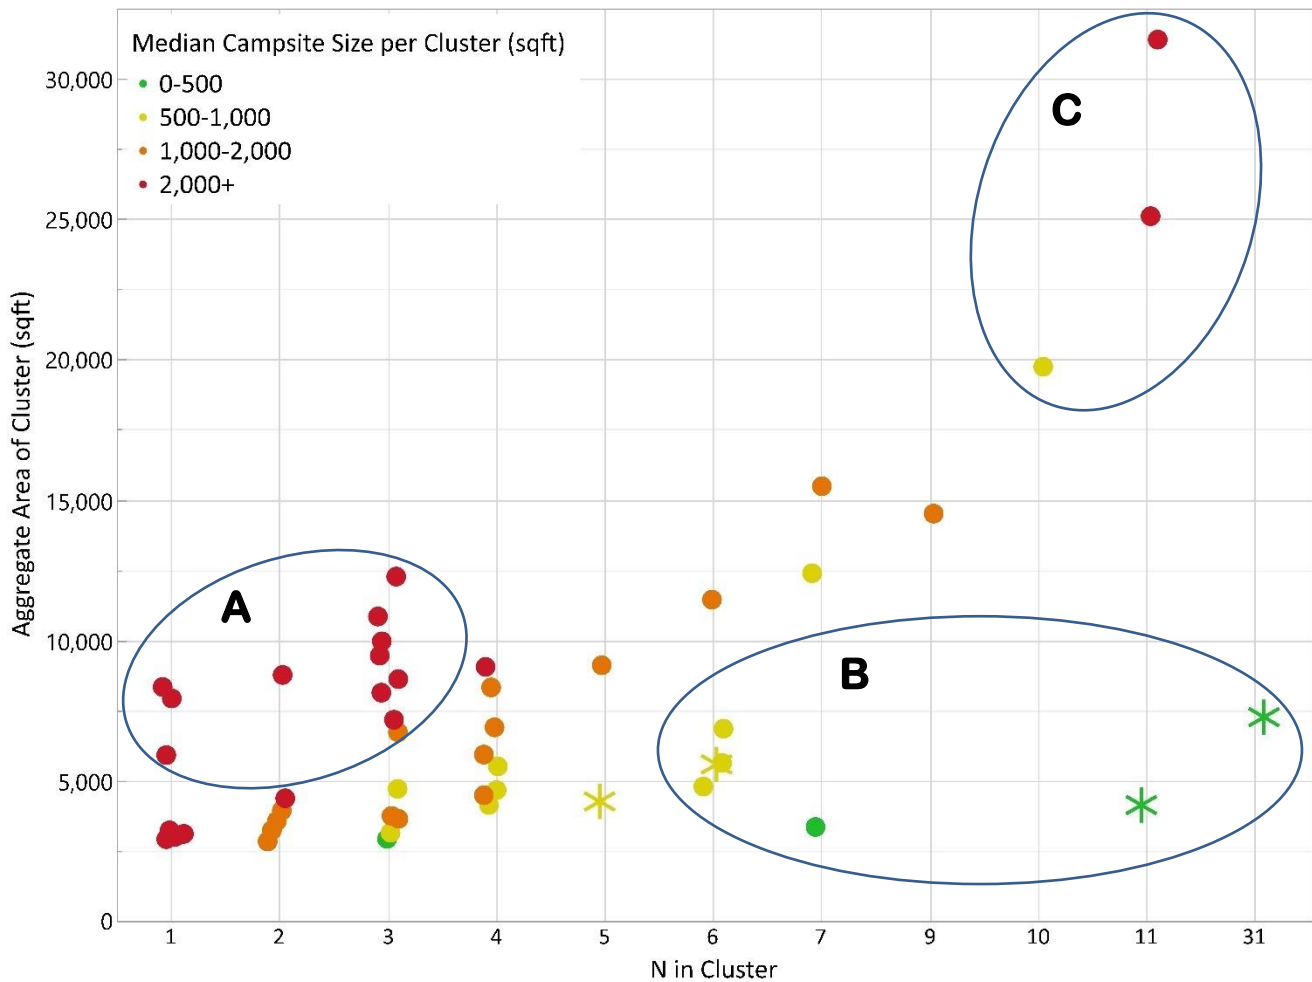
Figure 28. Aggregate area of cluster, number of campsites in cluster, and median campsite size per cluster (color-coded). Side-hill campsite clusters are shown as stars (*), all others as round points.

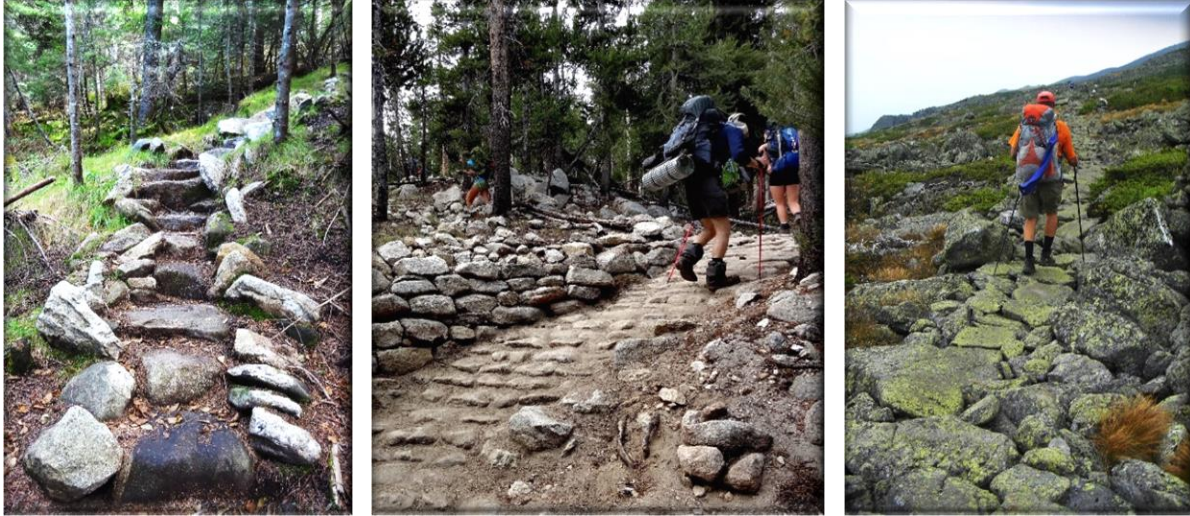
Figure 29. Tread construction with stone steps or stone armoring of trail treads can help minimize soil loss in steep terrain.

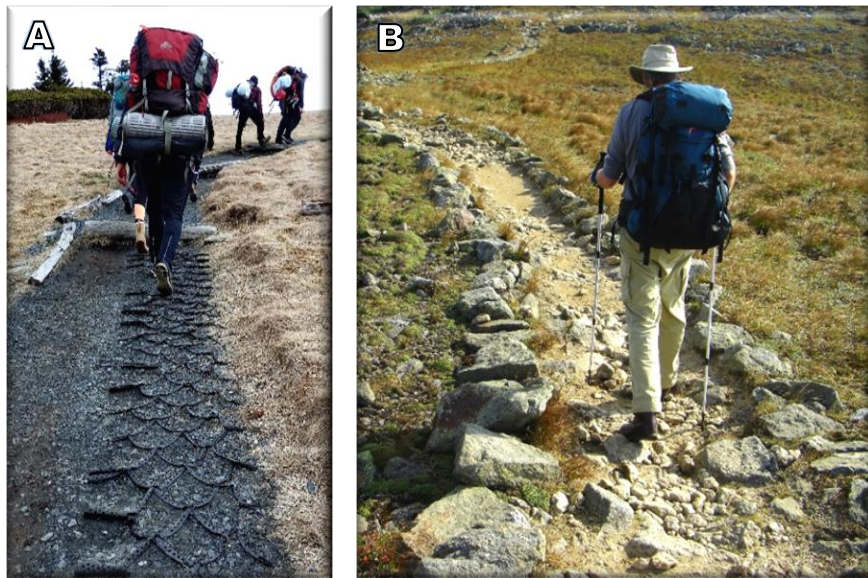
Figure 30. Cellular geotextile products (A) can retain soils within their 3-D cells but fill material placed on top will erode or displace downhill, exposing it to traffic and UV-radiation that breaks down the plastic. Its efficacy is higher in flat terrain and wet soils. Rock borders and scree walls (B) can be an effective practice for centering traffic and deterring off-trail travel.

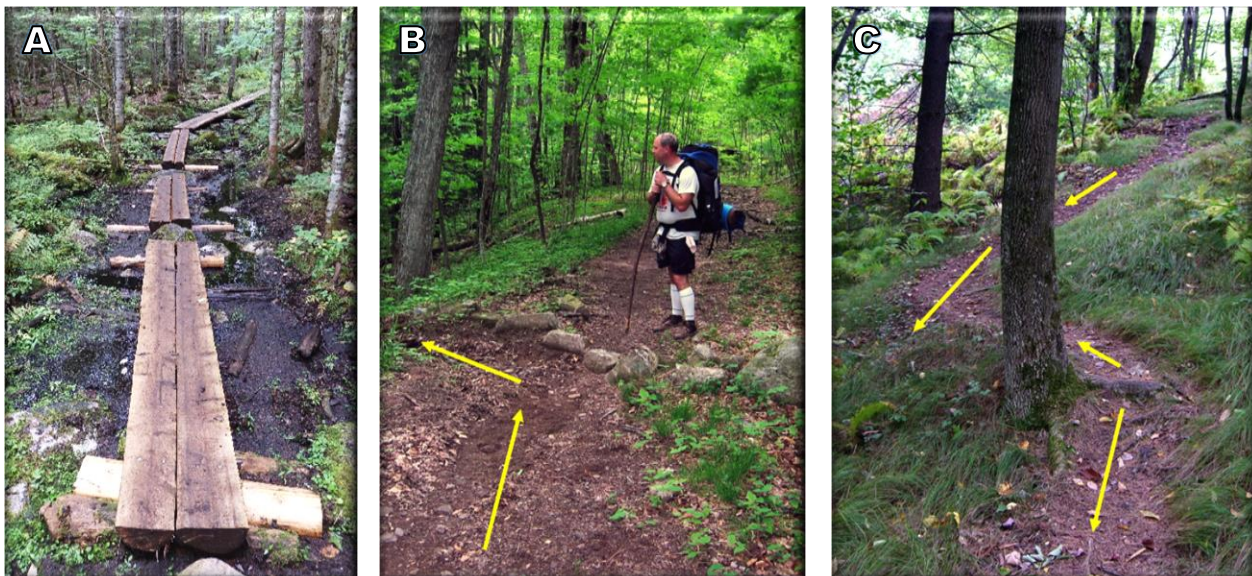
Figure 31. Bog-bridging (A) is an effective practice for raising the tread above wet soils. Rock or wood water bars (knicks) (B) remove water from treads but must be maintained annually to remain effective. Grade reversals of the entire tread (C) will always remove all water and require little to no maintenance.

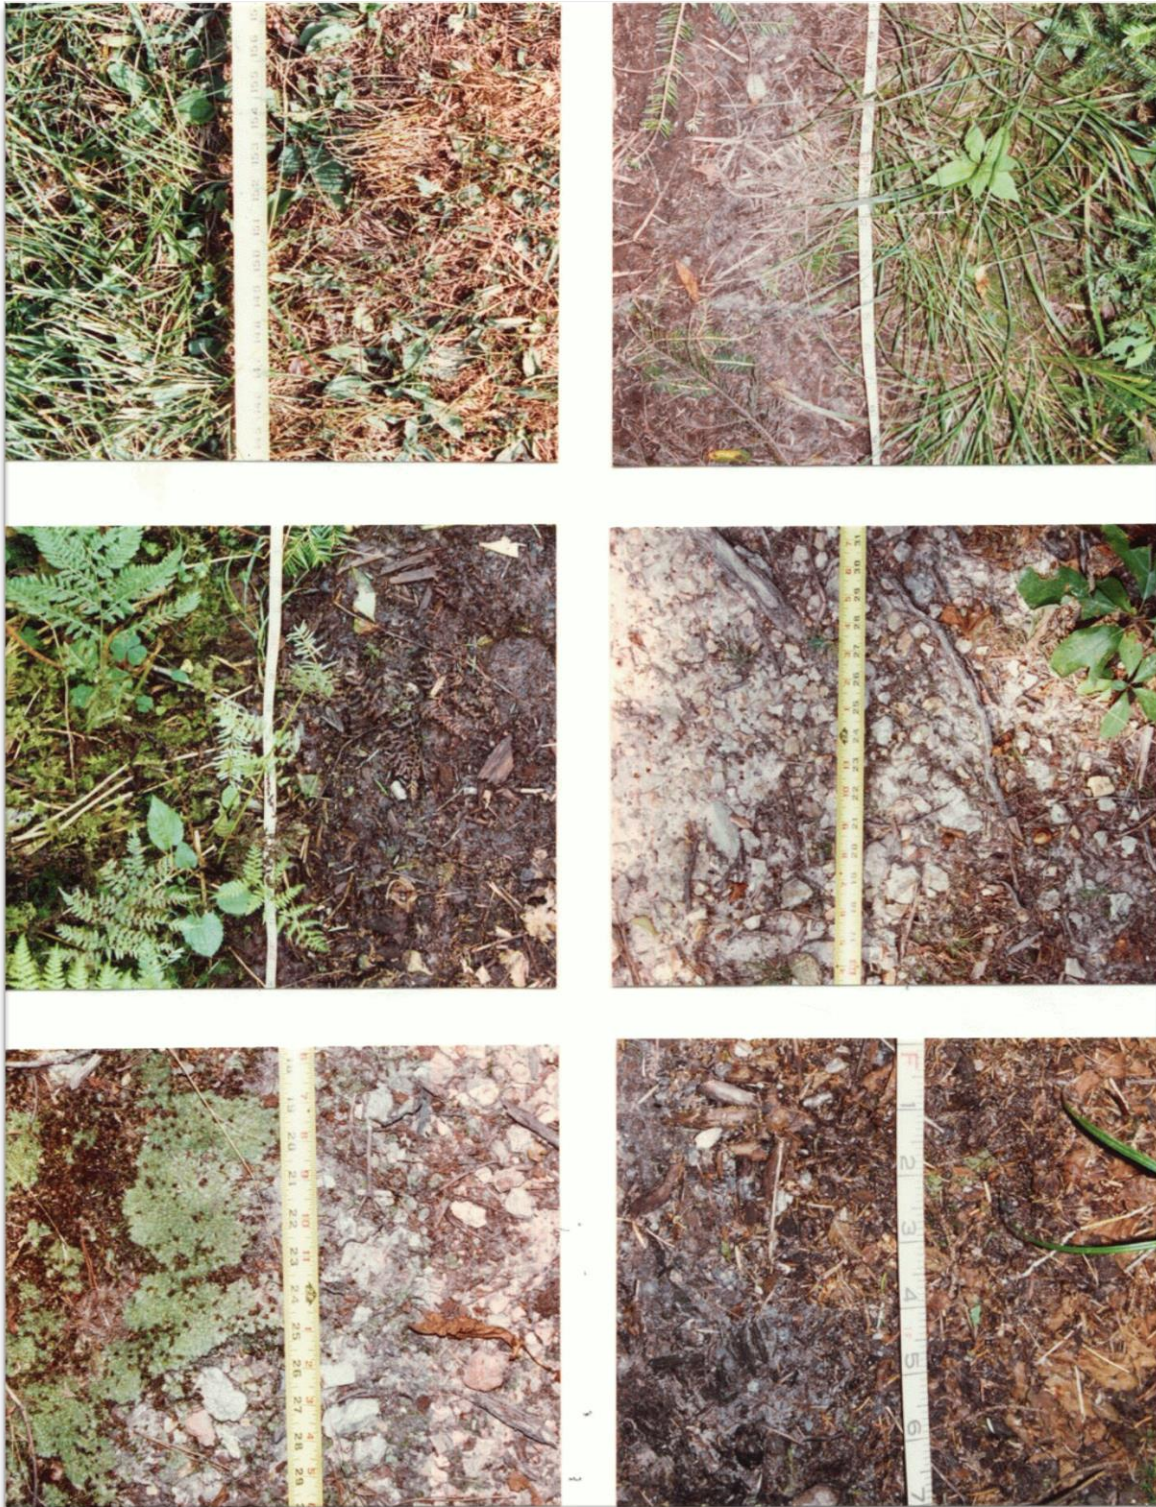
Figure 1. Photographs illustrating different types of boundary determinations. Trail tread boundaries are defined as the most pronounced outer boundary of visually obvious human disturbance created by trail use (not trail maintenance like vegetation clearing). These boundaries are defined as pronounced changes in ground vegetation height (trampled vs. untrampled), cover, composition, or, when vegetation cover is reduced or absent, as pronounced changes in organic litter (intact vs. pulverized).

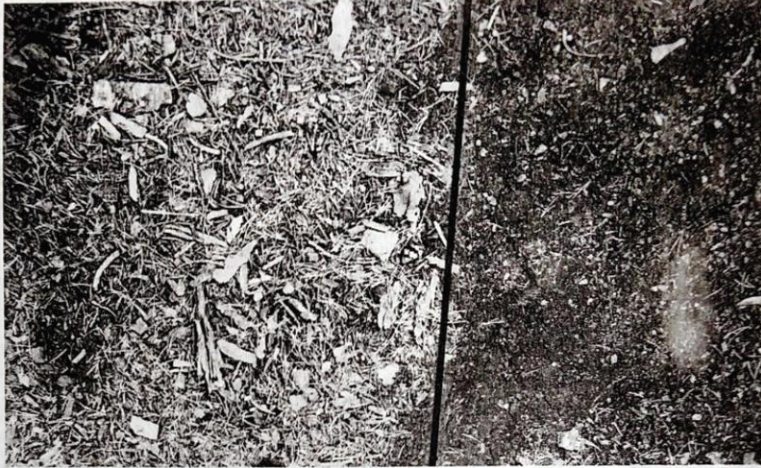
Organic litter on left is pulverized but still covers underlying organic and mineral soil. Dark organic soil on right, which covers lighter colored mineral soil, should be assessed as bare soil.

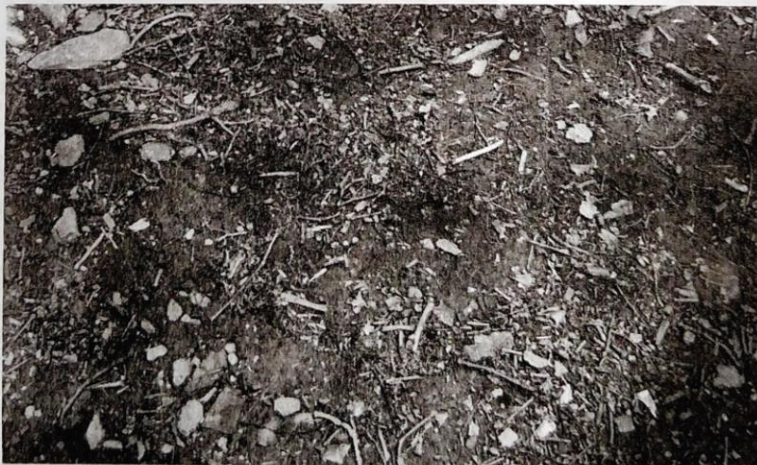
As organic litter is pulverized and eroded from sites the remaining materials often clump together, resulting in a patchwork of organic litter and bare soil which is difficult to evaluate. If patches of organic material are relatively thin and few in number, as illustrated in the photo above, the entire area should be assessed as bare soil. Otherwise, the patches of organic litter should be mentally combined and excluded from assessments.

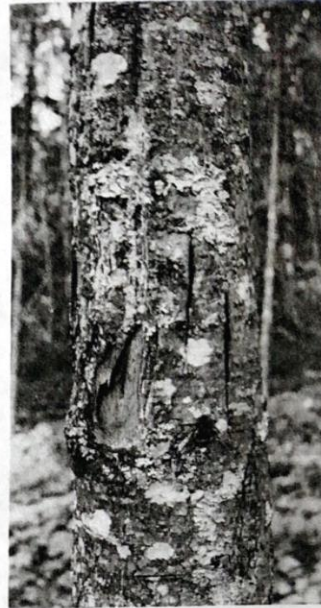
NONE/SLIGHT: No or slight damage such as broken or cut smaller branches, 1 nail, or a few superficial trunk scars.
