Maintenance Practices and Costs of Rail-Trails

rails-to-trails
conservancy

June 2015

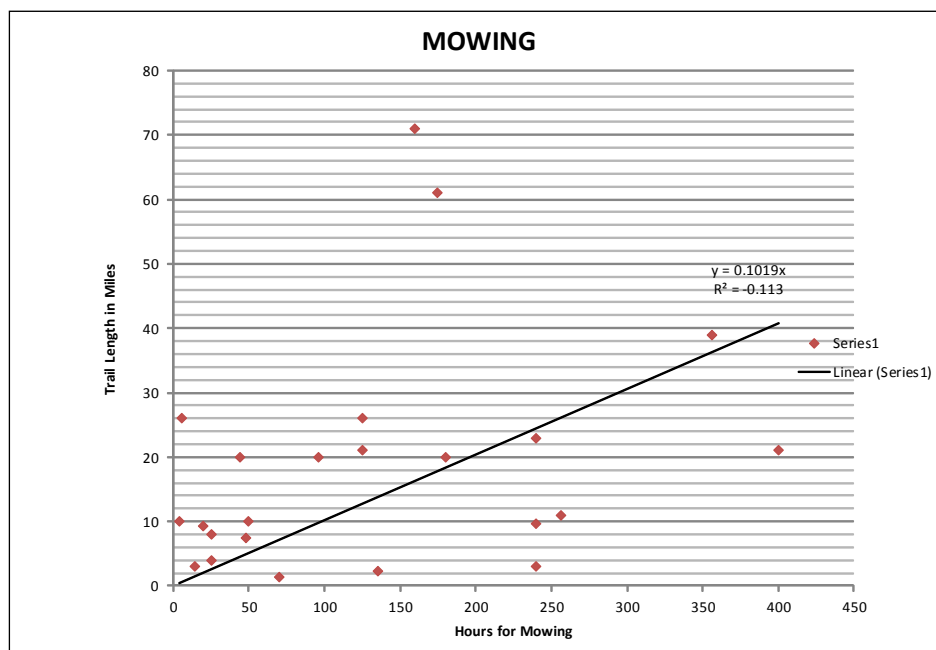
Figure 5. Correlation analysis shows no relationship between labor hours and length of trails.

Based on the data provided in the detailed cost analysis, it is apparent that the amount of time and expense associated with mowing is really a function of how the trail was designed. Some trails have a lot of grassy areas on the shoulders of the trail tread, while others have crushed stone or other shoulder materials that don't require periodic mowing.

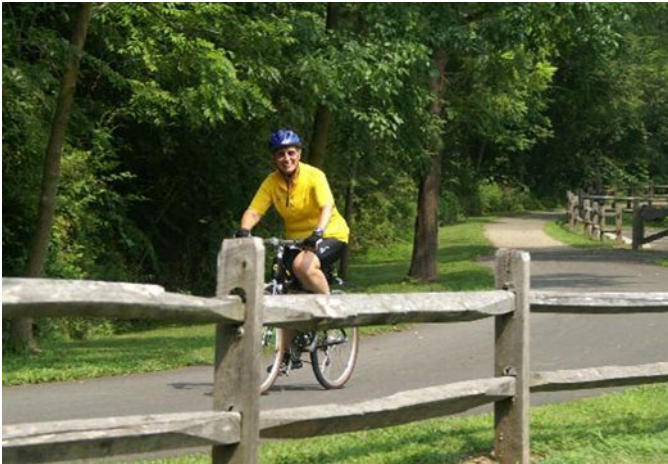
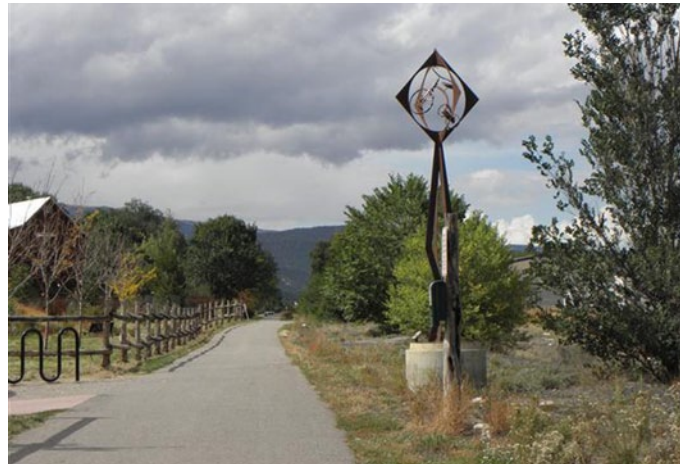
Perkiomen Rail Trail, PA
20 miles
Annual mowing costs \$12,542

Rio Grande Rail Trail, CO
20 miles
Annual mowing costs \$2,112

The Perkiomen Trail has a significant amount of grass along the shoulders of the trail and fencing that needs to be cut around manually. On the other hand, the Rio Grande Trail has more native vegetation or stone shoulders that do not require frequent mowing.

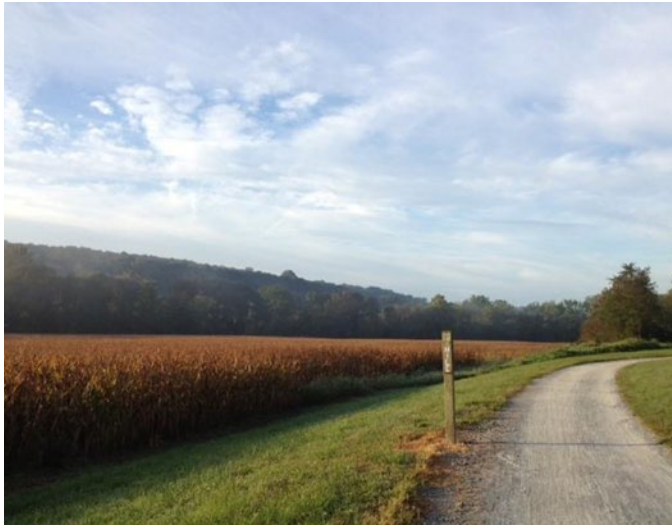
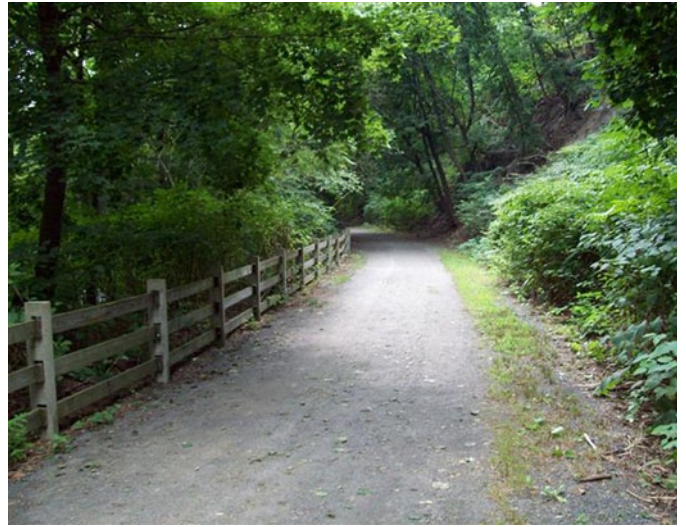
Heritage Rail Trail County Park, PA
21.1 miles
Annual mowing costs \$6,000

Lackawanna River Heritage Trail, PA
19.9 miles
Annual mowing costs \$7,367

The mowing cost for these two trails is fairly close on a per mile basis. The Heritage Rail Trail has a parallel rail bed along most of its length that requires herbicide treatment but no mowing. The Lackawanna Trail allows natural vegetation to grow along the shoulders or has placed stone shoulders.

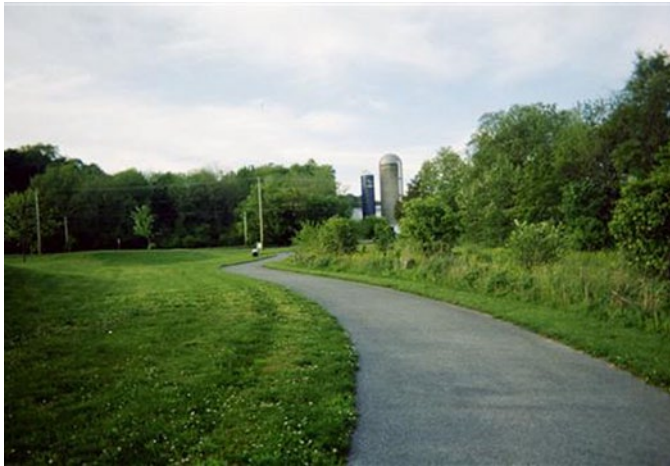
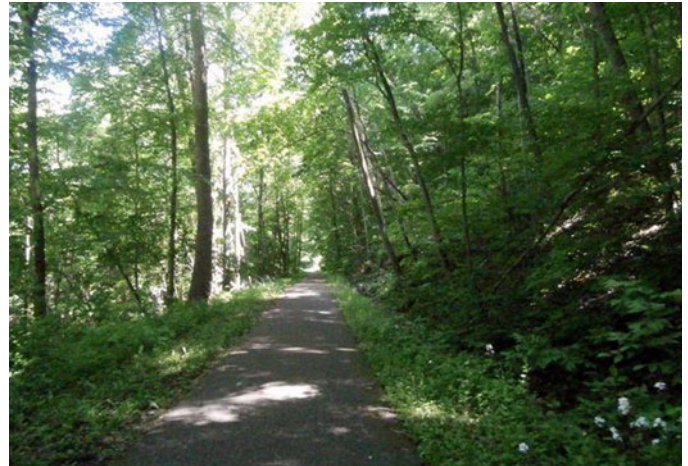
Lititz-Warwick Trailway, PA
3 miles
Annual Hours mowing 240
Annual mowing costs \$3,553

Oil Creek State Park Trail, PA
9.7 miles
Annual hours mowing 240
Annual mowing costs \$3,739

The Lititz-Warwick Trailway has significant amounts of grassy areas that require mowing along trail edges in a primarily suburban setting. Oil Creek State Park Trail is more rural and relies on natural vegetation along the trail edges that does not require much maintenance. Surprisingly, however, both reported 240 hours was required for mowing each year. This example appears to indicate that there is no correlation between labor hours and costs.

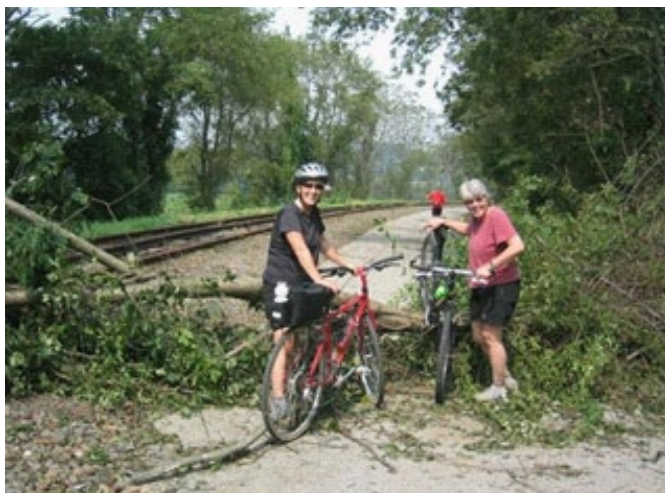
Tree down on Heritage Rail Trail County Park, PA.

Tree removal was a significant maintenance task reported in our detailed maintenance cost analysis survey. Most of the reported costs were in excess of \$1,000. Forty percent of the reporting trails indicated that they contracted out this activity. There are a number of reasons stated for removing trees. In some cases storms cause trees to block the trail. In others, a dead tree presents a potential hazard to trail users and is removed before limbs come crashing down on the trail.

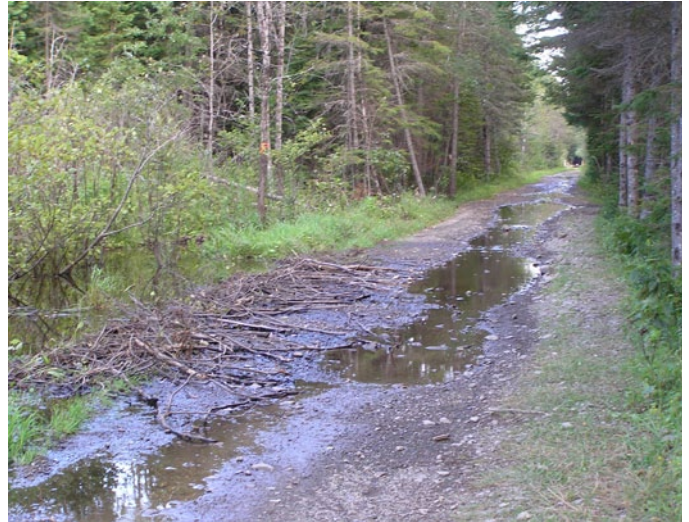
Beaver caused erosion damage, Ashuelot Rail-Trail, NH.

Not only did these costs vary widely across our sample, but they also varied widely from year to year. The major cause of damage to non-asphalt trails was because of water erosion, as reported by 55 percent of survey respondents.

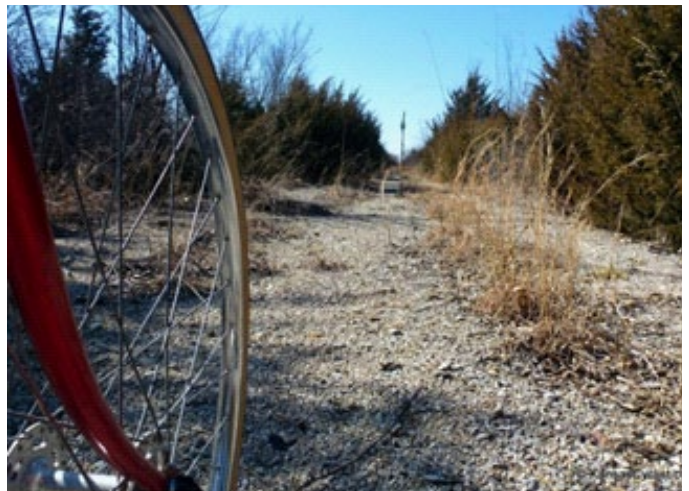
Uncontrolled weed growth through trail surface.

The second biggest cause for repairs is because of vegetation, as reported by 25 percent of survey respondents. This can be caused by grass growing through non-asphalt trail surface, vegetation encroaching on trail edges or proliferation of invasive species. Controlling damage caused by vegetation encroachment is manageable with a program of regular, scheduled inspection and preventative maintenance.

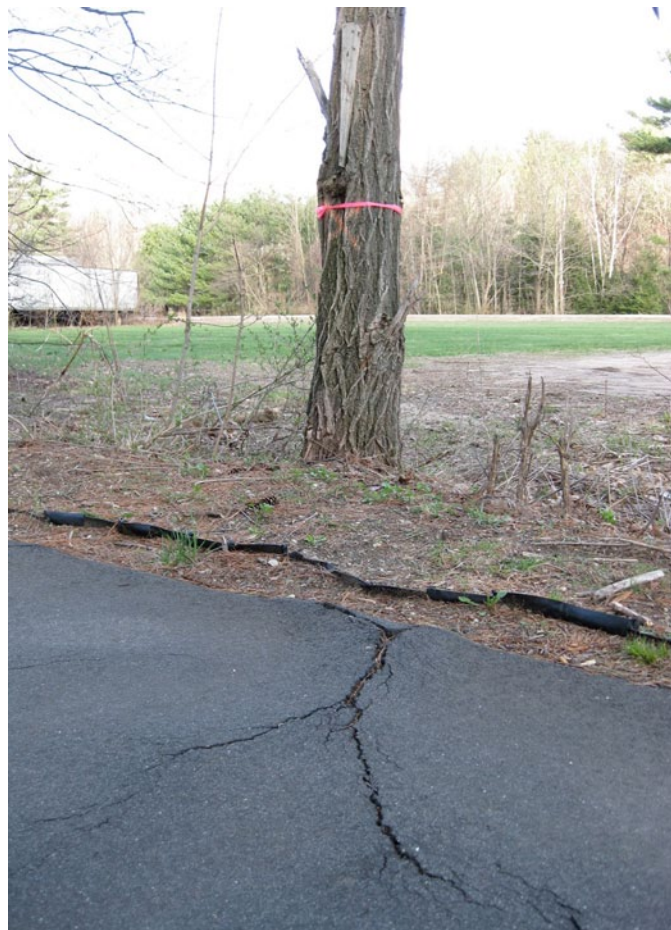
Tree root damage Manhan Rail Trail, MA.

Damage to asphalt trails from tree roots is significant and growing.

More than 60 percent of asphalt trail managers reported tree roots as the major source of trail damage. Clearly, as more asphalt trails are being built rather than stone dust trails (as required by some departments of transportation and metropolitan planning organizations); the true costs of these facilities needs to be better understood and shared. Replacing asphalt after several years is costly and frequently becomes a rebuild that is often funded by Transportation Enhancement (TE) programs or Transportation Alternatives Programs (TAP). This costly maintenance requirement might be prevented with better construction standards and possible use of root barriers in certain segments of a trail or periodic trenching to cut root growth. The removal of healthy trees several years after the trail is built is not the only option.

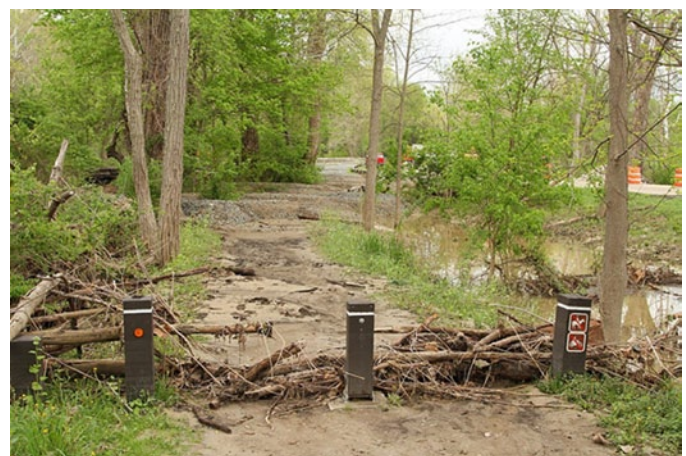
Erosion damage to stone dust trail.

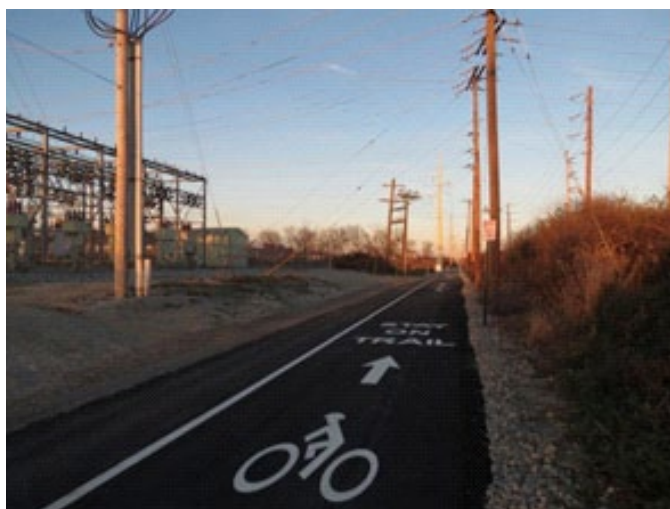
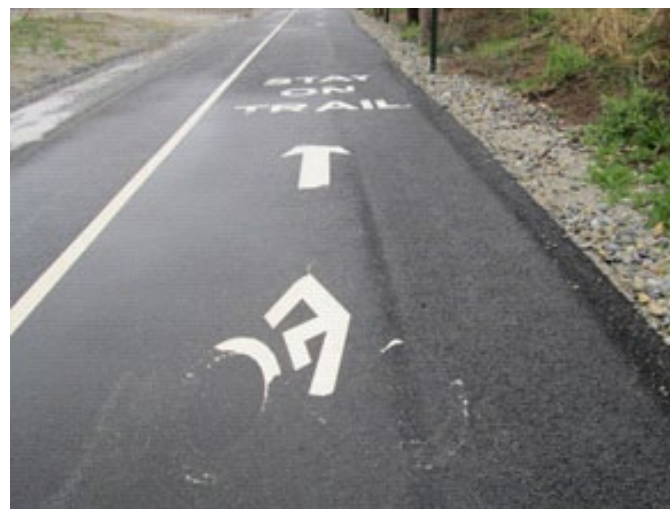
Pavement markings, Hanover Trolley Trail, PA.

Pavement markings are generally associated with asphalt-surfaced trails. This study found that a painted center line was the most common type of pavement marking. Other pavement markings are safety or instructional in nature. Some markings are painted on the trail surface, while others are applied thermally. The detailed cost analysis revealed that this activity, while not reported by many respondents, varied in cost from \$19 per mile to \$140 per mile.

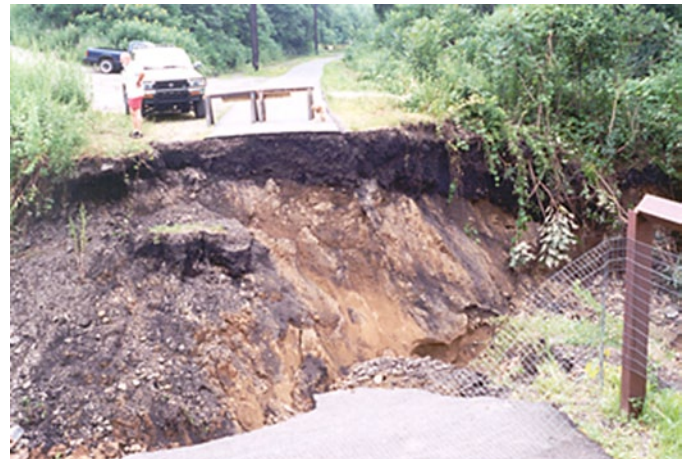
Culvert failure, Allegheny River Trail, PA.

Periodically investing several hundred or even several thousand dollars in maintaining trail drainage systems and culverts can prevent catastrophic damage to a trail when a major water event occurs.

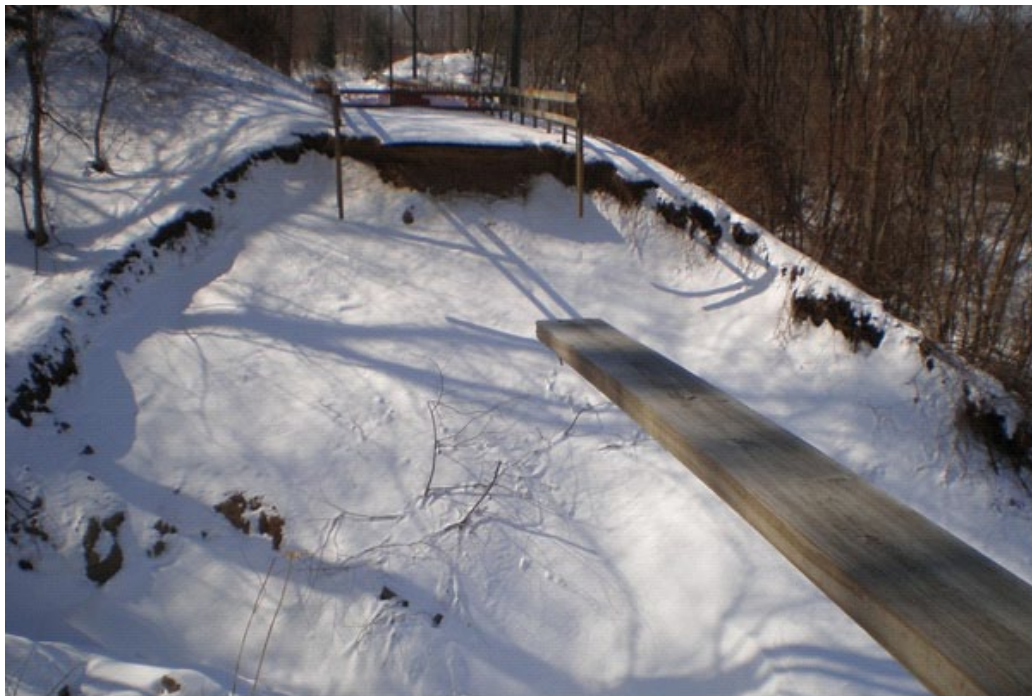
Culvert failure, Manhan Rail Trails, MA.

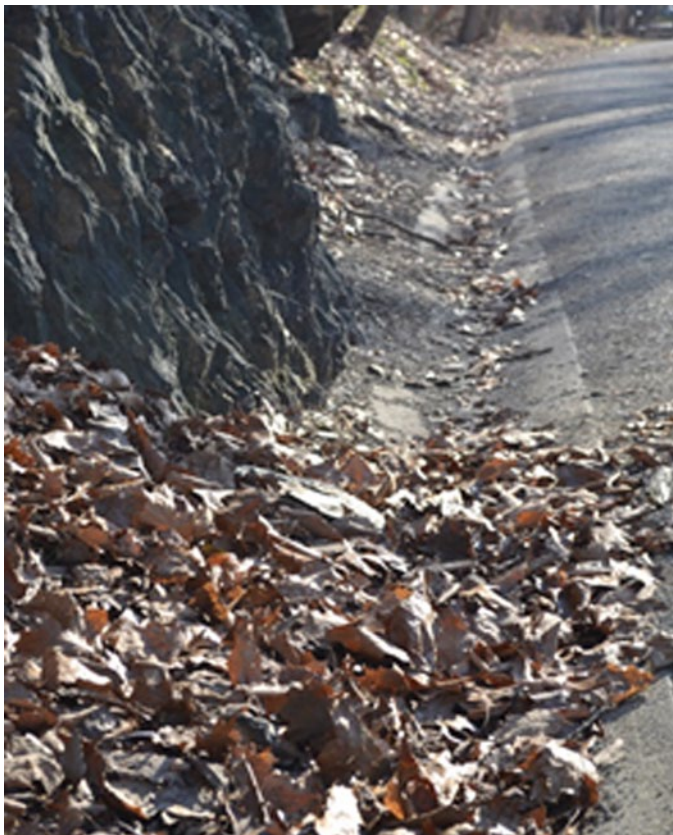
Drainage swale in need of cleaning.

The West Penn trail maintenance plan calls for clearing drainage swales twice a year or as needed. Most of this work is done with rakes and shovels. Some larger ditches may require the use of a backhoe.

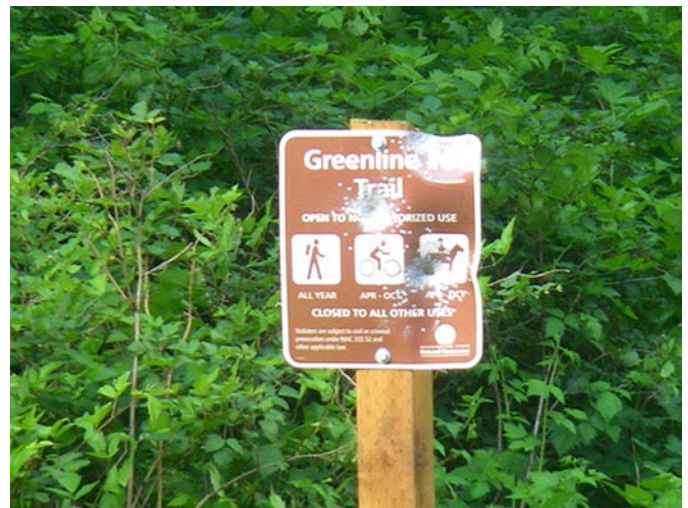
Greenline Trail sign used for target practice.

More than 75 percent of the respondents to the general maintenance survey reported that vandalism was the major cause of damage requiring signage repair and maintenance.

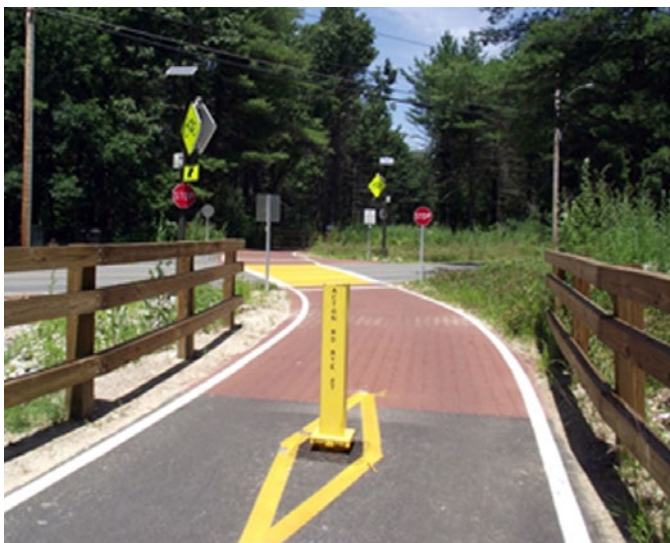
Bollard at intersection, Bruce Freeman Rail Trail, MA.

Gates and bollards are used to keep automobiles and other motorized vehicles off of trails that are intended only for non-motorized use. While maintenance costs associated with gates and bollards were reported by only 15 percent of detailed cost analysis respondents, most indicated costs of between \$2,300 and \$5,000.

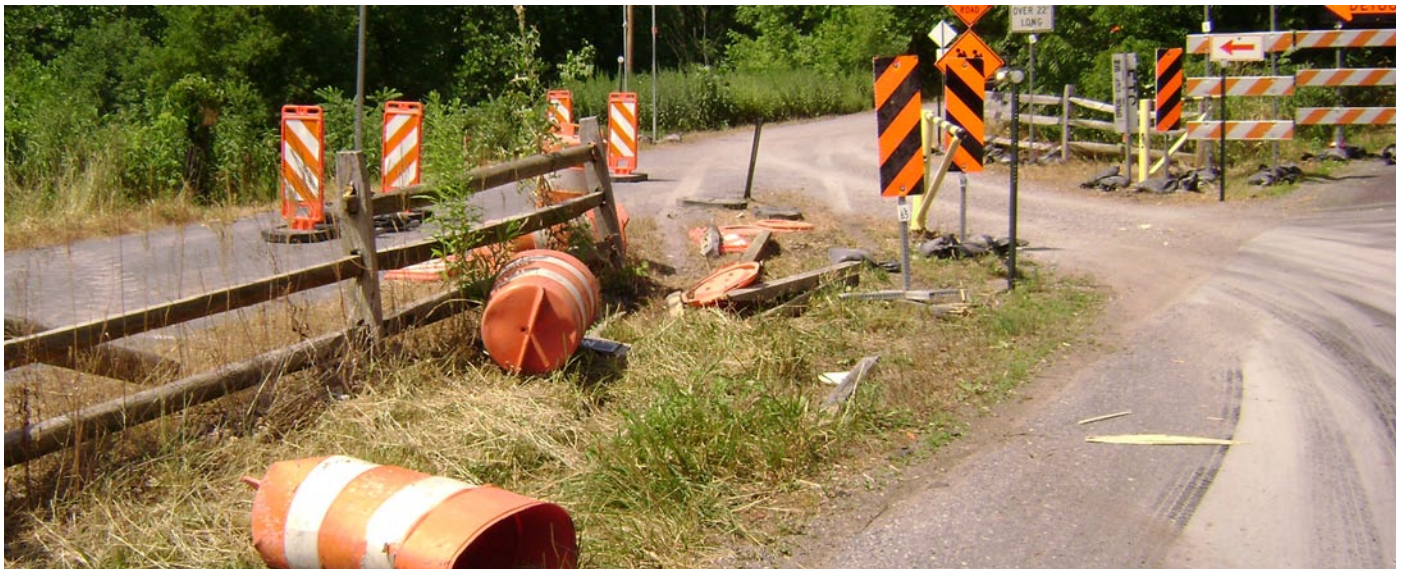
Damaged split rail fence along the Pine Creek Rail Trail, PA.

A majority of the respondents to our survey, 51 percent, indicated that they had some type of fencing along their trail. Most common was split rail wooden fencing, which was mentioned by 45 percent of the respondents. Over time this becomes a maintenance issue, as posts and rails rot or become damaged in some way.

Of these three types, wooden fencing was reported to require the most maintenance. Thirty percent of the detailed cost survey respondents reported time repairing wooden fencing. This maintenance can take the form of replacing fencing that had rotted or fencing that had been damaged by accident or acts of vandalism. Only 8 percent of respondents reported repairs to chain link fence. No respondents reported repairs to vinyl fencing.

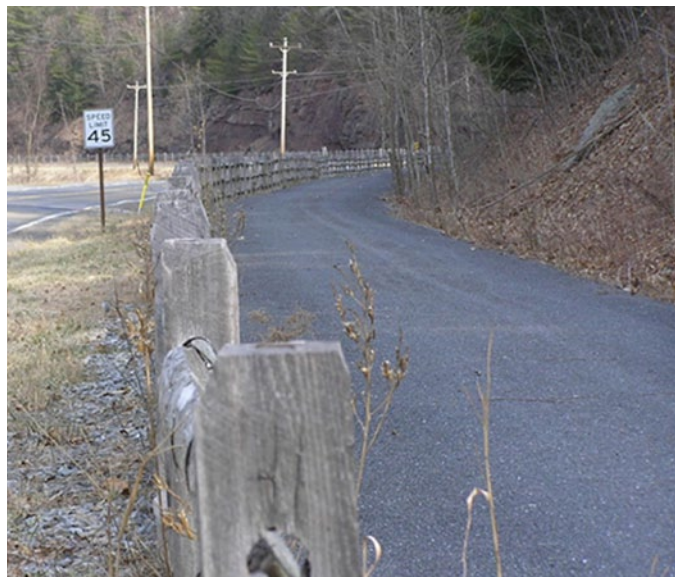
Split rail fencing, Pine Creek Rail Trail, PA.

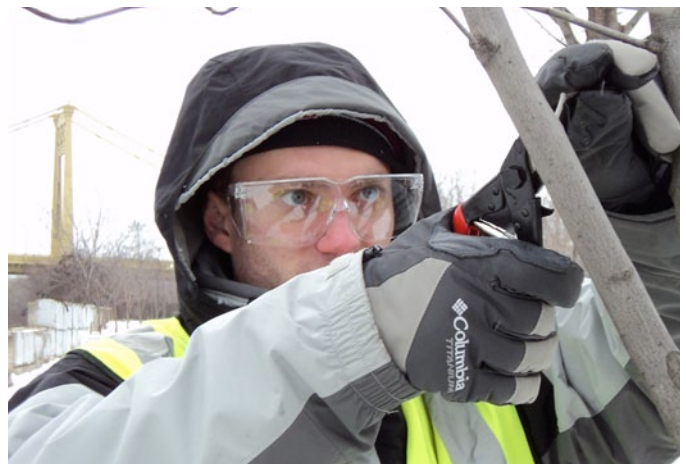
Tree pruning even occurs in the dead of winter, Three Rivers Heritage Trail, PA.

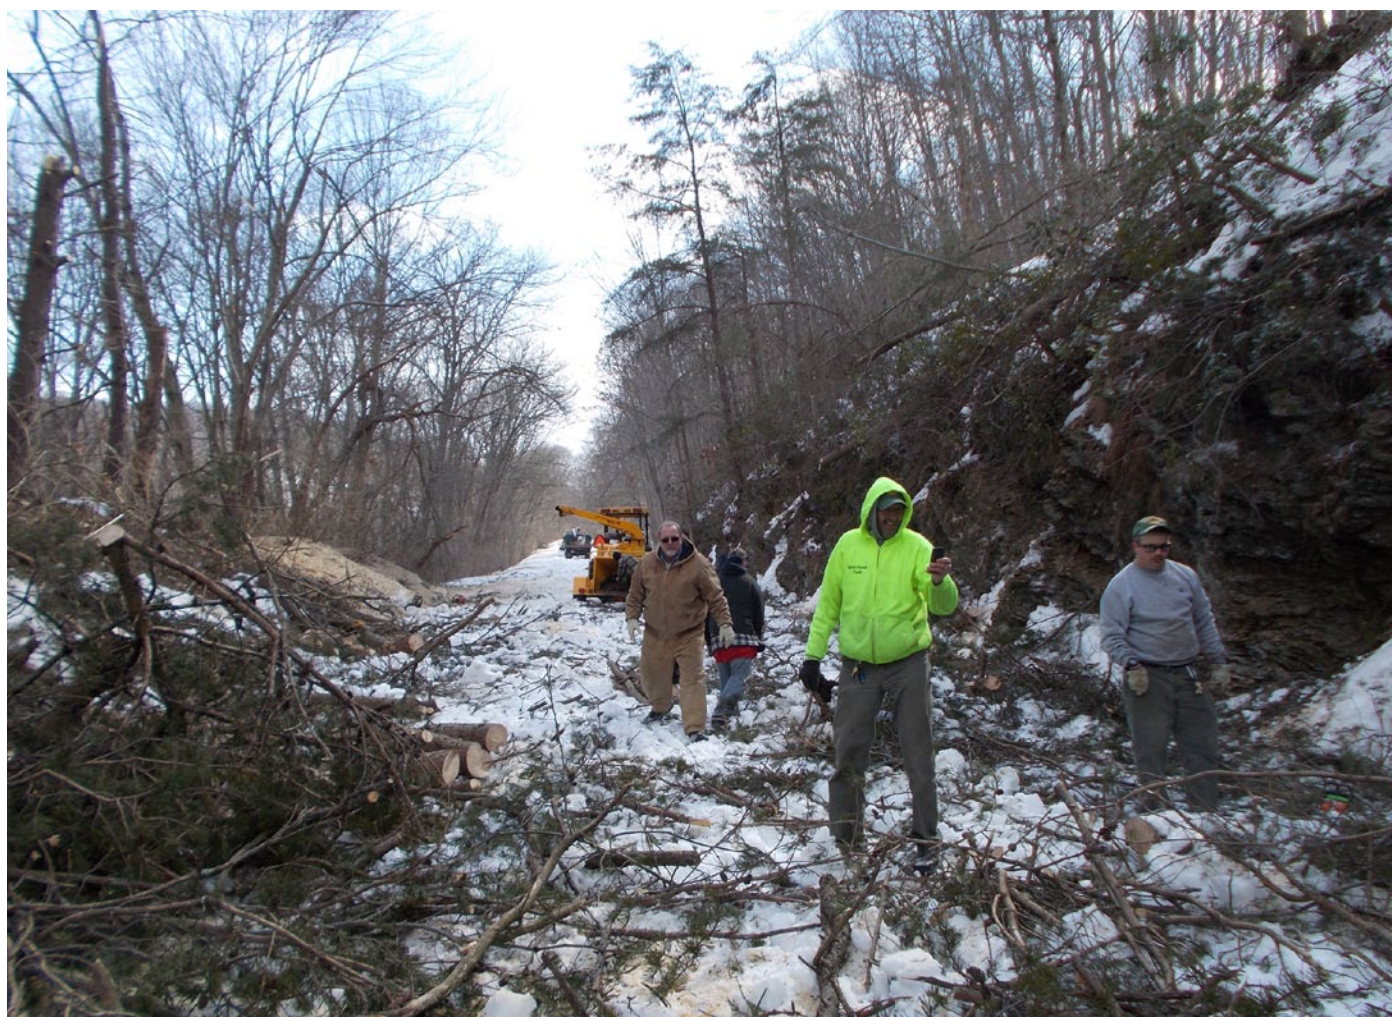
Volunteers clear storm damage along trail in Heritage Rail Trail County Park, PA.
