Minnesota Department of Natural Resources
ATV Trail Management

Ron Potter

May 5th 2009

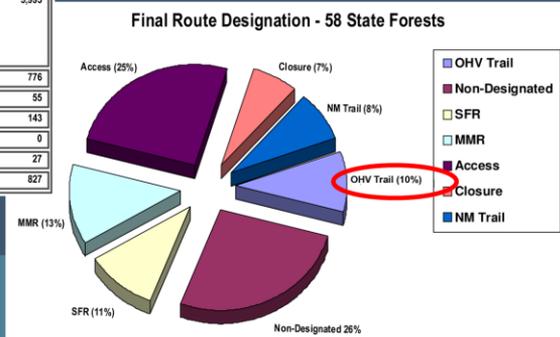
Forest Road & Trail Designation Mileage Totals for All 58 State Forests & Scattered State Forest Lands	
Route Designation	State Forest Land (miles)
Total Inventoried Routes	12,132
System Forest Road	1,886
Min. Maintenance Forest Road	1,293
Non-designated Routes	5,993
Proactive Closures	491
In closed forests	177
In limited forests	2,714
In managed forests (forest access routes)	2,611
ATV / OHV Trail	776
ATV-Only Trail	55
OHM-Only (Single-Track Trail)	143
ORV-Only Trail	0
OHV Trail (ATV+OHM+ORV)	27
Non-motorized Trails	827

Chart Source: MN DNR, Trails & Waterways, Aug. 2008. Some county-administered routes are included in the route inventory and designation totals. Shared trail miles result in some double-counting of reported miles of OHV trail designations.

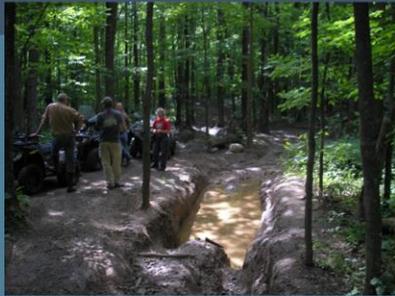
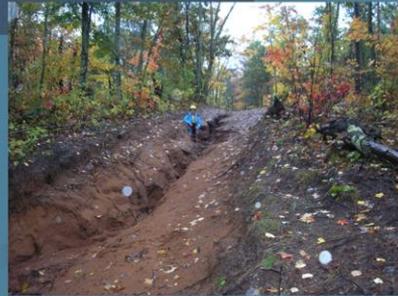
Must implement some of the techniques for dealing with water so it does not flow down the trail to any great length or steep grade that would allow the water to increase velocity and thereby increase sediment movement.

Goal is to keep the water off the trail and provide ways for the water to sheet off the trail as quickly and often as possible.

Fall line trails need to be avoided whenever possible.

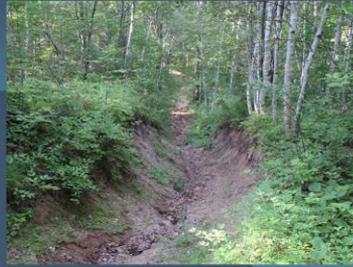
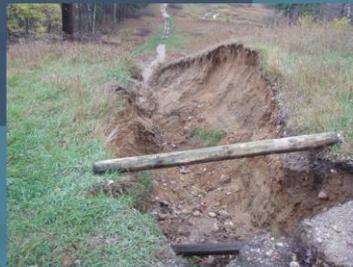
Fall line trails are not sustainable.

Trails that are properly designed are sustainable, can provide the technical riding that the enthusiast is looking for and take minimal effort to maintain.

Water flow must be dealt with and should be paramount when considering trail layout.

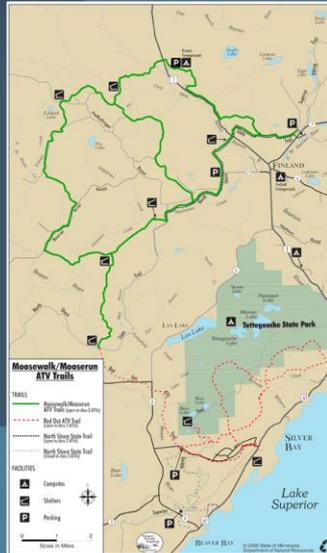
- 26 Miles of trail
- Near vital trout habitat
- Close to the "North Shore"
- Connects to:
 - 6 mile segment of the non-motorized North Shore State Trail
 - Red Dot trail in Silver Bay
 - 28 Mile system

Managing sediment movement is vital when providing trail opportunities near or when crossing trout streams.

Stream crossings must be with a bridge or culvert, fording is not a good option for trout streams.

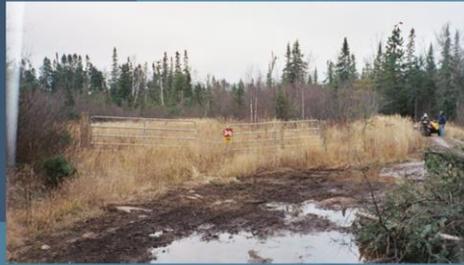
One segment of the snowmobile trail that will become part of a summer ATV trail. Wetlands not an issue for the snowmobile season but a major concern for summer ATV use.

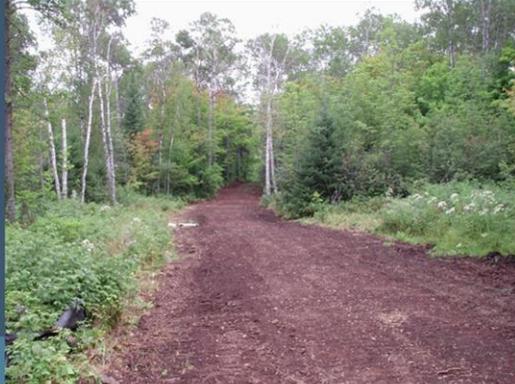
- Bridges
- Mulch on exposed soils
- Filter fabric
 - Minimizes disturbance
 - Maintains drainage
- Silt fence
- Culverts

Using existing snowmobile trail (wide path), much wider than needed.

No steep grades to address on these portions of shared treadway, only wetland issues.

All streams already crossed by permitted culverts or bridges.

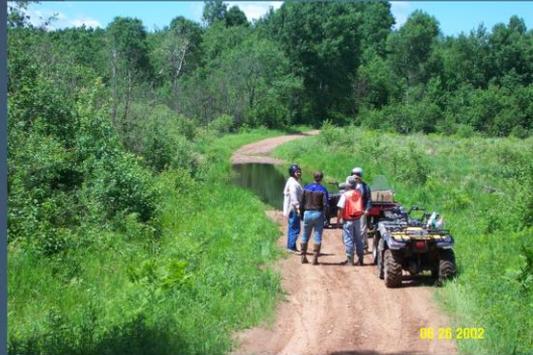
- Proximity to rivers and streams
- Flooding, high water table
 - Erosion
 - Siltation

Rain events can raise water table causing trail to be under water for periods of time. Need to harden crossing to ensure safe and environmentally sustainable crossing during those periods.

In cases where this cannot be accomplished need the ability to temporarily close segments of the system.

Culverts are not good options for crossing due to high beaver population in this region.

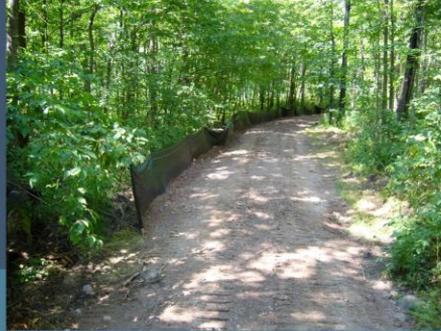
Trails are kept narrow to minimize footprint and meet users' expectations.

Fill is brought in to elevate trail surface to promote a more sustainable surface.

Silt screening is used to control erosion and run-off until vegetation can be re-established along trail edge.

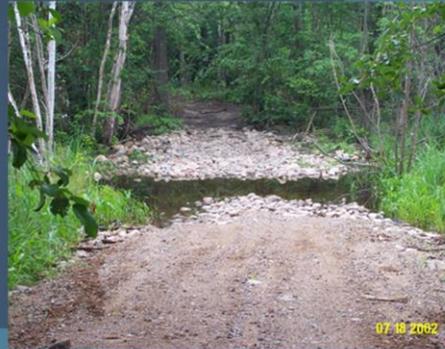
Crossing of intermittent streams are dealt with by using hardened crossing, course washed or screened rock to reduce sediment into the surrounding wetland yet allows for good cross flow. These hardened crossing are usually dry, only have standing water after major rain events or if beavers are working in the area, down stream.

Bridges used on the larger crossing and certainly on any inventoried stream.

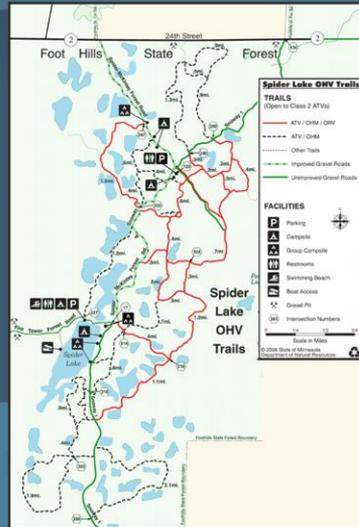
ATV only: 14.9 miles
ATV, OHM, ORV: 11.4 miles

- Historic OHV use area on county and state forest lands following old logging trails and other routes like cross-country ski trails

Located in the North-Central Lakes Area of Minnesota. One of the State's first designated OHV facilities. Retro-fitted to old ski trails, logging trails, and user-developed ATV routes.

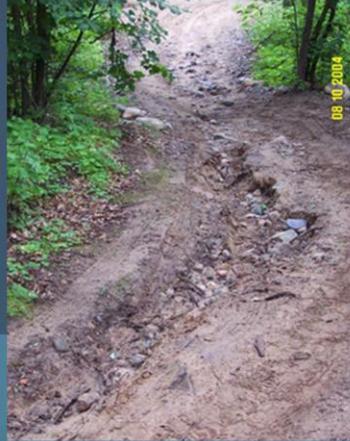
This trail system contains areas with highly erodible soils. Many trail alignments travel the fall line up steep hills which presents a continuing challenge for site managers. Soil stabilization, erosion controls, and stormwater management are very important here. In this case, we needed to harden a climbing turn.

Trails run up the fall line because it had originally been a cross country ski trail system and due to a shift in demand the land managers decide to use as an ATV trail during the summer months. Few modifications were made to deal with the water, increased summer use removed the vegetation and the water removed the soil.

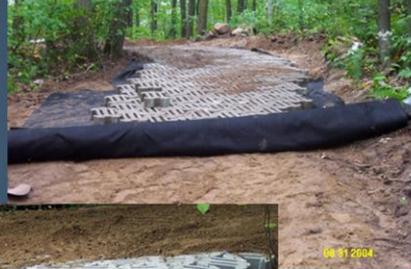
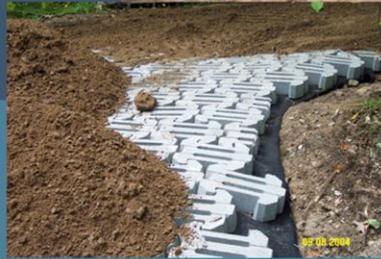
Supports and dissipates loads on difficult soil situations

Preserves soil integrity and allows water infiltration

- Geo-links are only one way to stabilize and maintain soil structure.
- We also use a variety of other similar technologies such as Geo-blocks, and Geo-web.
- This segment of trail open to ATV's, off-highway motorcycles, and 4X4 trucks, made finding a good solution more challenging.

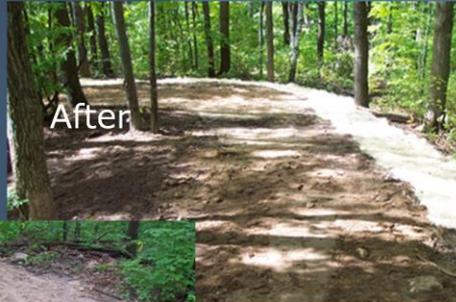
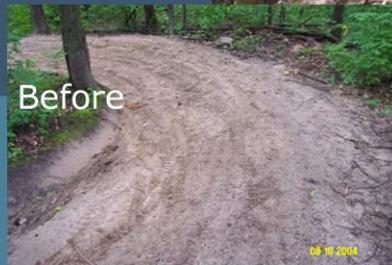
- ¼ mile
- \$31,000
- 435 labor hours

Blocks (1680): \$6,800 - Fabric (3,125sqft):375 - Seed(1 bag): \$50 - Erosion blanket (6): \$222 - Equipment: \$10,800 - Soil (350 yards): \$3,500 - Labor (435 hrs): \$9,292.20

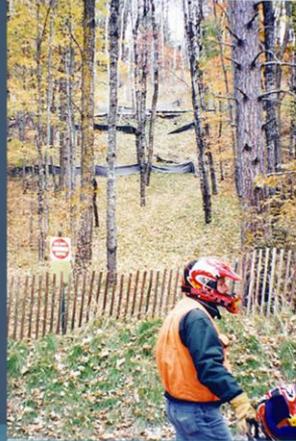
Photo: Taken the fall after the completion of the project.

-Old user-created motorcycle hill climb which became an eroded gully.

Entire hill was eroded and closed to riding. Displaced soil was pushed back up the hill and re-vegetated. A new trail route was created to provide a sustainable, yet technical, route up the hill. The closed trail was re-contoured and re-vegetated.

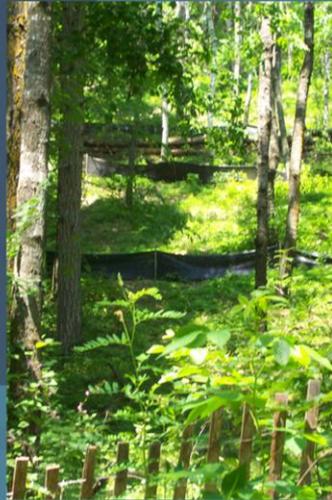
Image 1, USGS topo map and 3D hill mockup showing trail before and after.

-Note wetlands, ponds and lakes, topography

-We flagged in the trail paying special attention to the change in the degree of the slope, length of the run of the trail, and effective control of stormwater runoff.

Image 2, Small dozer working on a trail.

Image 3, ATV on the trail showing trail cut into the side of the hill and the silt fencing.

Image 4, The trail ~ 1 year later at the point of the hill climb. Note how the user trail has stabilized and people are no longer using it.

Image 5, The old user trail three years later looking lush and healthy.
