**Assessing the Condition and Sustainability of the Trail System
at Tallgrass Prairie National Preserve**

Final Research Report, June 2022

Final Report to:	National Park Service, Tallgrass Prairie Natl. Preserve 2480B KS Hwy 177 Strong City, KS 66869	Nature Conservancy Kansas Flint Hills Office 2480B KS Hwy 177 Strong City, KS 66869
-------------------------	---	--

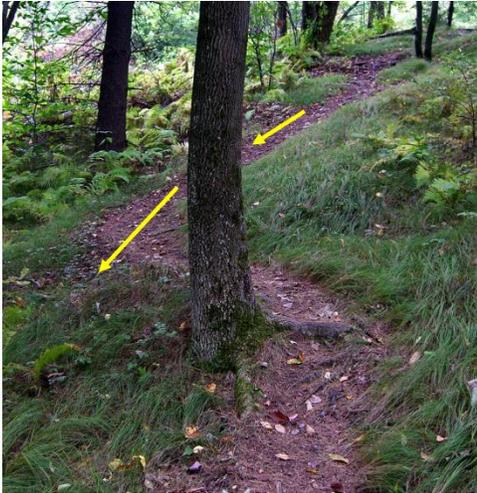
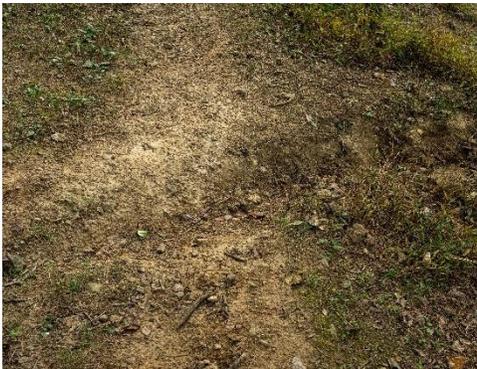
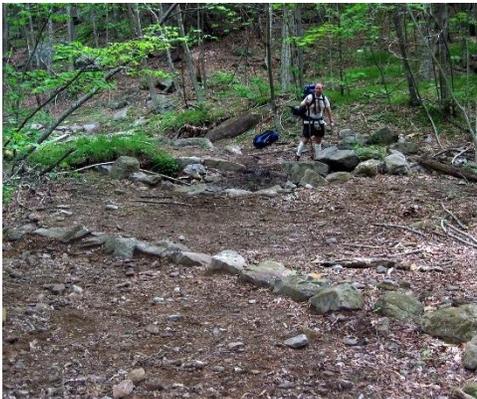
Figure 2. Sustainable tread grade-reversals (top) are 100% effective in draining water and rarely require maintenance. Drainage ditches (middle) are easily installed, with excavated soil mounded just downhill, but require annual cleaning to maintain their efficacy. Water bars constructed of rock (bottom) or wood are longer lasting but also require cleaning and are generally not tire friendly.

The most sustainable option for diverting water from treads is to periodically reverse the grade of the trail, forcing all water off the trail and lessening the need for maintenance (Marion & Wimpey 2017, Parker 2004) (Figure 2). Tread grade reversals are optimally designed during a trail's layout, though these can be retrofitted on side-hill trails with low to intermediate grades (Hesselbarth et al. 2007, IMBA 2004, 2007). More commonly maintainers install unarmored drainage dips (Figure 2), or rock and wooden water bars to minimize erosion by diverting flowing water from treads (Birchard & Proudman 2000, Hesselbarth et al. 1996). Research reveals greater soil loss with increasing distances between drainage features, that feature density must increase with increasing trail grade, and that drainage features become ineffective when not maintained (Marion & Wimpey 2017, Mende & Newsome 2006). Drainage features become ineffective when filled with leaves and sediment, and armored water bars are sometimes circumvented by hikers, widening the trail (Hesselbarth et al. 2007).

Corrective management responses are like those discussed for flatter terrain. Limiting wet season use and/or graveling deeper ruts can be effective, possibly with slightly larger aggregate (1.5-inch vs .75-1-inch) that is less likely to erode or be displaced downhill. If ineffective, then relocating problem segments to side-hill alignments is preferred as a more optimal long-term solution. In all areas, including the graveled segments, more attention is needed to accommodate cross-trail water flow during large rain events. We found evidence of flows at low points along the graveled segments where water has carried gravel well-away from the road out into the prairie. Constant tread out-sloping is one solution, particularly in areas of lower use and vegetated treads. On higher use non-vegetated treads consider ditching along the uphill side draining to armored swales or culverts, to carry the flow across or under the road. New or relocated trails should incorporate an appropriate density of tread grade reversals, as described in the literature review (Figure 2).

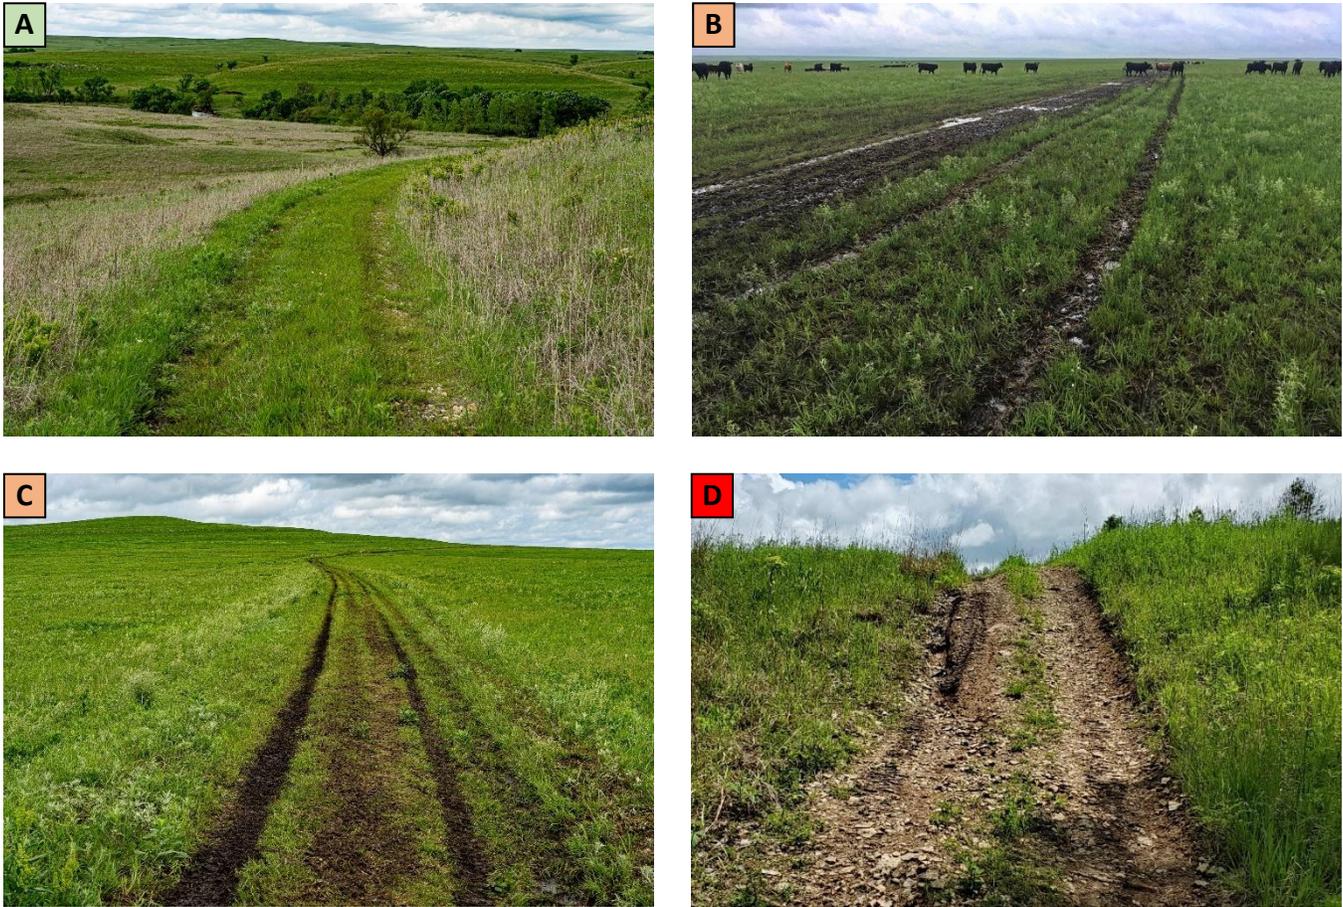
Figure 6. Photos illustrating a highly sustainable side-hill trail (gentle trail grade and steep landform grade) (A), a trail in flat terrain that can't be drained (susceptible to muddiness, rutting, and widening) (B), a non-sustainable fall-line trail segment (lower sections) and sustainable side-hill alignment (uppermost section) with intermediate landform slopes (C), and a very non-sustainable fall-line trail segment up a steep landform grade (D). Colors of letter blocks equate to sustainability color-coding in Table 3.

Mean and median values for trail grade, landform grade, and slope ratio are presented in Table 5. Examining the trail grade and landform values reveals the trails located in predominantly flat terrain: Bottomland Nature Trail, RLCH Connection Trail, Fox Creek Trail, and Ranch Legacy Trail (omitting the short connector trails). Trails located in the steepest terrain include: Southwind Nature Trail, Davis Trail, and the Palmer Creek Loop. Slope ratio values closer to 1 are least sustainable with alignments closer to the fall-line, suggesting the least sustainable trails are the Gas House Cutoff, West Branch Trail, Ranch Legacy, and Lantry Lane (Table 5). The most sustainable trails based on slope ratio are Southwind Nature Trail, Bottomland Nature Trail, Fox Creek, and Two Section. Given that most of the trails are situated in flatter terrain and that side-hill alignments are rare we shouldn't put too much emphasis on these characterizations based solely on slope ratio, which also do not penalize side-hill trails with nearly flat trail grades.

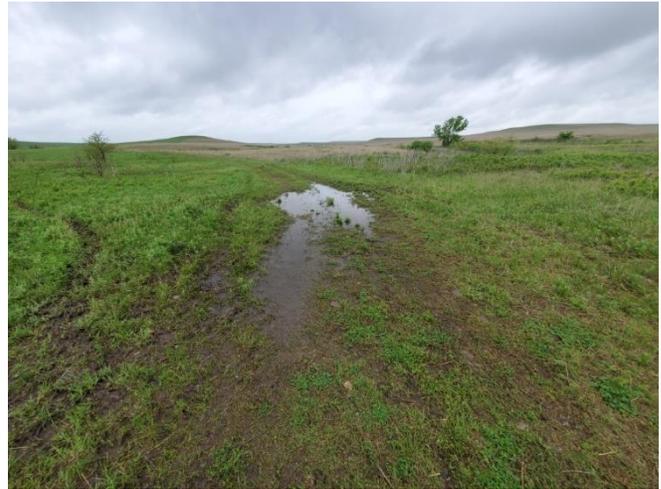
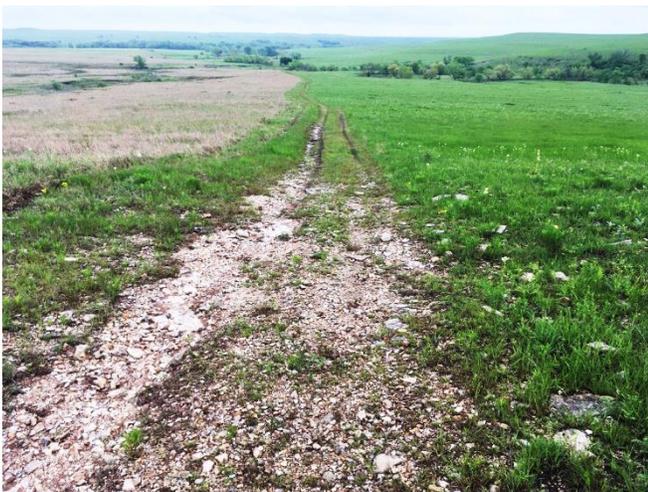
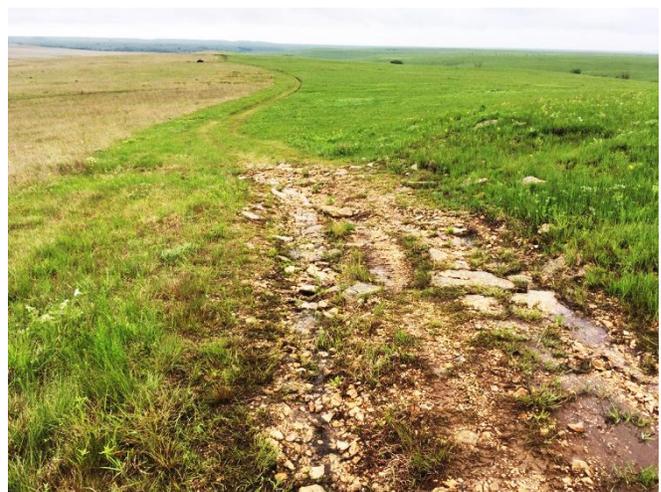
Palmer Creek Loop (PCL)

This 2.26 mi trail is located in the northeast corner of the Big Pasture. The tread is native soils and prairie vegetation, generally with 100% plant cover except in areas of tree cover. The trail is generally 8 ft wide with native soils and full prairie vegetation cover, except in the forested areas where shade reduces tread vegetation, and near stream crossings where native rock is exposed. There is one instance of excessive soil loss affecting 50 lineal feet where the trail descends an exceptionally steep muddy stream embankment near Palmer Creek to cross a side tributary. This effectively ends the trail for vehicle use and even hiking use is very challenging. This section needs to be rerouted and marked to fix these problems. There are two creek crossings, one is normally dry (more of a swale) and one has a gentle approach with native gravel (pictured).

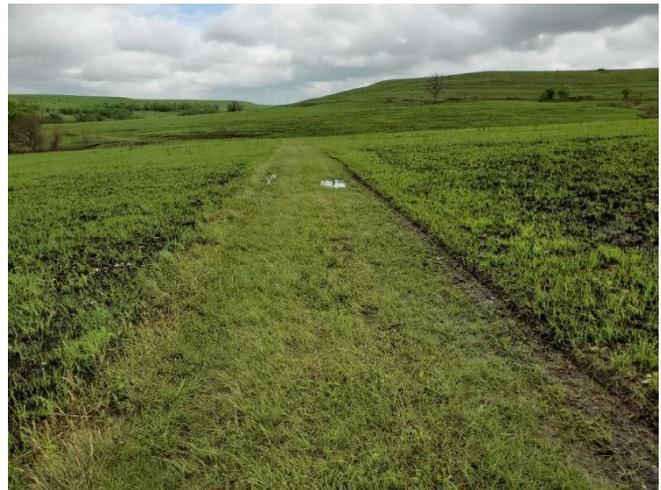
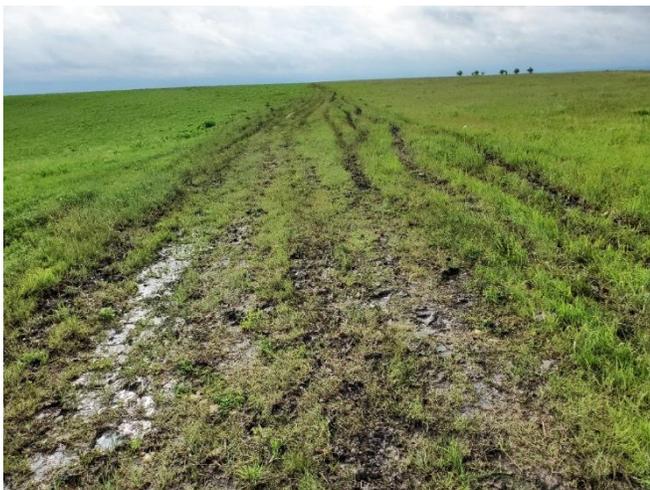
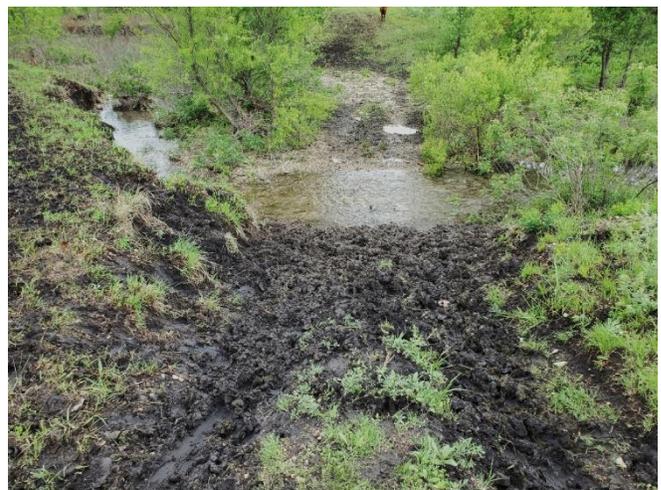
Two Section Trail (TS)

This 3.17 mi trail runs through the Two Section Pasture and East Traps Pasture with a 8-10 ft wide tread of native prairie soil and vegetation. The Two Section portion has numerous muddy cattle trails with many areas of poor drainage that pool with water. The East Traps segment, which has not been grazed since 2005, is in better condition, though muddiness remains a problem due to flat terrain and poor drainage. There are conflicts between the cows and hikers and the road noise/visibility is also an issue. This trail has two gates and one stream crossing.

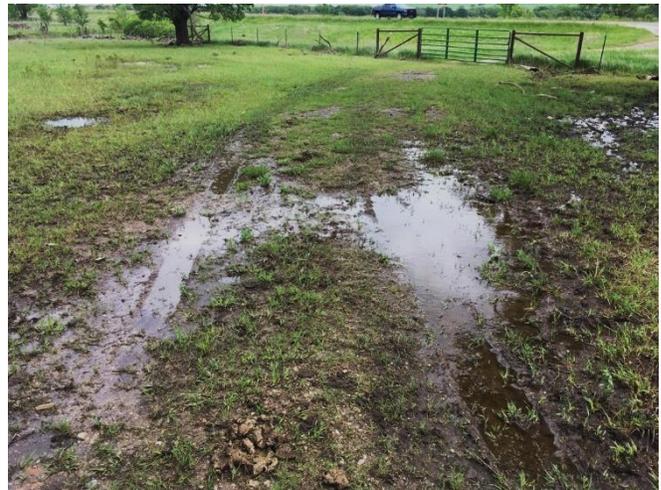
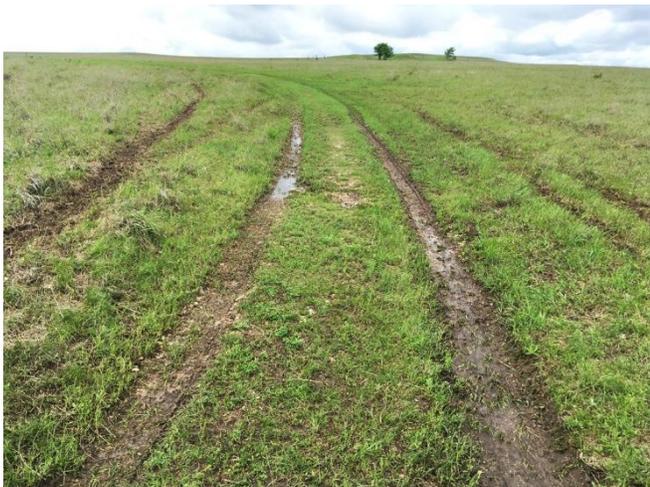
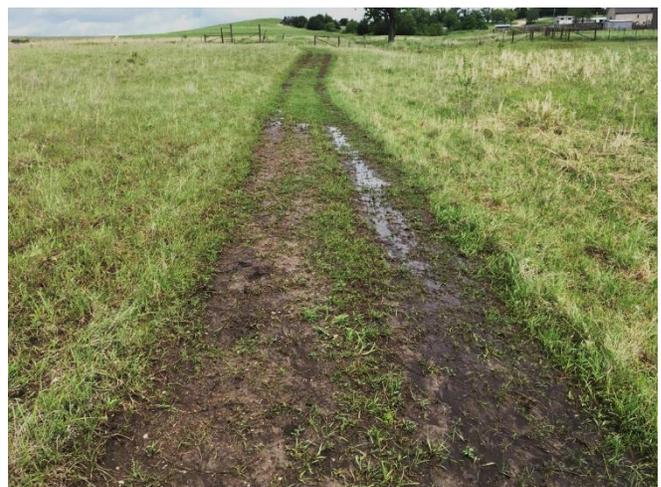
Z Bar Spur (ZBS)

This 0.4 mi road is primarily a ranch infrastructure route, though it does provide access from the visitor center area to the Fox Creek Trails. This route is generally about 8 ft wide and has native soil and vegetation cover. In some flat areas there is considerable exposed soil and muddiness from the cattle, including some eroded streambanks from cattle trampling. Navigation is a bit confusing around the visitor center. Not in a way that people will get lost as the visitor center is always visible but there is a confusing network of trails with few markers and it is unclear which trail is the official one. Recommend improving signage and potentially closing out some of the excessive additional routes. Three segments were identified as excessively muddy totaling 130 ft; these areas were associated with the cattle at a feeding tank and near gates. On section has excessive soil loss (100 ft) due to deep tire rutting and a section assessed as unsustainable (100 ft) was both muddy and rutted with a fall line alignment near a stream.

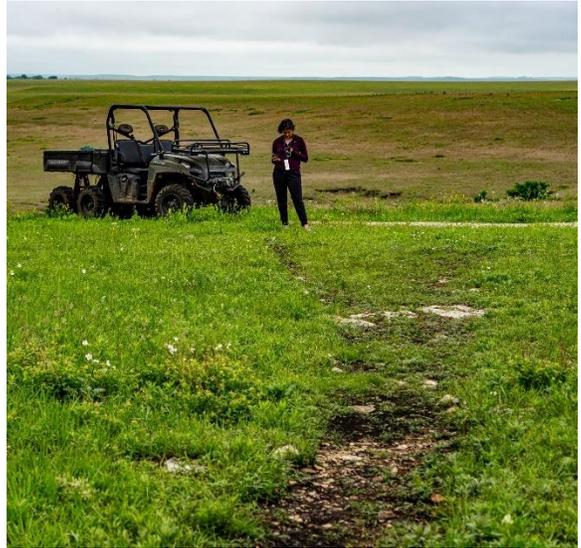
Field staff found only two informal (visitor-created) trails, both on the Scenic Overlook Trail. The first trail (148 ft long, pictured) departed from the road to access a small pond located adjacent to the road. The second trail (165 ft) departed from the road at a right-angle bend just prior to the buffalo pasture gate to access a scenic overlook. Both these trails departed from the formal trails and accessed visitor attraction features. While we saw many other side-trails elsewhere in the Preserve we judged them to have been created by cattle or buffalo as opposed to visitors, though it's possible we missed a few. Regardless, the creation/proliferation of informal trails is clearly not a visitor management problem currently in the Preserve. We also note that it requires a substantial amount of visitor traffic to create and maintain visible trails in prairie vegetation.

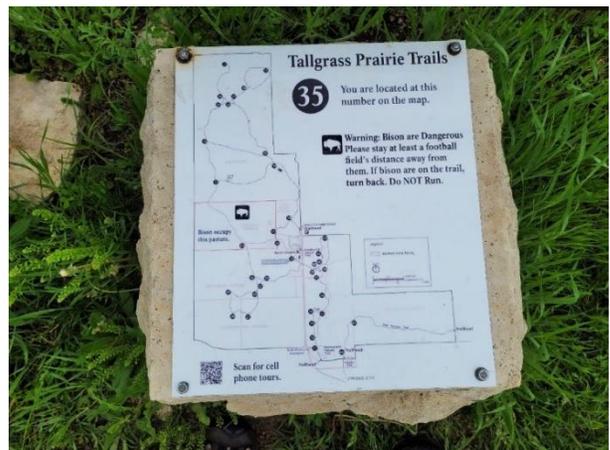
Table 21). A geospatial GIS databased of these features is a product of this research, allowing staff to select each feature to see its location, photo, condition, or comment information (Figure 7). Representative photos of these features are included below. As an example, we recorded the locations and took photos of all 38 trail system markers (pictured below). Sixteen informational signs were located, including those at gate locations. Twenty gates were inventoried but only four culverts were found. Ten visitor benches were found, including blocks of stone and those constructed of plastic wood (pictured). Finally, we identified 32 stream crossings, again captured with one or more photos and comments that can be used to begin evaluating their condition and possible threats to water quality. Also included in Table 22 is a listing of each watershed with GIS-calculated “upstream” watershed sizes – larger watersheds should contribute greater volumes of water during rain events and can help to inform decisions about alternative management options such as no action, armoring with large stone, culverts, or bridges. As previously discussed, some stream crossings with steep embankment grades revealed clear evidence of soil runoff directly into streams and further evaluation by specialists seems warranted. Many of these were pictured on the individual trail summary pages.

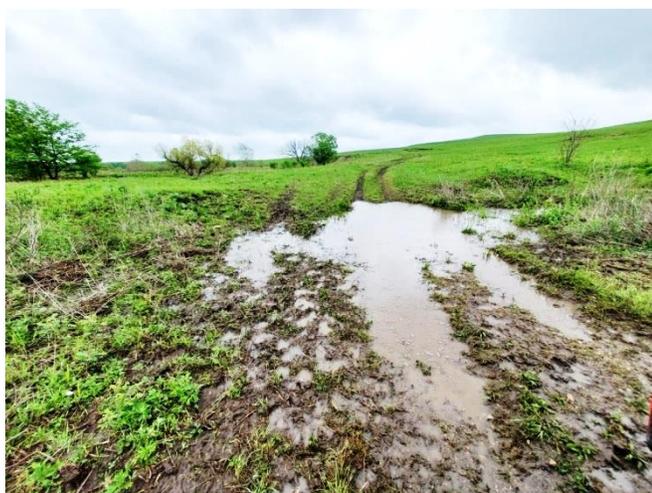
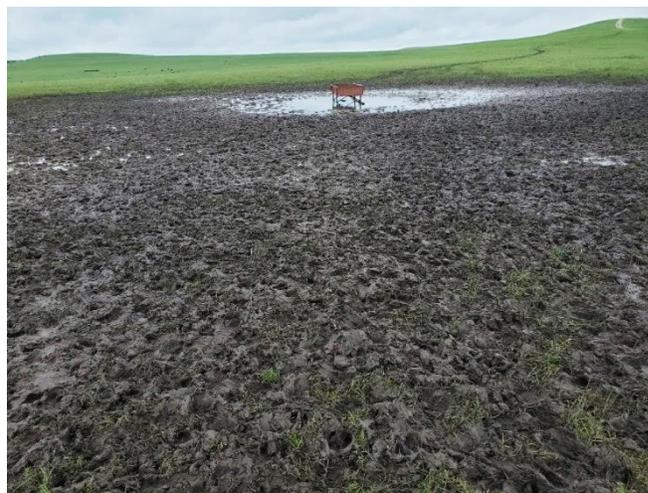
Figure 10. Prairie Fire Loop lower swale area (intermittent drainage) that could be spot fixed with gravel (left). Mud generated by cattle hooves along the Prairie Fire Loop Trail (right).

Alternative management responses for managing the trails in flatter terrain are varied. Limiting traffic, particularly by heavy trucks, during periods when soils are wet will limit deeper rutting (soil displacement). Using the lighter 6-wheel Ranger vehicles is a preferred alternative during wet periods when access is essential – ground pressures are substantially reduced. If deeper ruts do develop in some areas that begin to retain water and create chronic muddiness that trail users avoid, then applying a mixture of crushed angular gravel and native mineral soil to the ruts can be an effective solution as this ensures that traffic can remain on the designated trail (Figure 10). If this is inappropriate or ineffective, then relocating the affected trail segments to adjacent side-hill alignments with low trail grades (3-5%) is a more sustainable long-term practice (Figure 6). We also encountered a few locations along the trails where cattle are provided with minerals/salt that create excessive muddiness for trail users, and significantly degrade aesthetics and viewsheds (Figure 10). Perhaps these locations might be shifted annually (rest-rotation) or moved to less visible locations away from trails and streams.

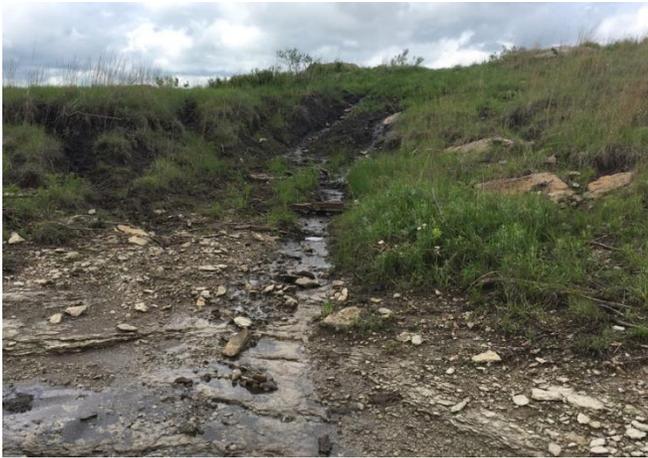
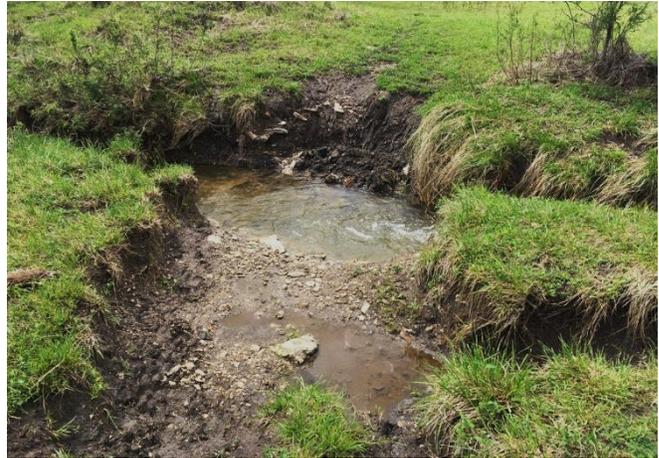
- 7) Consider using well-maintained culverts and elevated treads to cross smaller intermittent or permanent streams but ensure that culvert sizes are designed to accommodate the expected size of large, rare, flood events (e.g., 100-yr floods). Armor and protect abutment soils with large angular rock.

- 8) Bridges represent more effective but expensive options and must be professionally engineered to accommodate large flood events without erosion of the abutments and treads. Further evaluations by soil conservation specialists with road engineering expertise seems warranted, perhaps funded by a major NRPP funding project to develop and execute the necessary professional guidance and solutions.

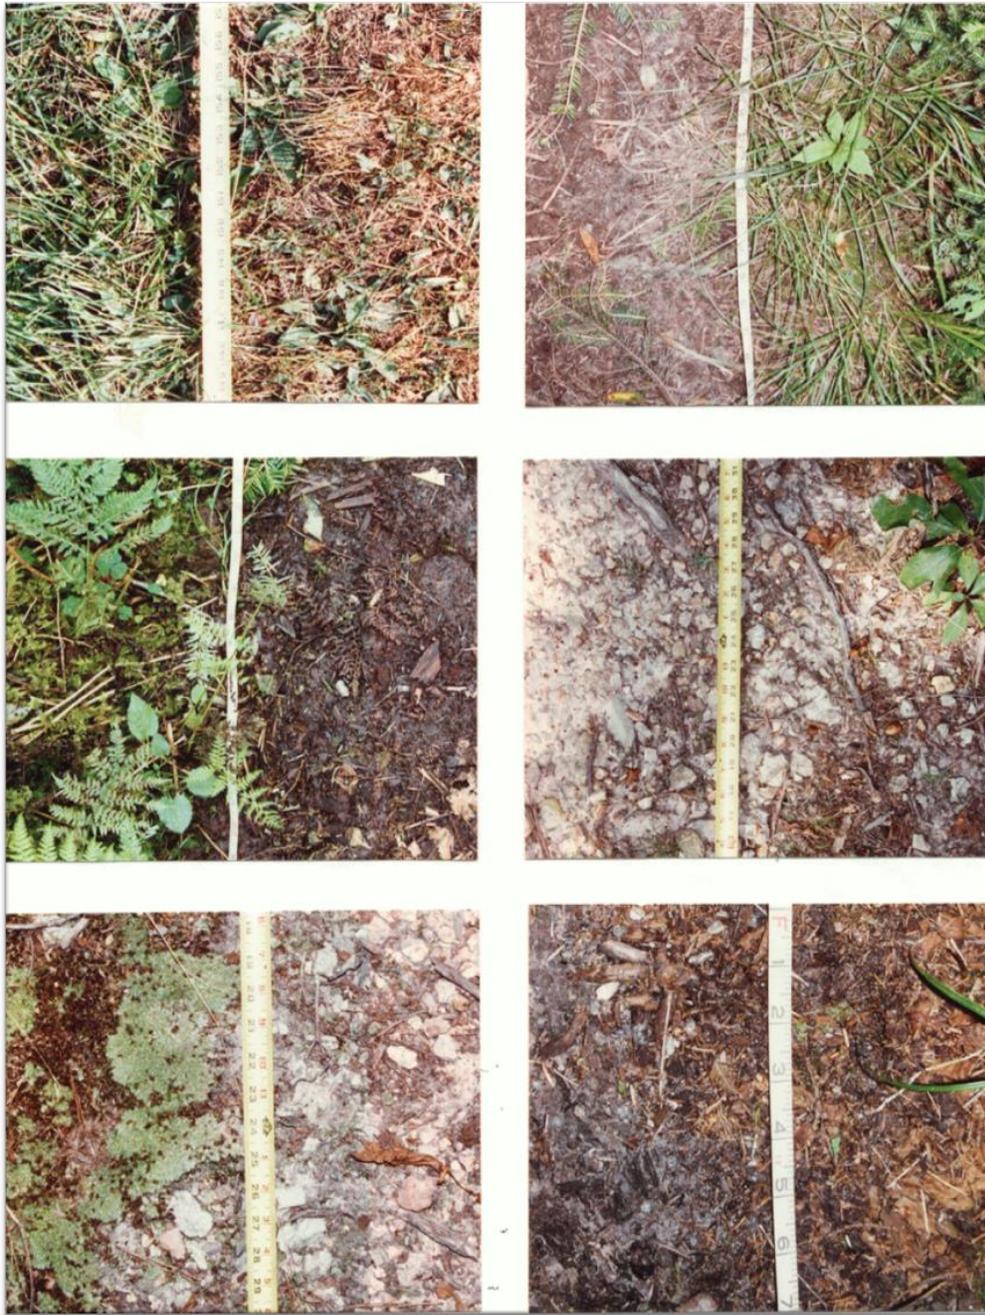
Figure 1. Photographs illustrating different types of boundary determinations. Trail tread boundaries are defined as the most pronounced outer boundary of visually obvious human disturbance created by trail use (not trail maintenance like vegetation clearing). These boundaries are defined as pronounced changes in ground vegetation height (trampled vs. untrampled), cover, composition, or, when vegetation cover is reduced or absent, as pronounced changes in organic litter (intact vs. pulverized).
