BEST PRACTICES FOR BICYCLE TRAIL PAVEMENT CONSTRUCTION AND MAINTENANCE IN ILLINOIS

Research Report FHWA-ICT-12-009

**Developing Best Practices for Bicycle Trail
Pavement Construction and Maintenance in Illinois**

June 2012

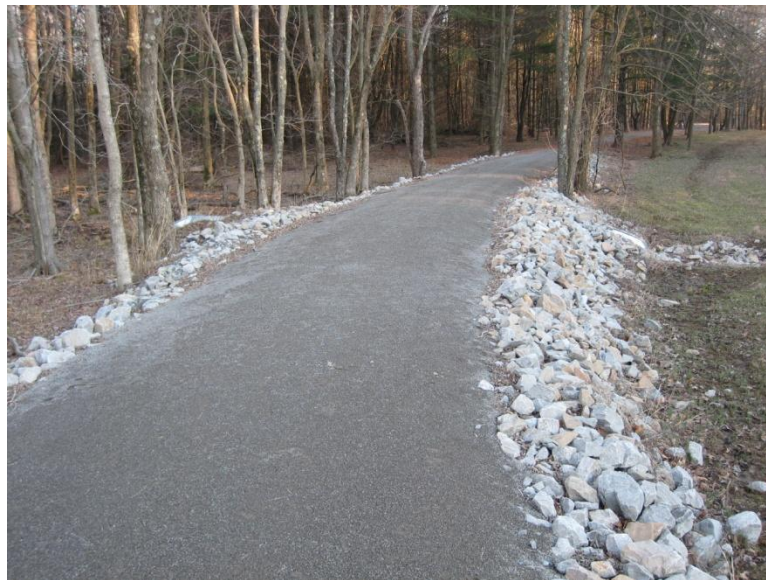
Figure D.21. Fortification of drainage components after installation.

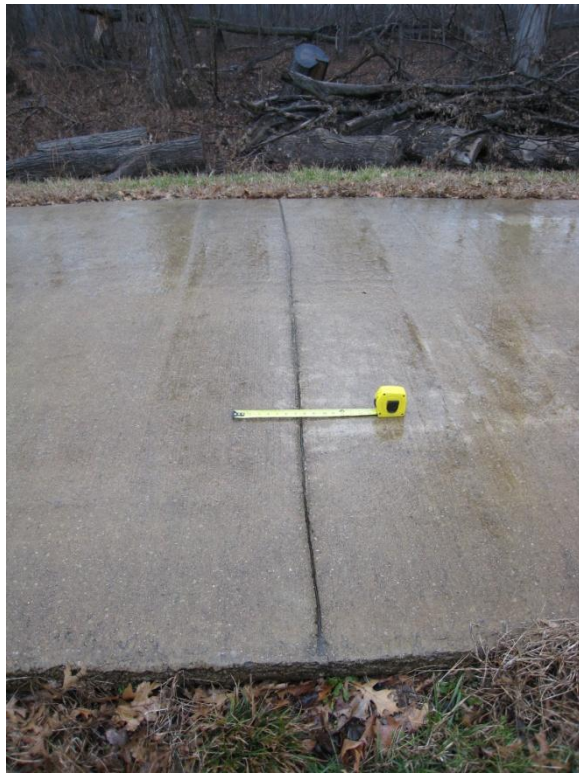
Figure D.26. Typical tooled contraction joint.

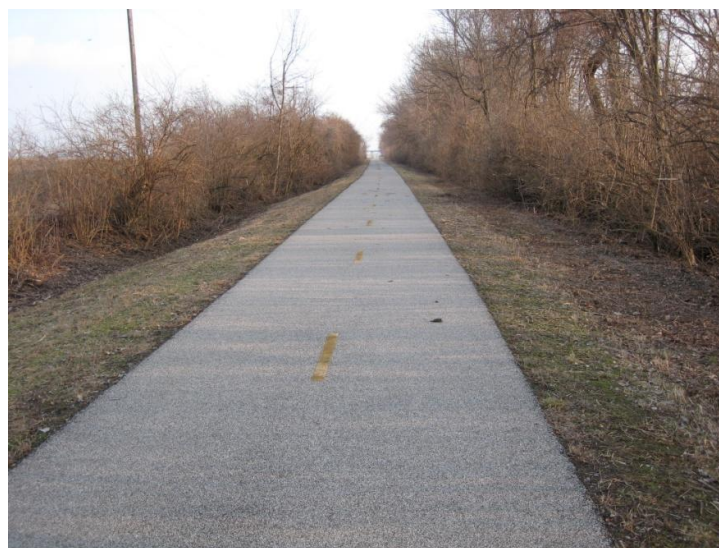
This trail was in outstanding condition. Like the Nature Trail, there were no thermal cracks present. As shown in Figure D.38, there was good vegetation clearance and pavement edge support. Some areas had low-severity longitudinal cracking, as shown in Figure D.39. One localized area of binder bleeding was observed, as shown in Figure D.40.

Figure D.38. Good edge support and vegetation clearance.
