CUSTOMER SUCCESS STORY

WIRELESS MONITORING PREVENTS PRODUCTION LOSS

INDUSTRY | Automotive – Rubber

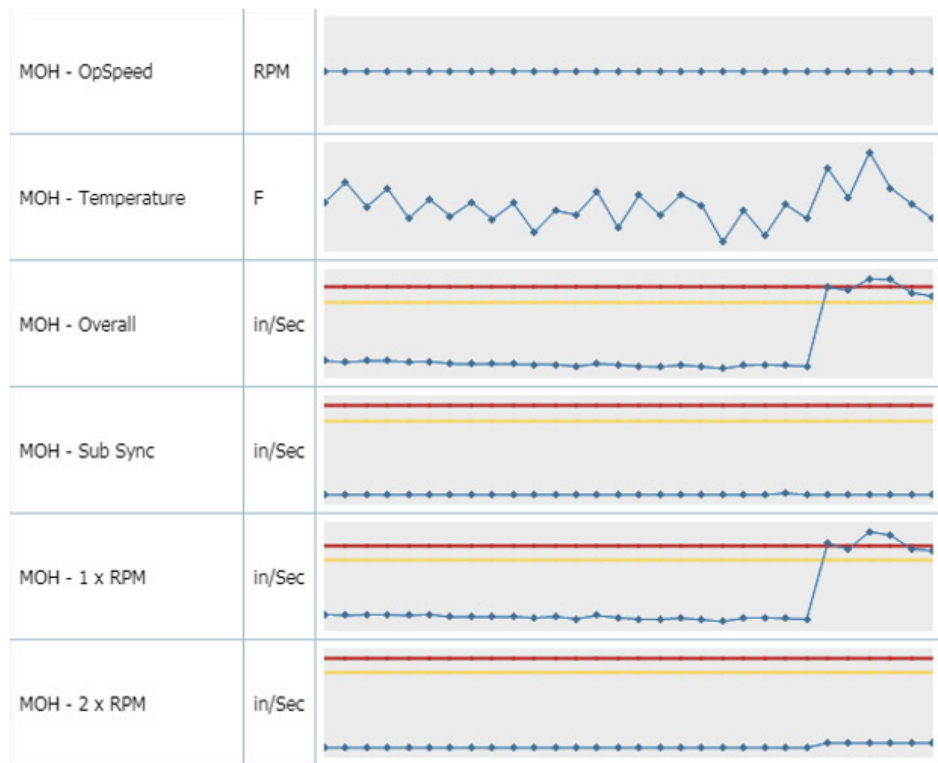
A full review of the data indicated that the coupling on a boiler feed water pump had locked upon startup. The analyst completed a fault entry report for the customer and communicated to everyone that was impacted. The report clearly outlined the assessment and the repair recommendation.

Analysis Comment: The vibration data and cross channel phase analysis indicates misalignment at the coupling.

Failure Mode: Misalignment

Reason: Improper Alignment

Fault entry report capturing analysis and repair recommendation for client

Assessment Comment: Perform precision motor alignment and replace coupling insert.

Repair Recommendation: Perform a precision alignment and replace the elastomer coupling insert. Align the key ways 180 degrees apart. Set the coupling gap to the manufactures recommended distance for the coupling being installed. Properly lubricate the coupling if applicable.
