Flexible solutions for complex wound reconstruction

Table of contents

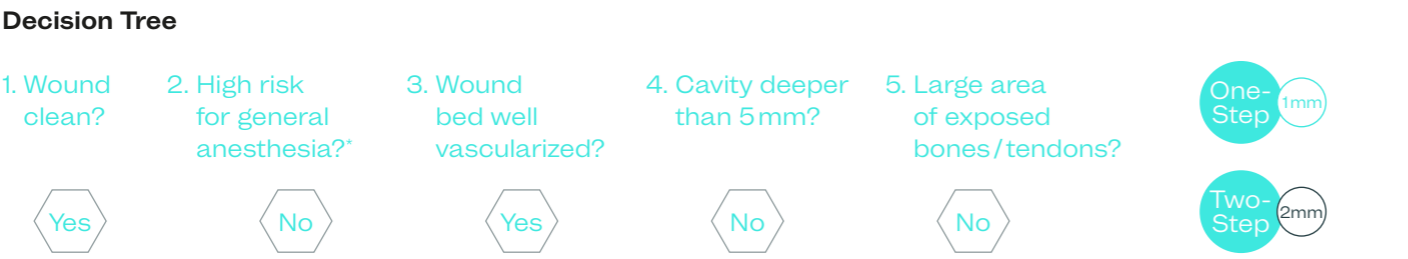
Pre-operative: Hyperextension of the MCP joint – function is considerably limited (Fig.1). Fist closure is not possible (Fig.2). Intra-operative: Complete excision of the scar tissue (Fig.3). Intra-operative: The scar tissue – laid back onto the wound bed for the photo – reveals the dimension of the scar contraction, the skin deficit and the substantial functional limitation (Fig.4). Long-term follow-up: Normal function of the hand without any limitations (Fig.5 – 7).

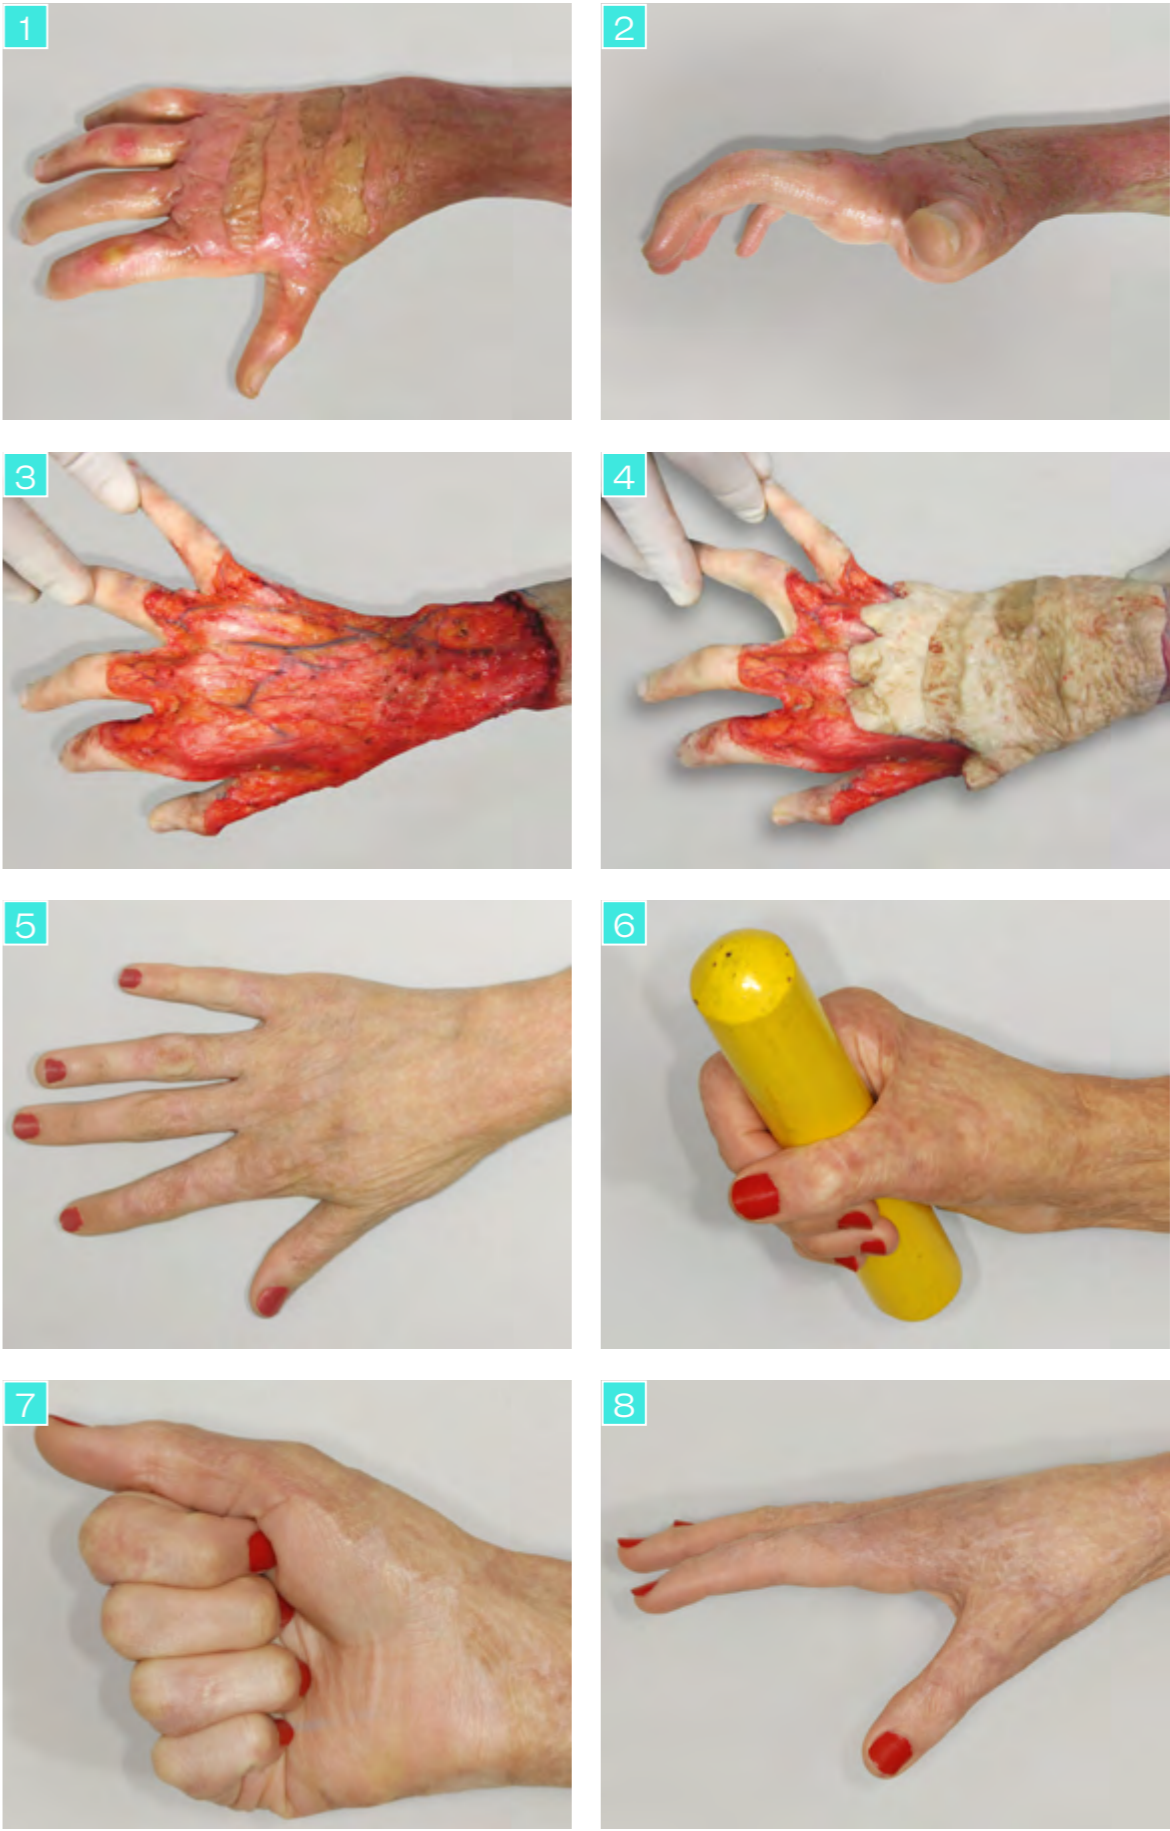
* Courtesy of L. Kamolz, MD, Graz, Austria

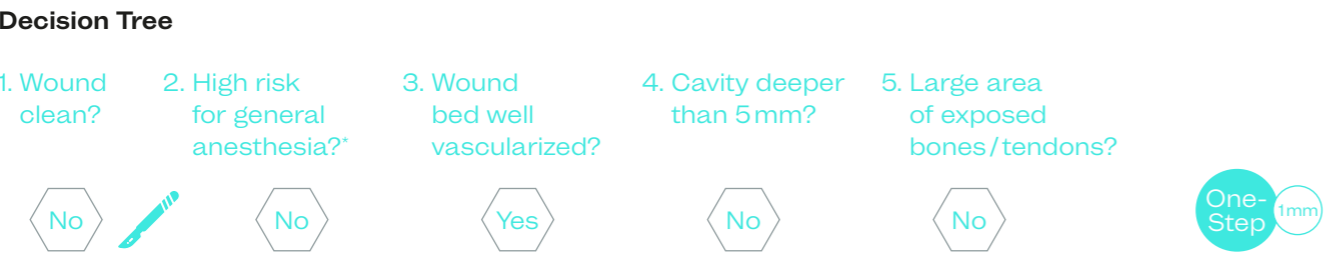
A 2-year-old child presented with a scald burn on the right foot (Fig.1). At the subsequent surgery the wound was carefully debrided (Fig.2). Due to the higher risk of contracture because of the young age of the patient, it was decided to use MatriDerm® in an attempt to prevent scar tissue formation and contracture.

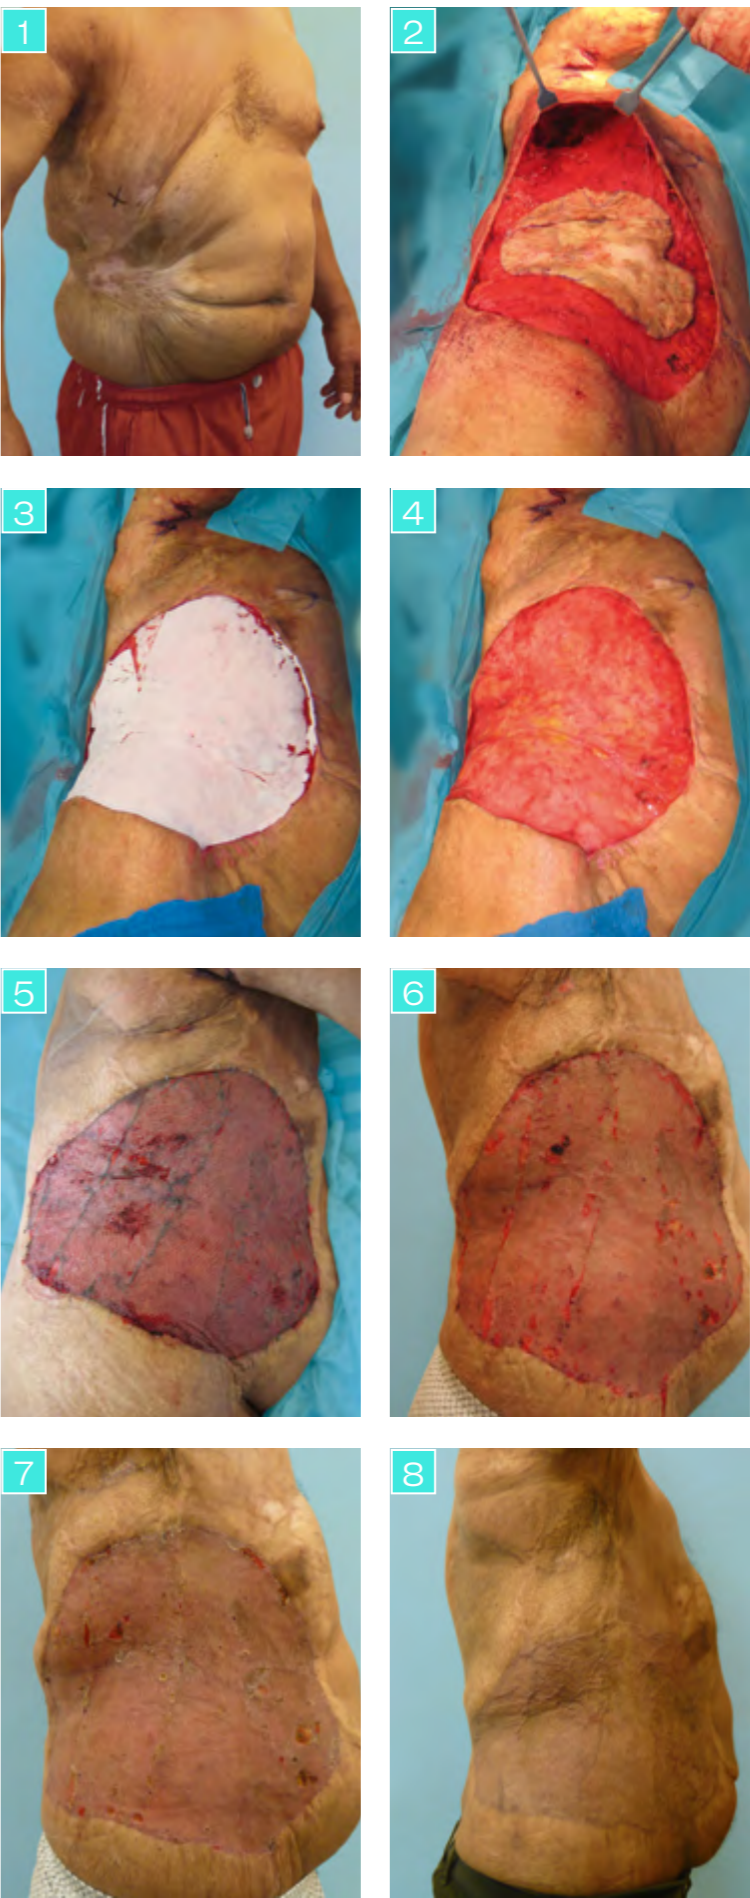
* Courtesy of J. Grünert, MD, St. Gallen, Switzerland

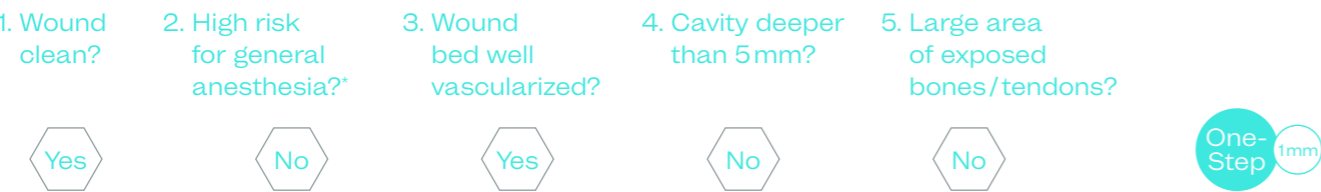
Aspect of the wound before operation (Fig.1,2). Pre-operative marking of the area to be excised (Fig.3). Aspect of the wound after scar resection with release of healthy tissue. In order to show the extend of contracture release the scar tissue was put back onto the wound bed for this photo (Fig.4). Application of MatriDerm® (Fig.5), covered with fenestrated split-thickness skin graft (Fig.6). Negative pressure wound therapy as dressing (Fig.7). Result after 2 weeks (Fig.8). Result after 3 months (Fig.9). Result 1 year later (Fig.10,11). Pleasing functional and aesthetic outcome with full pain release. Complete and stable healing of the wound.

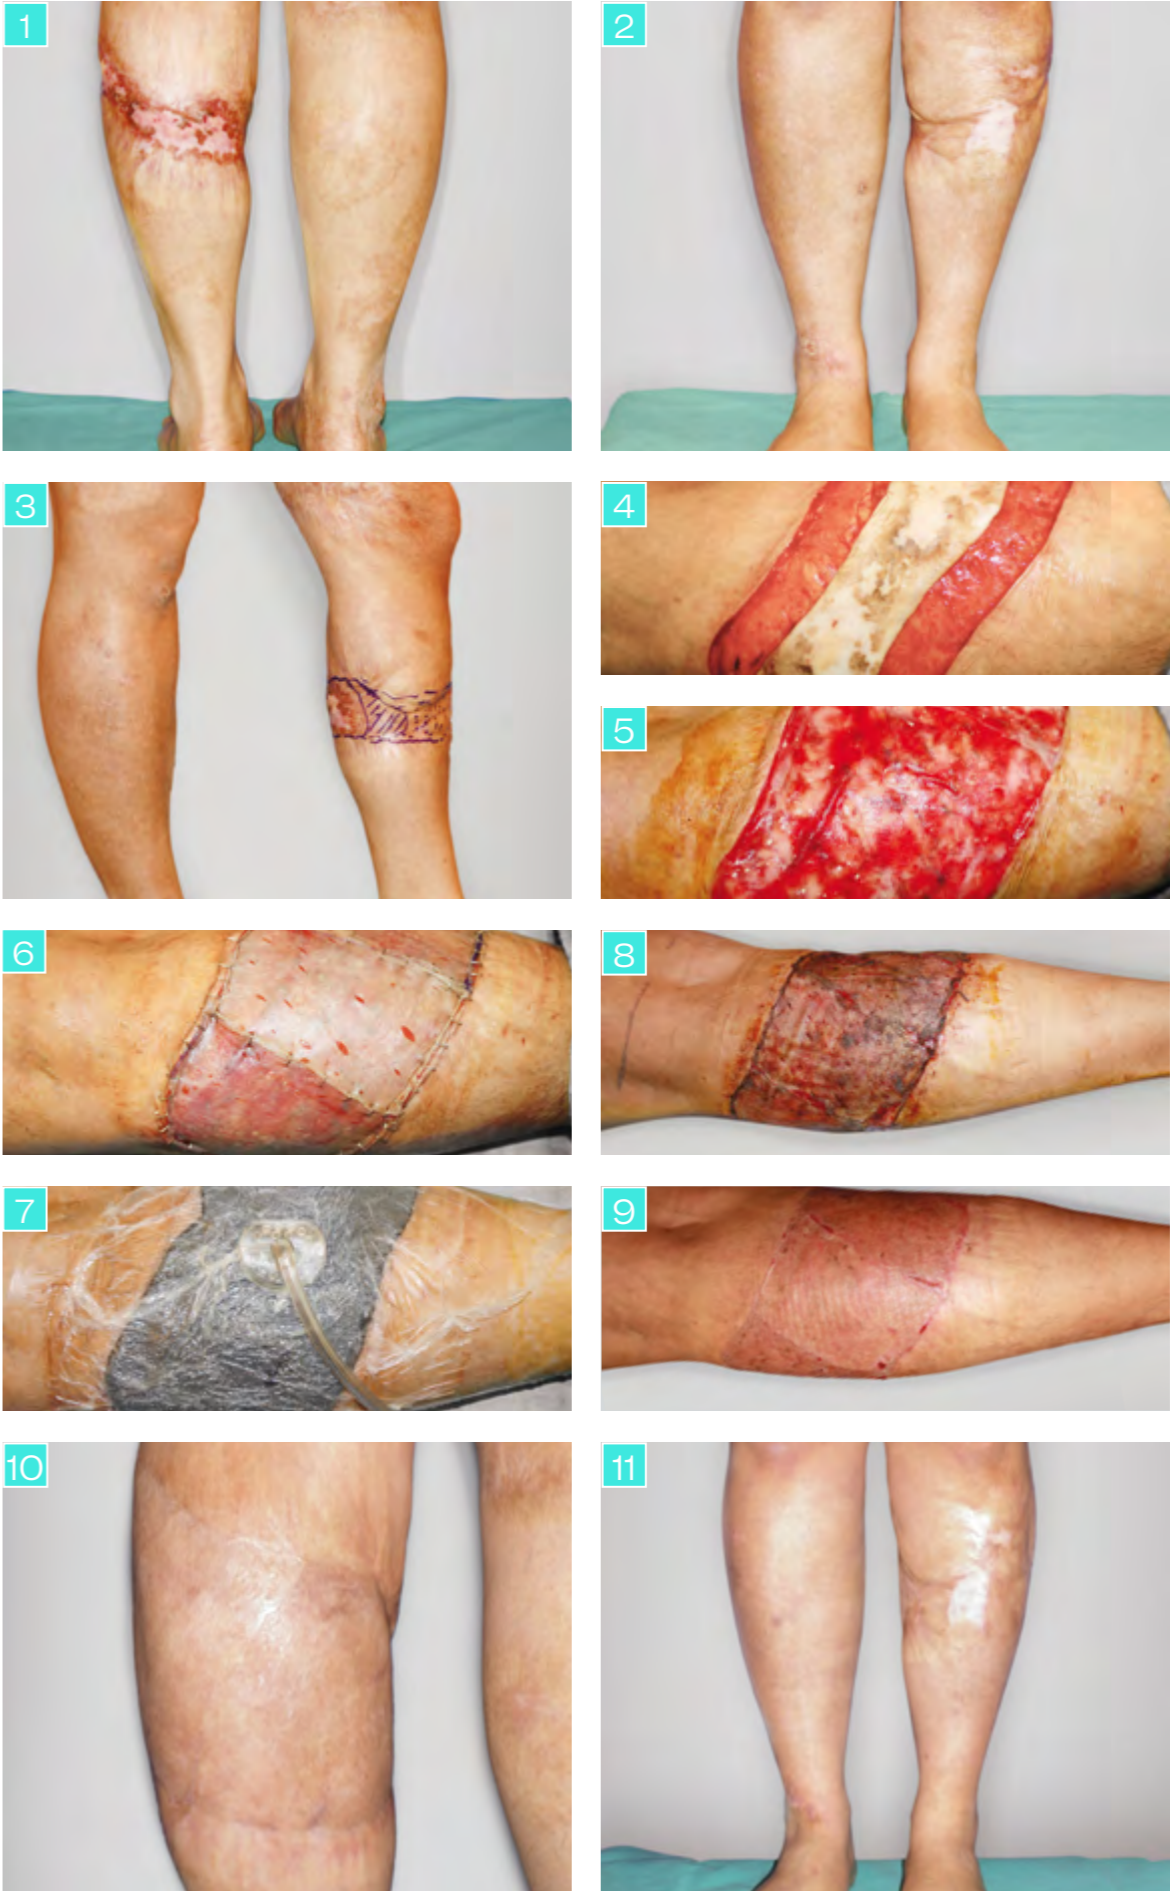
* Courtesy of A. Modarressi, MD, Geneva, Switzerland

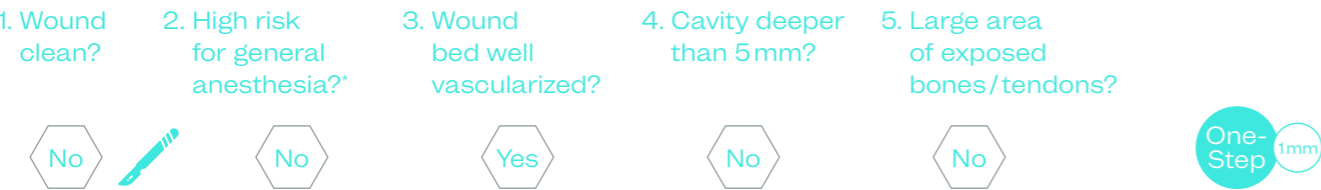
A 42-year old male presented with a flame burn on chest and neck (60% TBSA) (Fig.1). This is a challenging region due to high incidents of contractions, so high elasticity is very important.

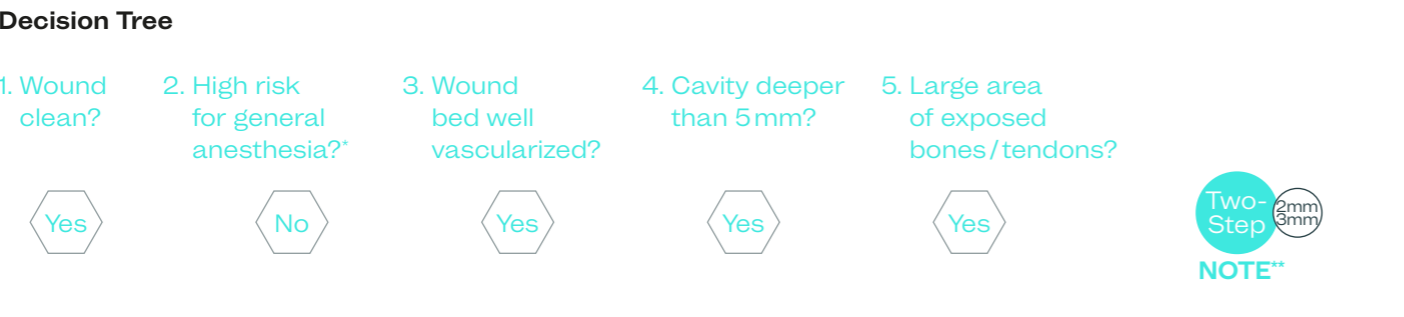
The patient suffered from a work accident where his arm was crushed into an industrial roller, which resulted in multiple bone fractures and degloving of his right arm (Fig.1).

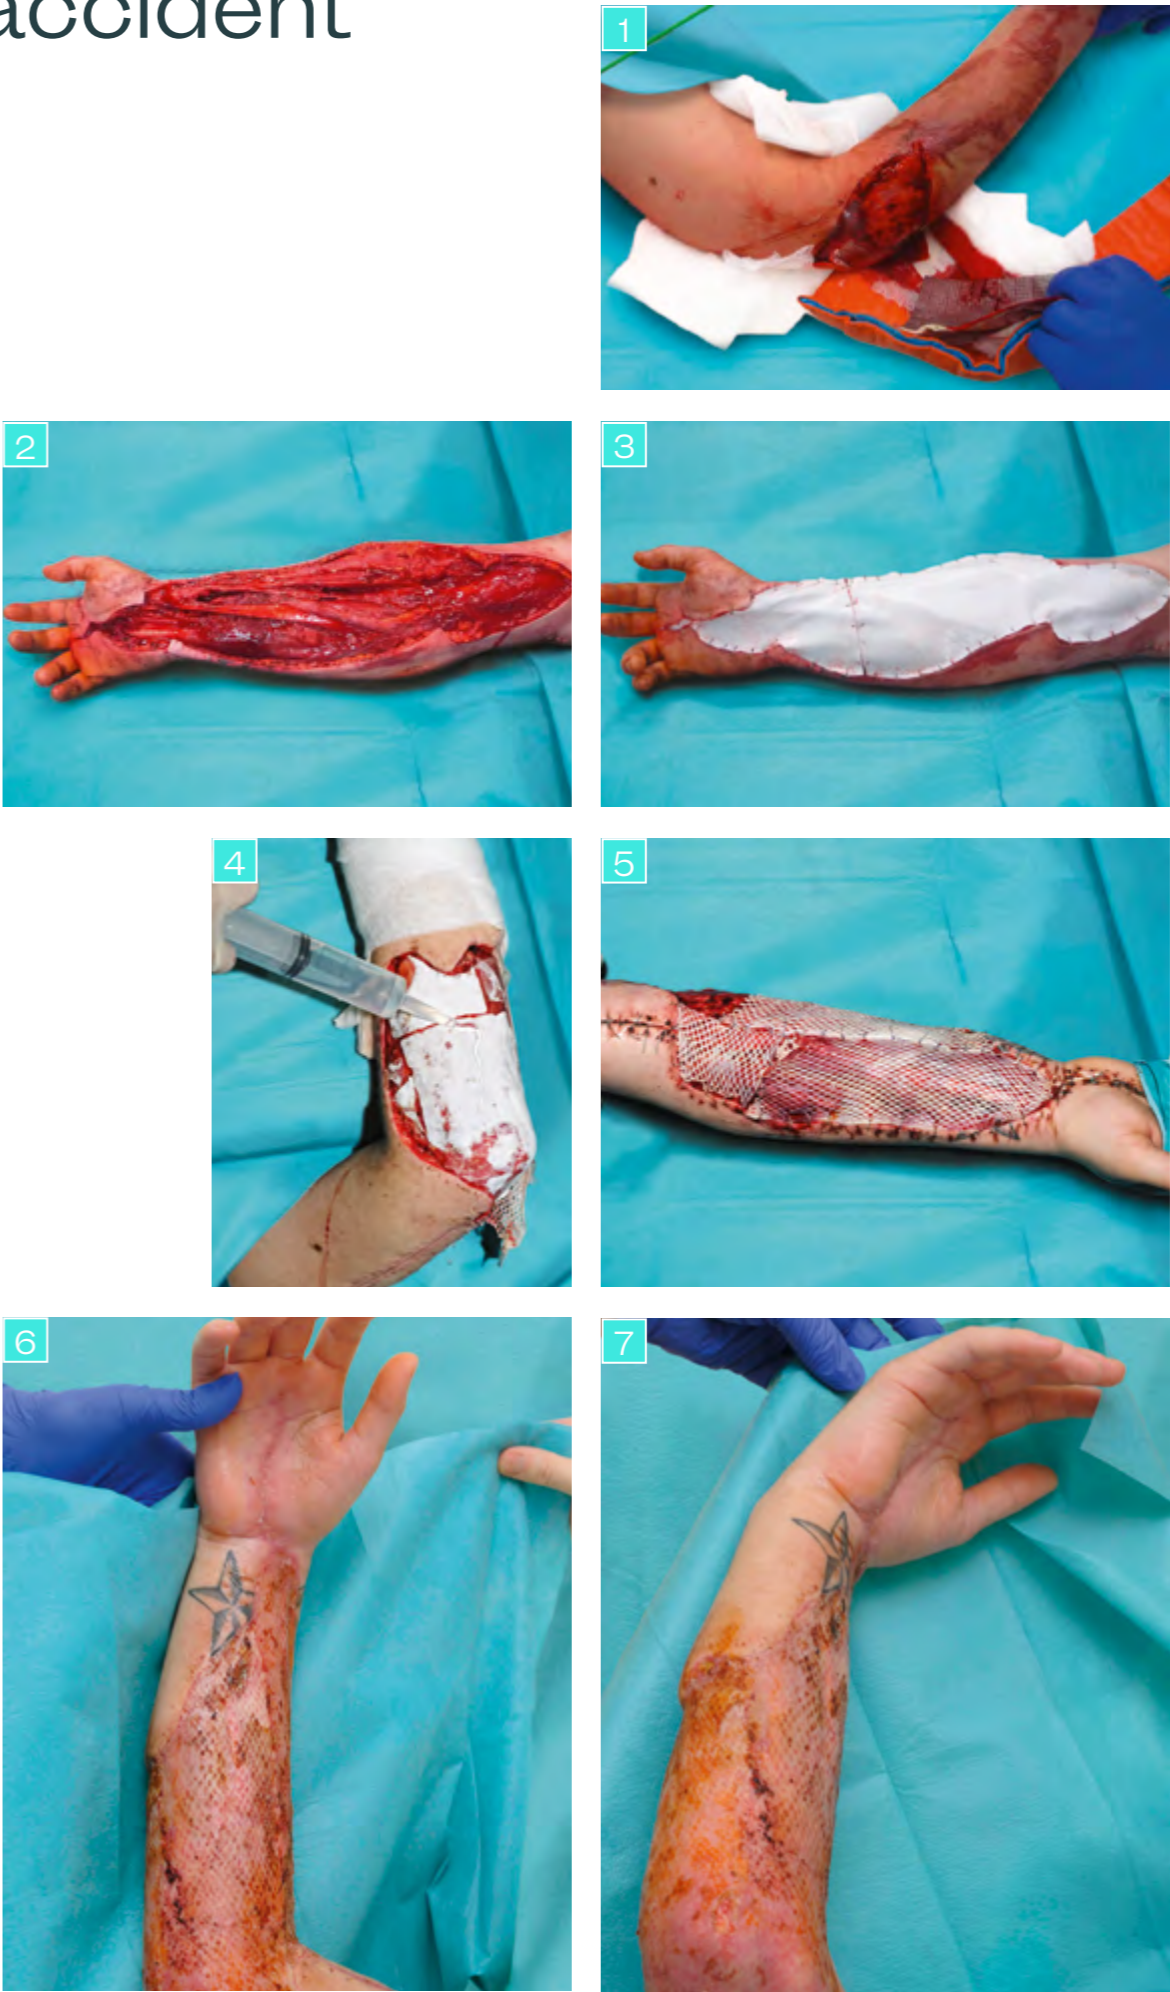
Degloving injury at lower leg

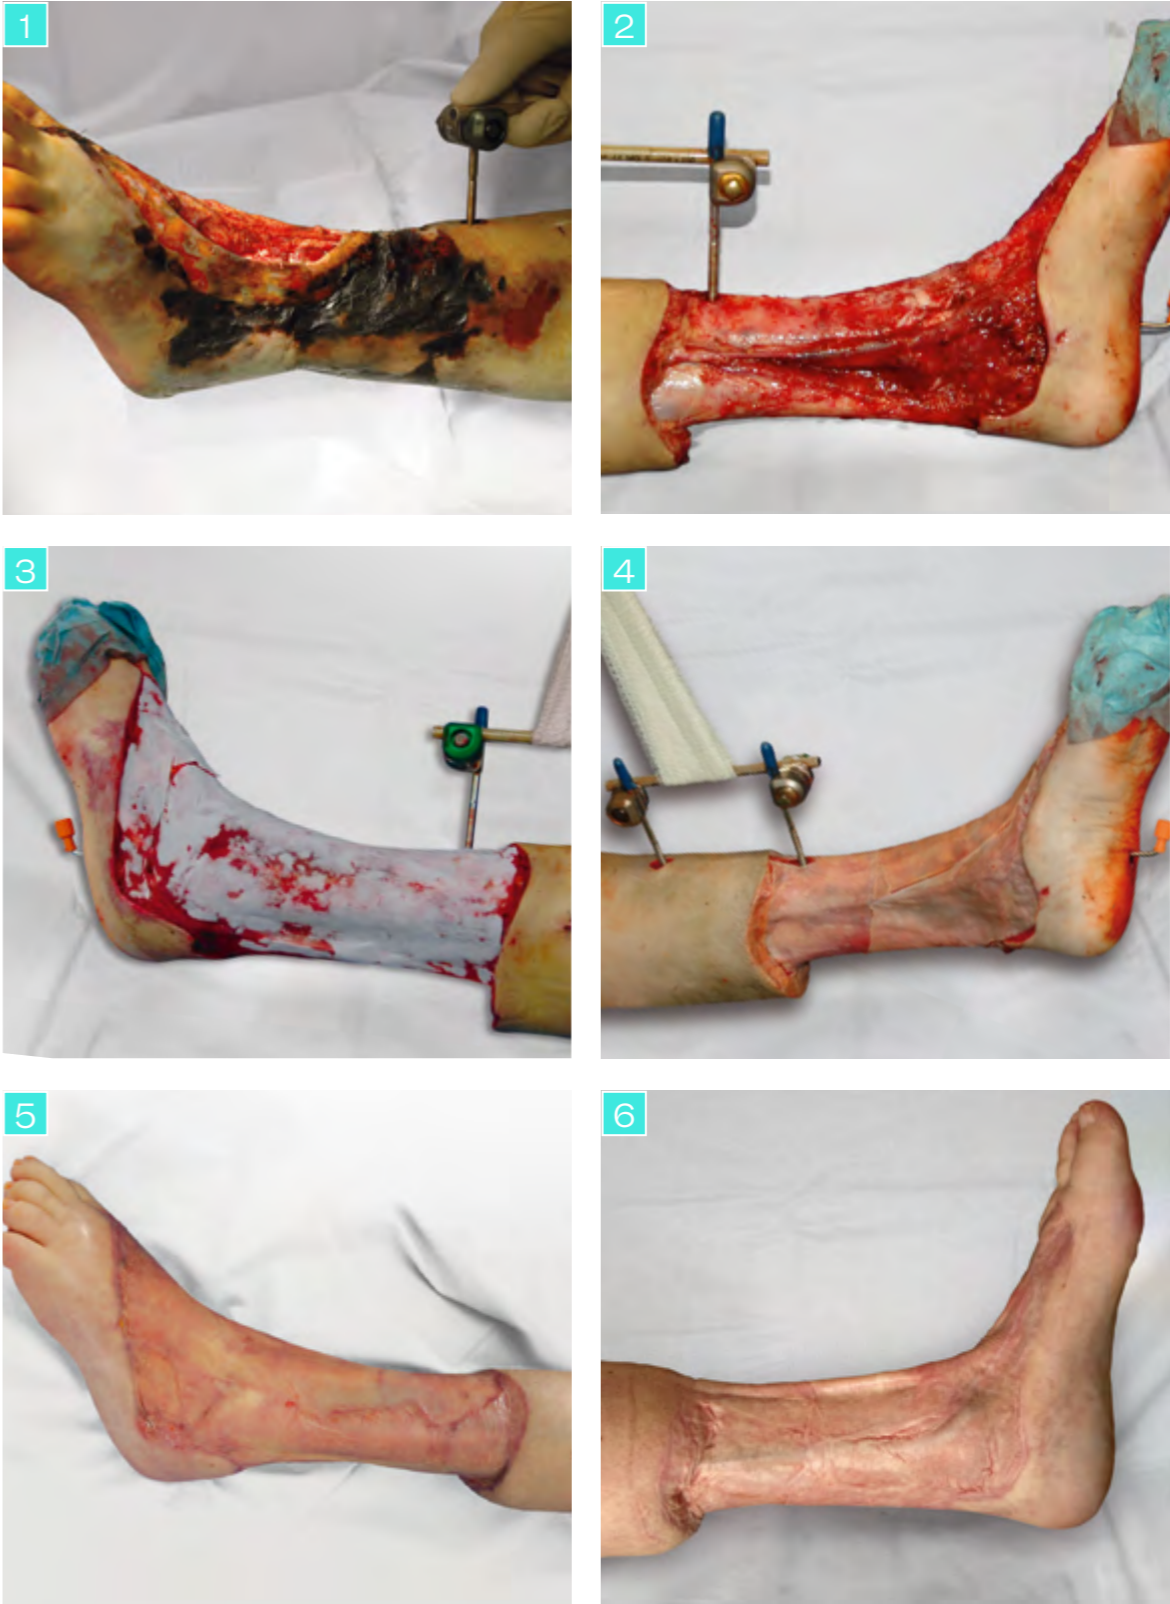
* Courtesy of M. Öhlbauer, MD, Murnau, Germany

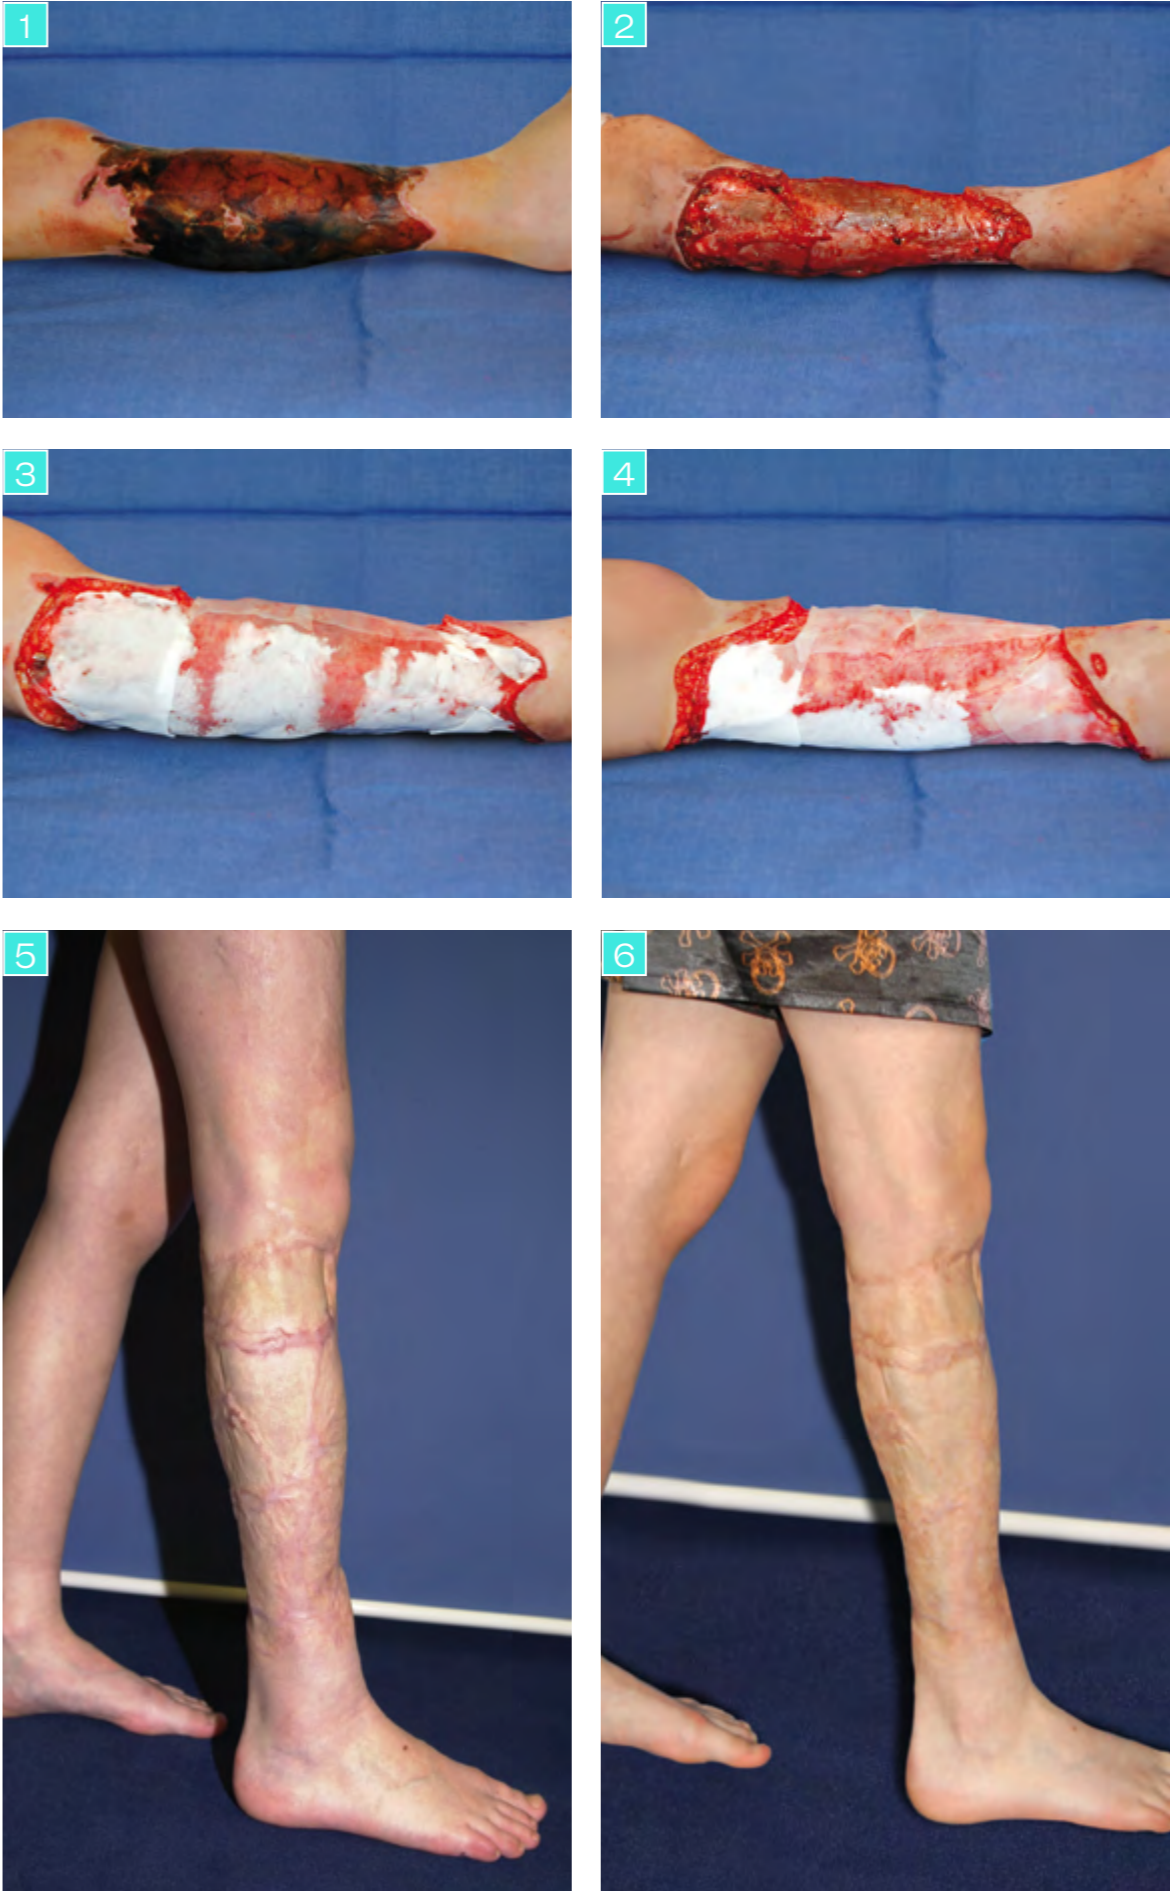
* Courtesy of M. Öhlbauer, B. Wallner and M. Miltz, MD, Murnau, Germany

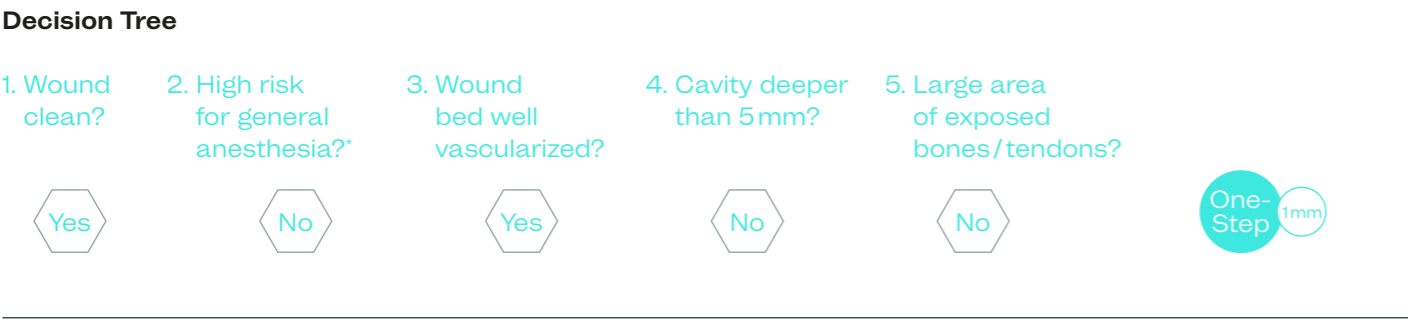
In this case a 60-year-old patient was hospitalized with an acute avulsion after motor-bike injury. The intra-operative view revealed a defect at the heel and a 2cm exposed Achilles tendon (Fig.1). The wound was treated with 1mm MatriDerm® and unmeshed split-thickness skin graft in a One-Step Procedure. 2.5 weeks later the wound area showed a closed skin with good tendency to heal (Fig.2). The physiotherapy started at this stage. A follow up of 5 weeks p. o. demonstrated a good development with a completely stable wound also over the Achilles tendon (Fig.3,4).

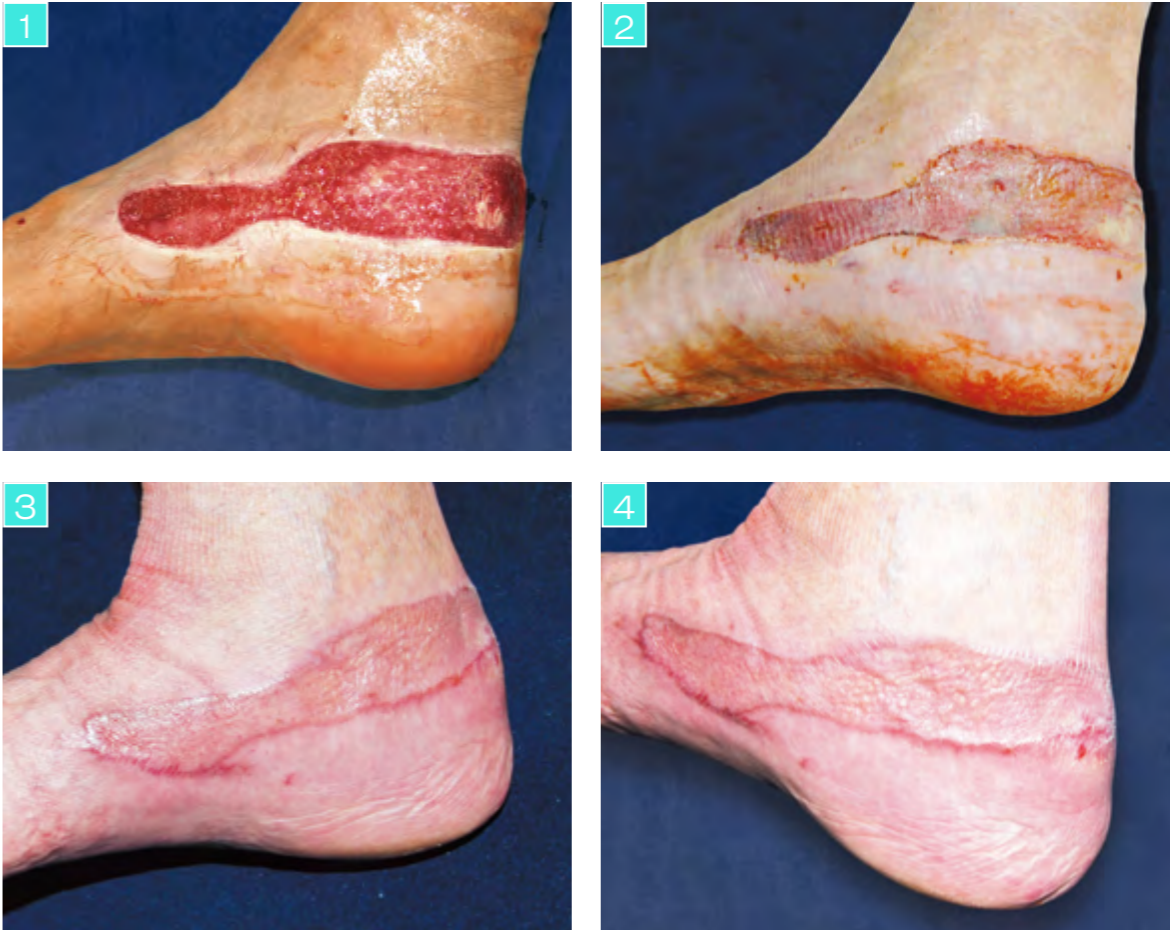
* Courtesy of U. Graf, MD, Zurich, Switzerland

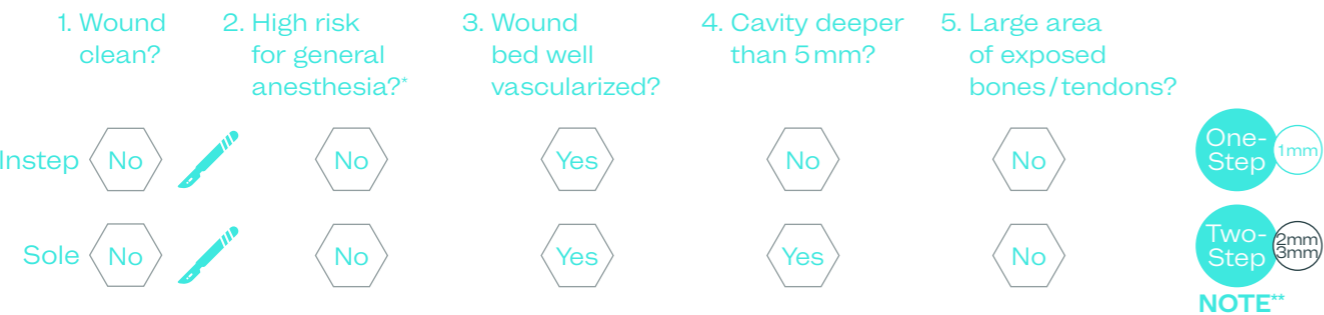
One week after motor-bike injury the traffic victim was transferred to a specialized trauma hospital with deep soft tissue loss on the instep and sole of the foot (Fig.1, 2). Debridement was performed including amputation of the necrotic first toe (Fig.3). Wound closure was achieved by using 1mm MatriDerm® in combination with unmeshed split-thickness skin graft in a One-Step Procedure (Fig.4,5).

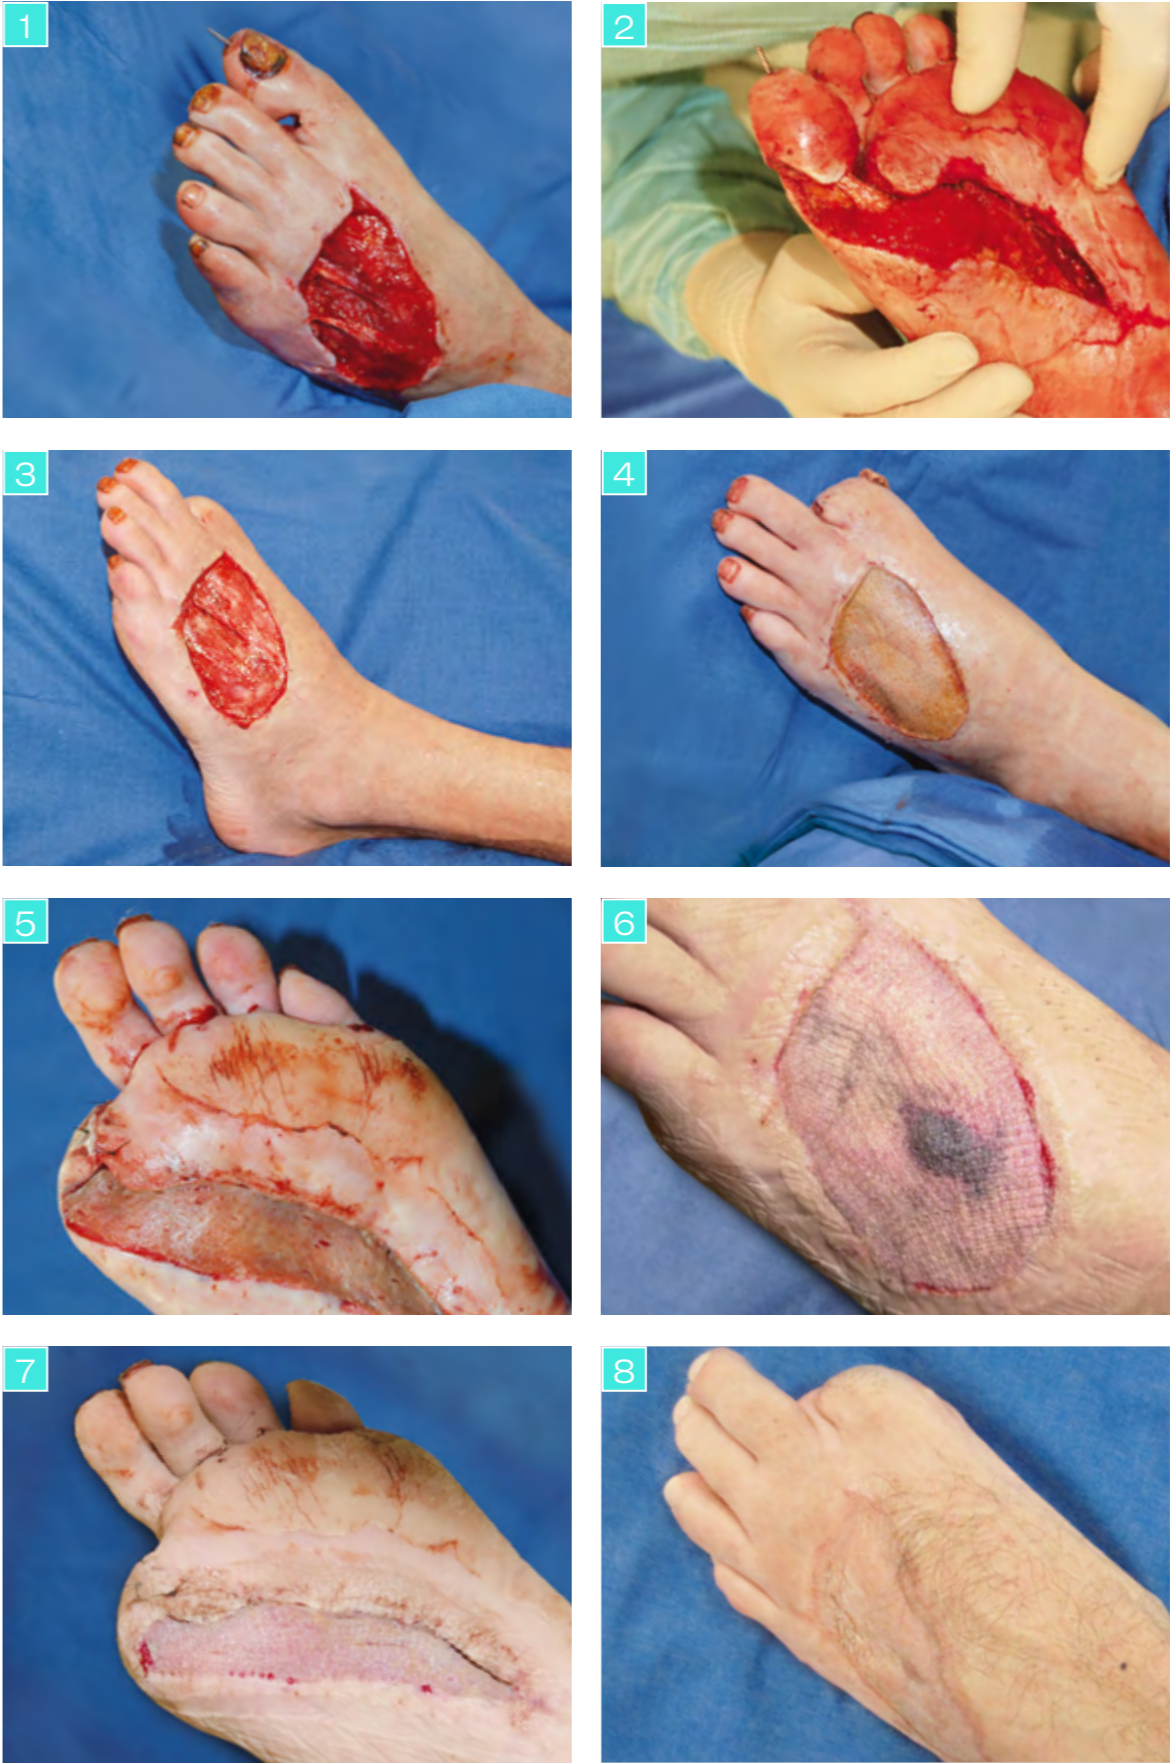
* Courtesy of M. Öhlbauer, B. Wallner and M. Miltz, MD, Murnau, Germany

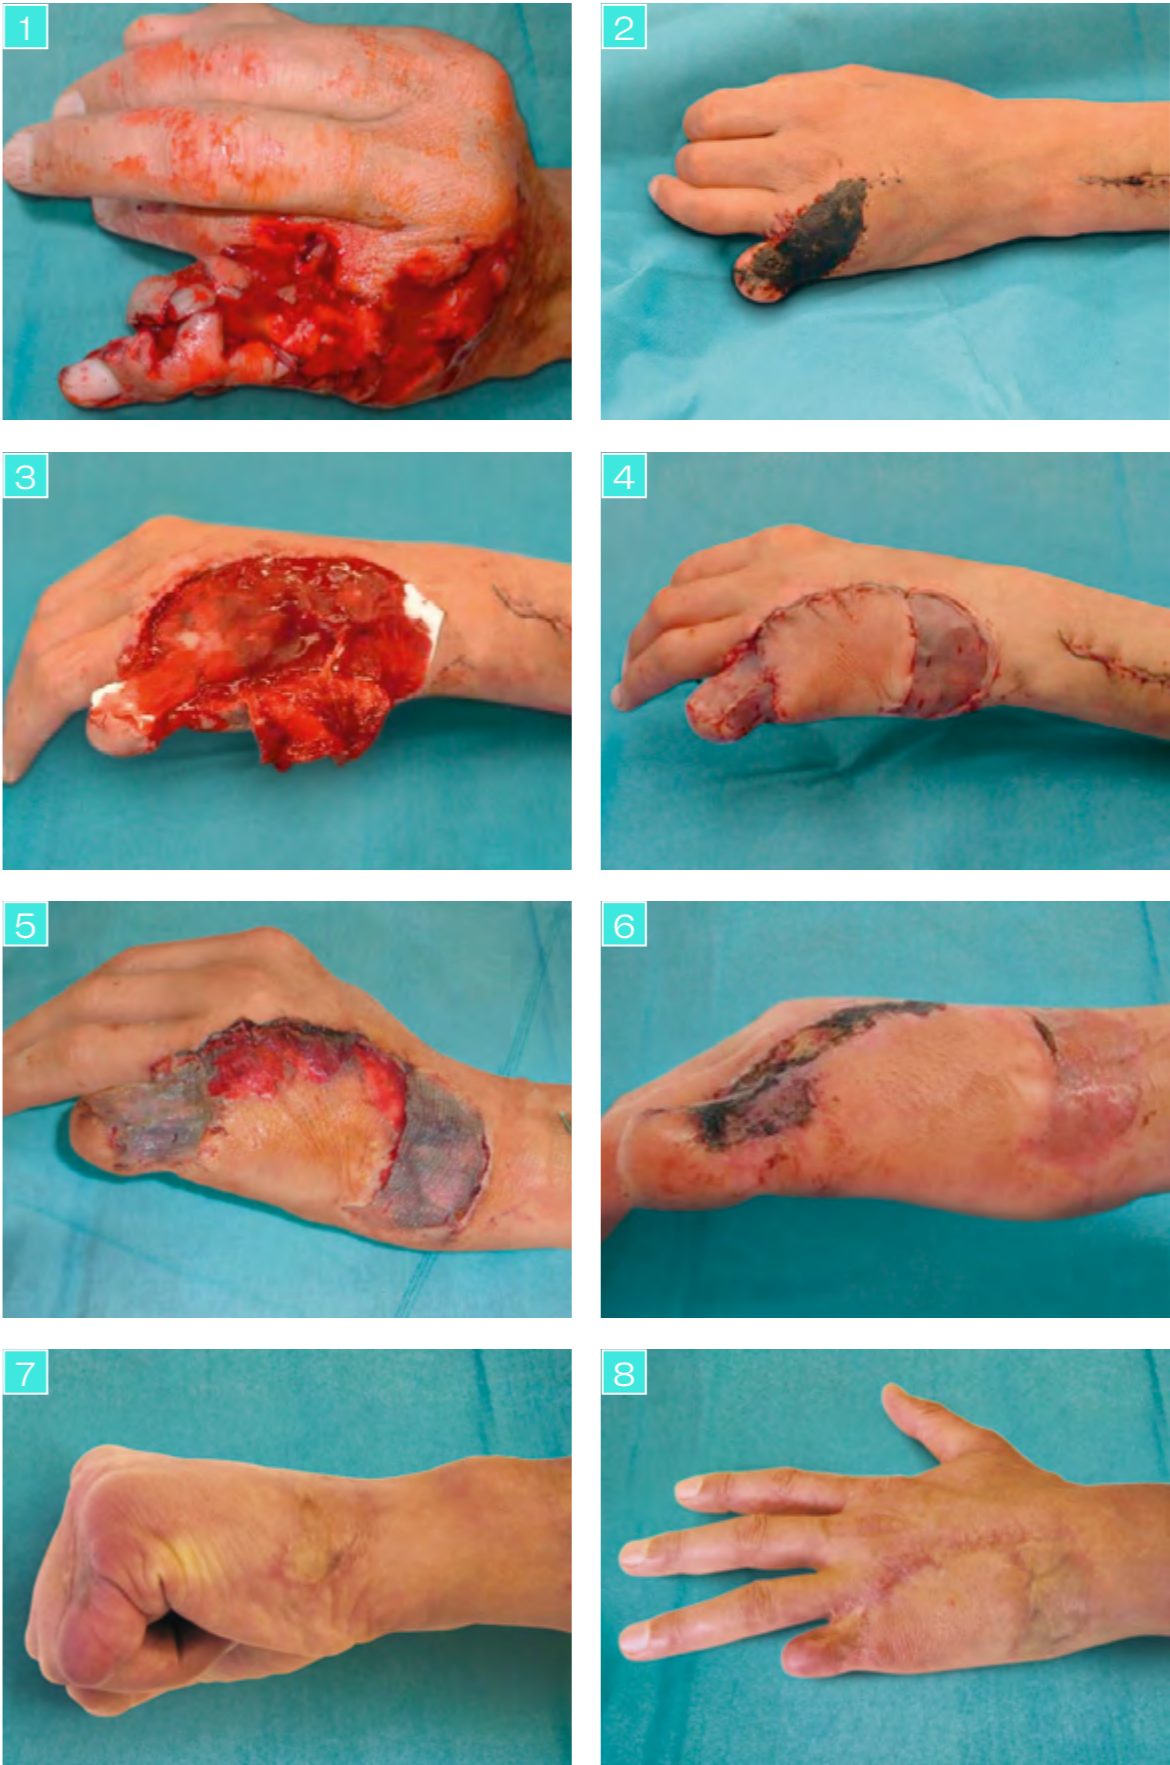
* Courtesy of L. Mathys, MD, Bern, Switzerland

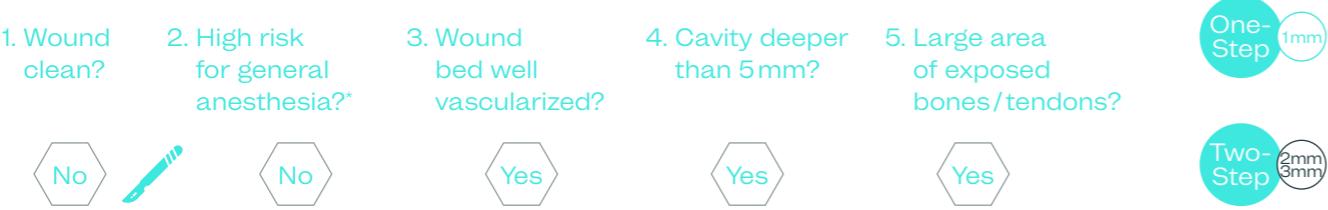
This 55-year-old patient suffered a laceration of the left lower leg and foot (Fig.1). After operative debridement, there was significant soft tissue loss (Fig.2). Defect coverage was performed with a free latissimus dorsi-serratus flap to replace the soft tissue loss. On top of the muscle flap a dry MatriDerm® (1mm) was placed (Fig.3) and rehydrated in situ. A meshed split-skin graft (meshed 1:1.5) was placed on top of the rehydrated MatriDerm® in a One-Step Procedure.

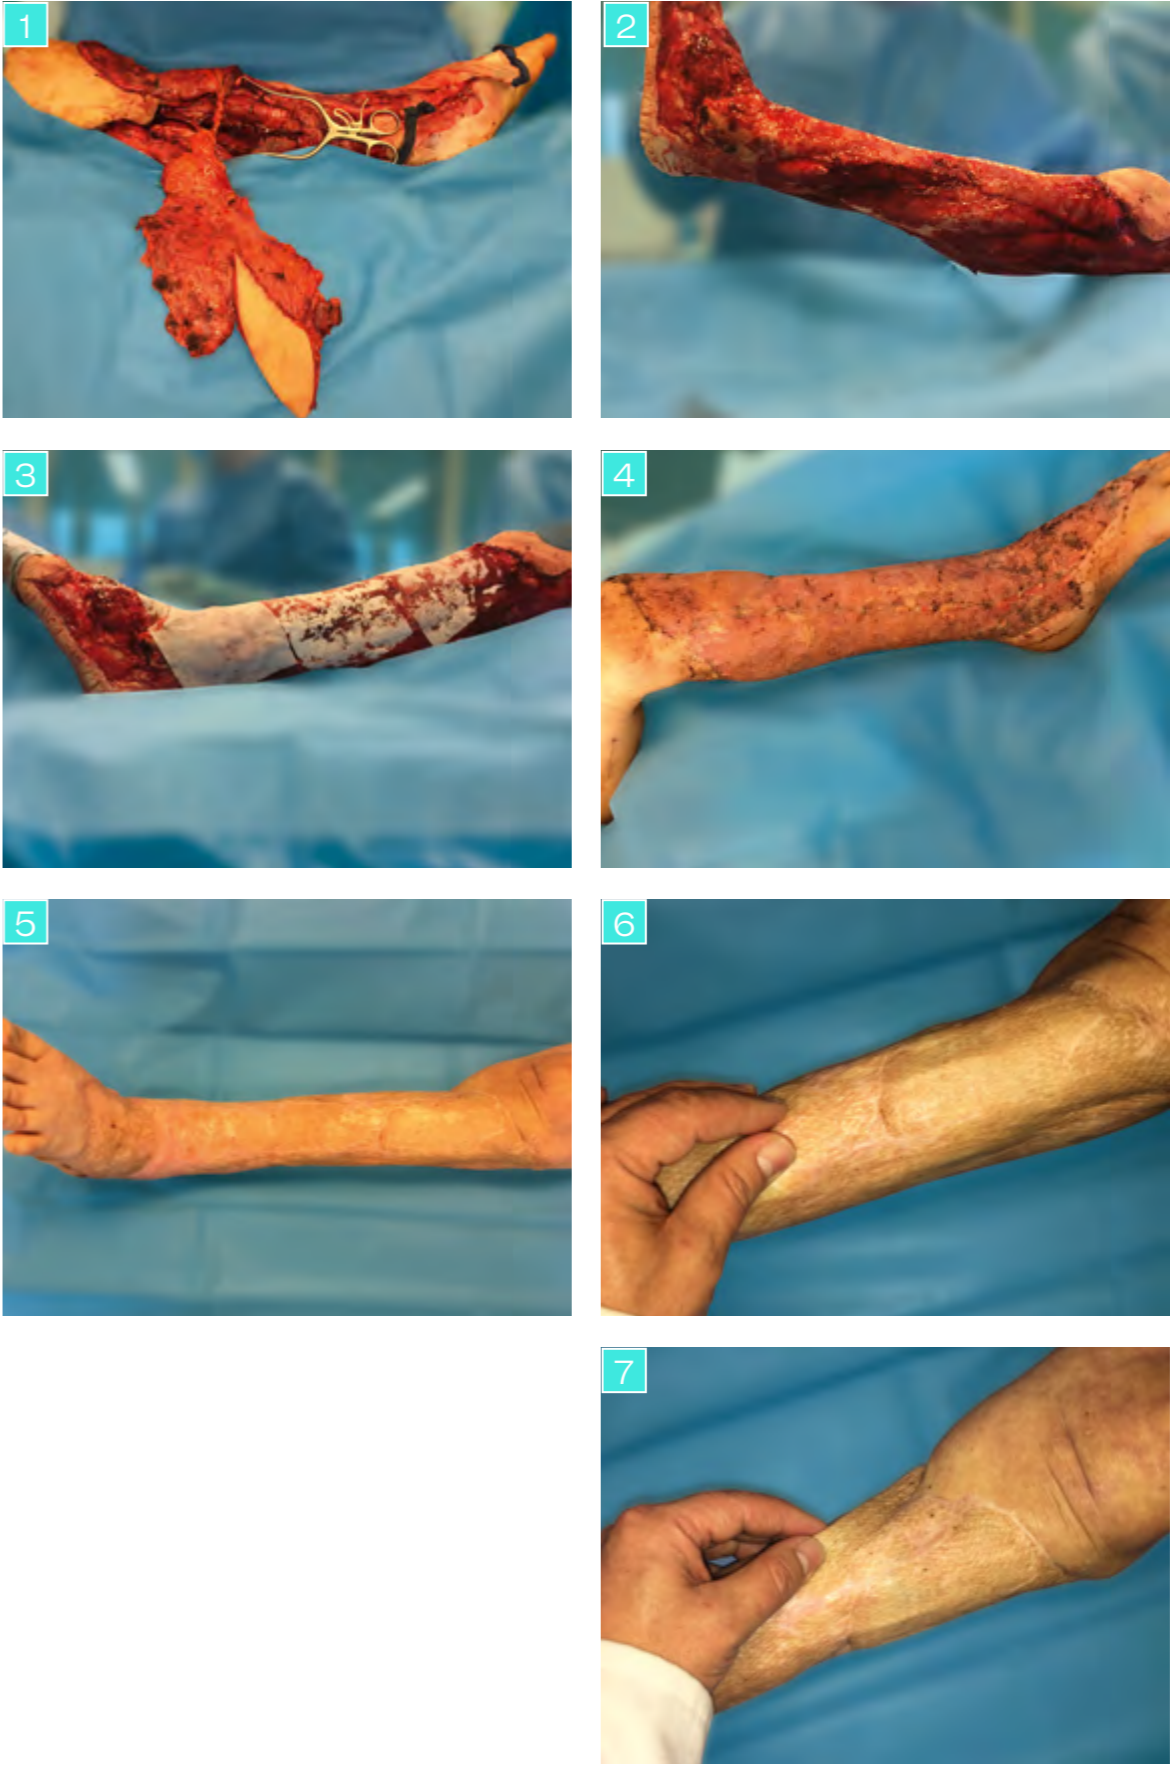
* Courtesy of D. F. Kalbermatten, MD, Basel, Switzerland
