Flexible solutions for complex wound reconstruction

Table of contents

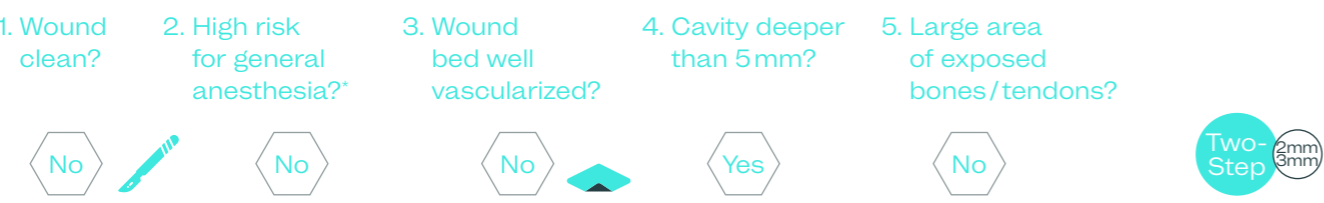
This patient required extensive life saving abdominal wall debridement after developing necrotizing fasciitis following ovarian cancer surgery. After debridement, she was admitted to the intensive care unit for several weeks with an 'open abdomen' measuring 34x33cm. There was exposed bowel covered by a fragile layer of granulation tissue and yellow slough with discharging cavities under the skin flaps laterally (Fig.1). The rectus muscles had retracted laterally and, therefore, it was inappropriate and unsafe to attempt an abdominal wall reconstruction using mesh and/or advancement techniques at that stage. The objective was to get the wound healed in a timely manner with as much protection and padding over the bowel so the patient could commence the rest of her oncologic treatment that included chemotherapy.

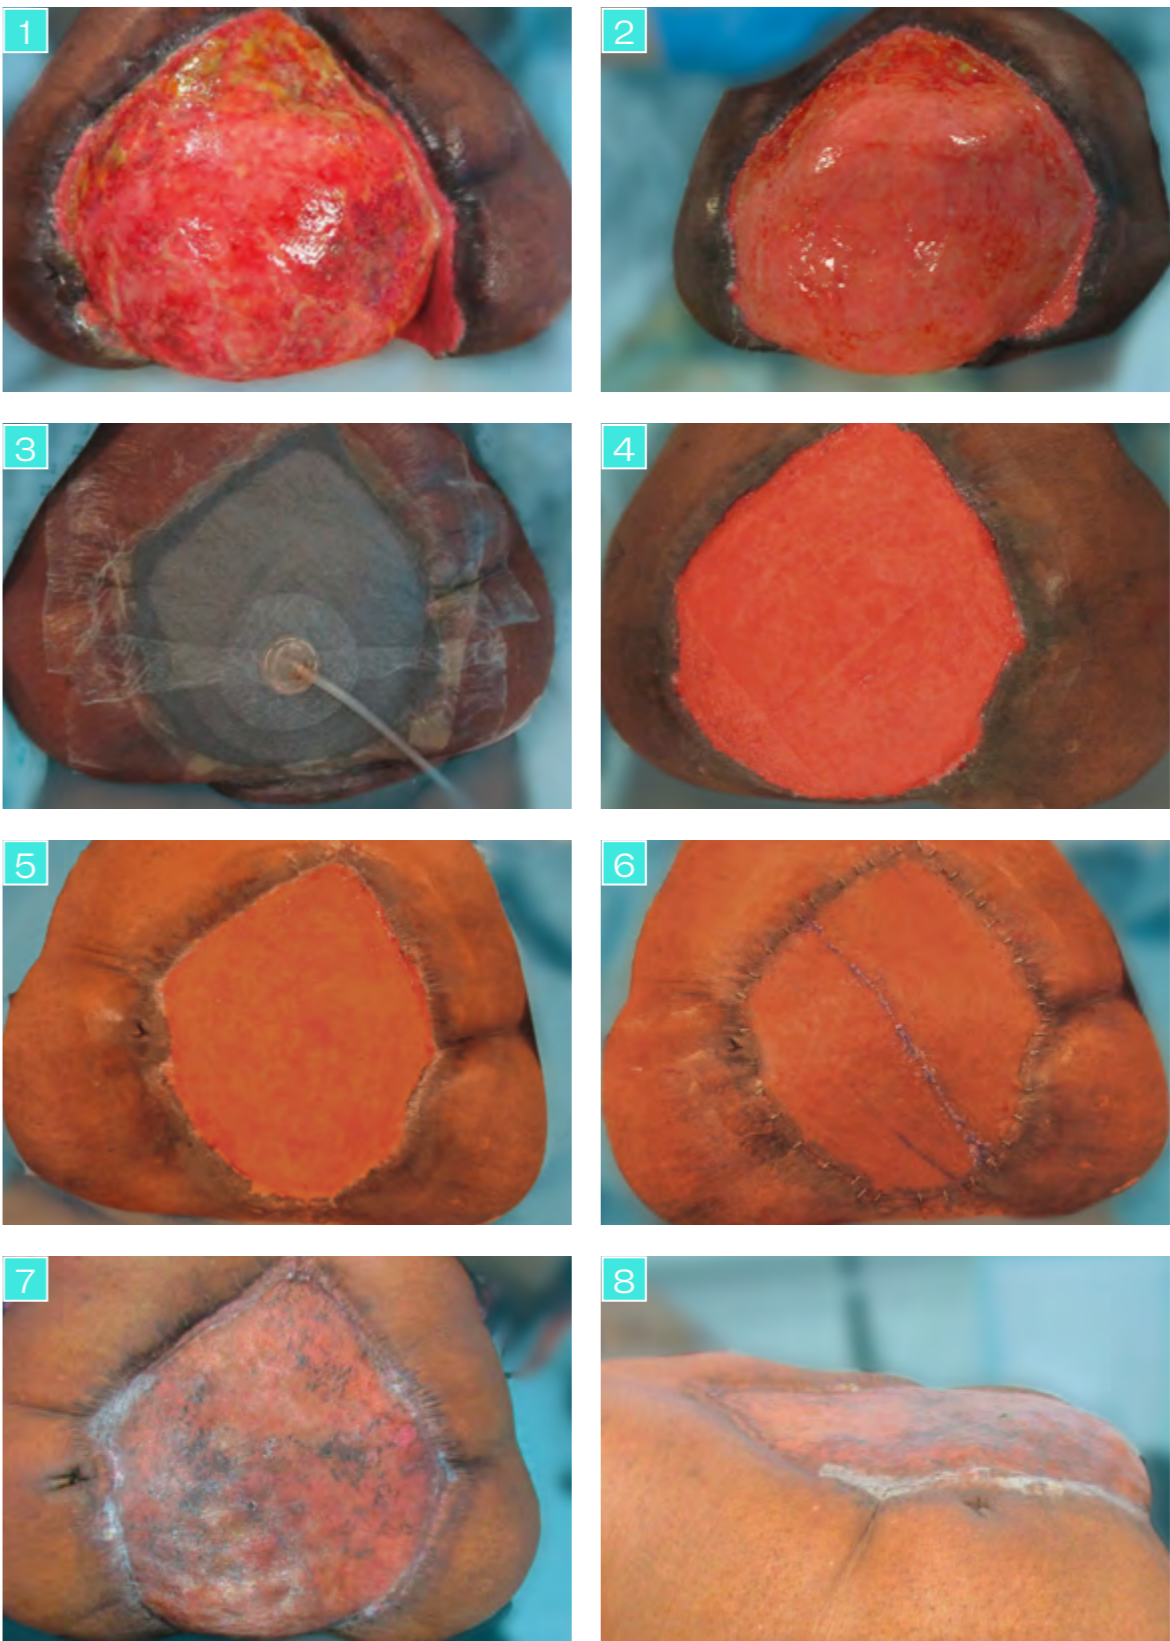
* Courtesy of I. Younis, MBBCh, MRCS (Eng), MSc, FRCS (Plast), London, UK

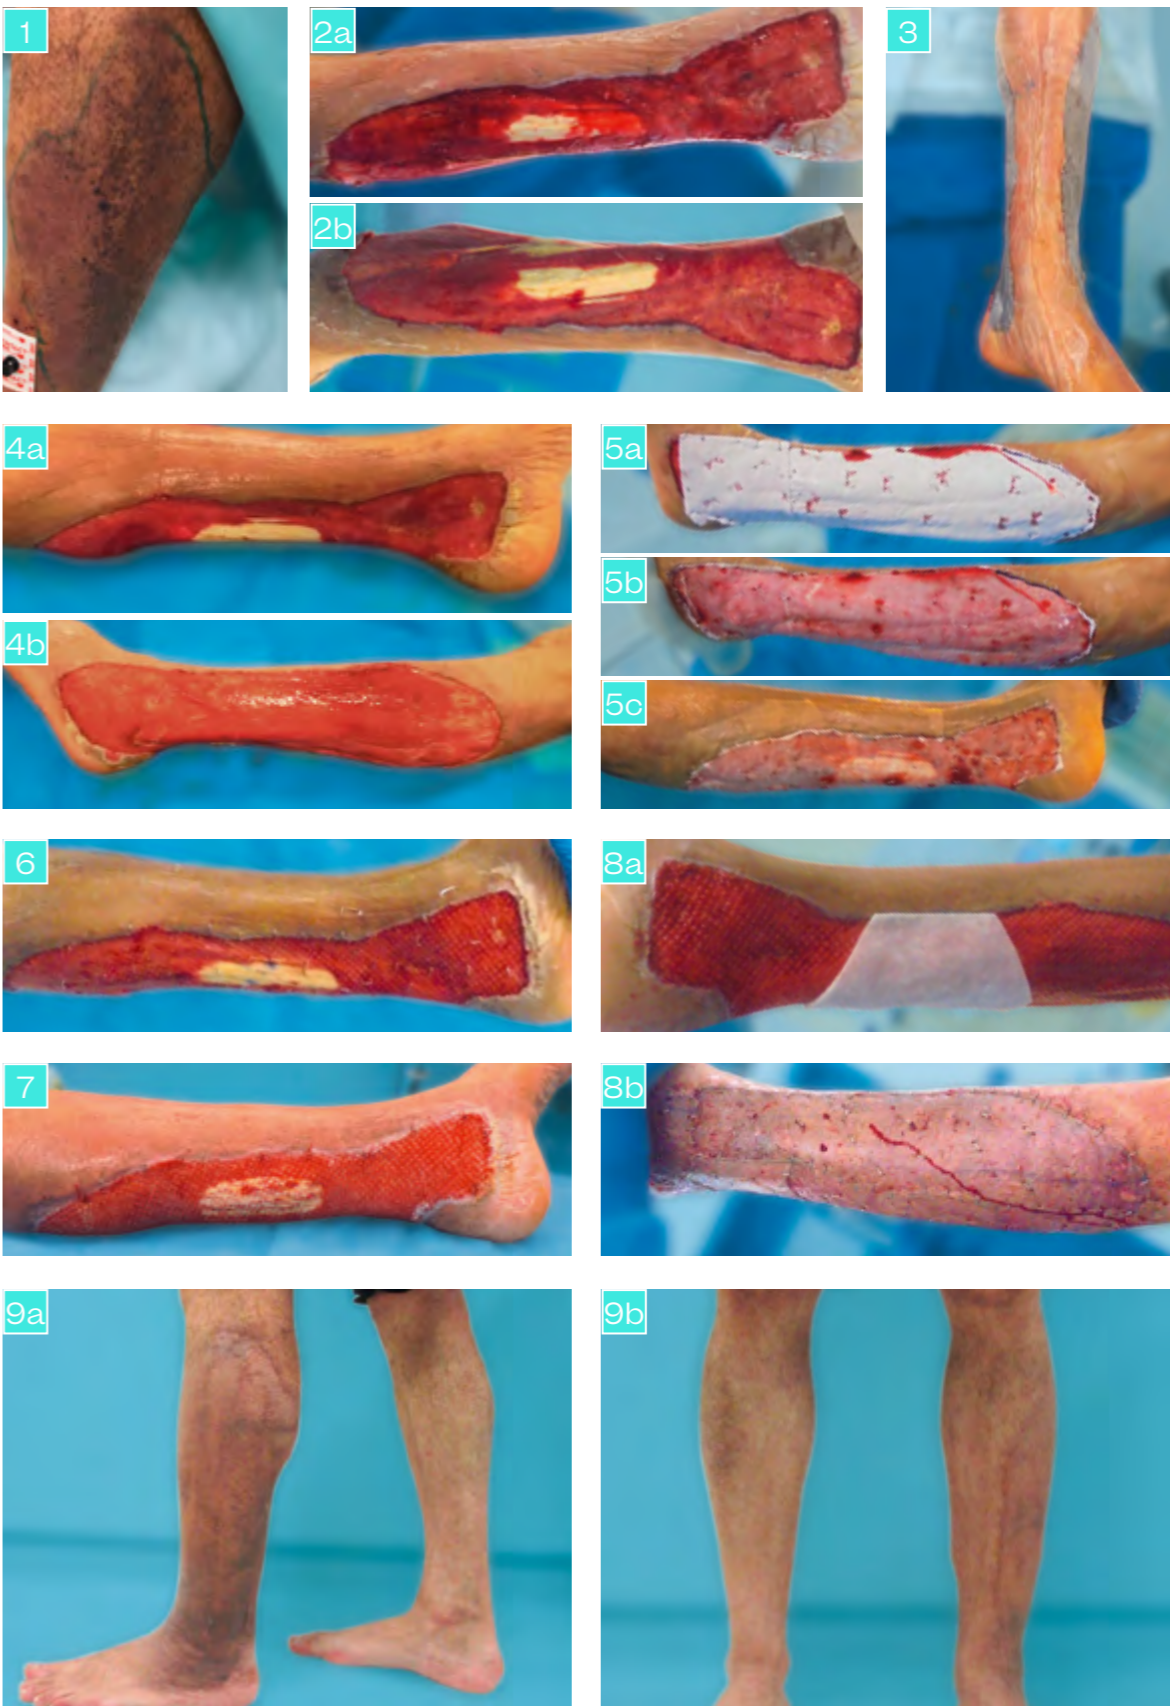
* Courtesy of I. Younis, MBBCh, MRCS (Eng), MSc, FRCS (Plast), London, UK

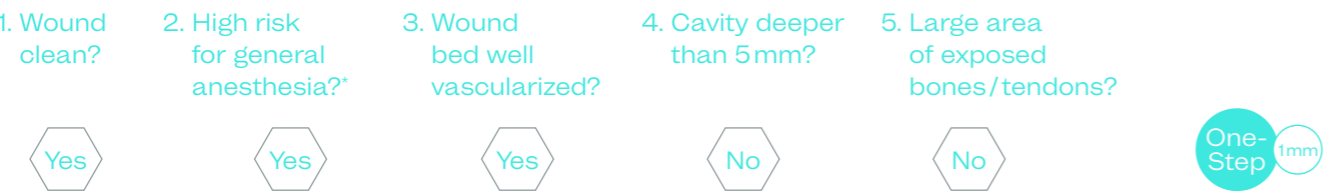
This patient with a neuropathic cavoid foot and an idiopathic clubfoot has a 4-year history of infected ulcerations on the plantar and lateral dorsal side of the foot. In the weeks prior to the reconstructive surgery, the Pseudomonas-infected ulcer was treated with MediHoney to control the infection. The wound bed was optimized with Hyiodine.

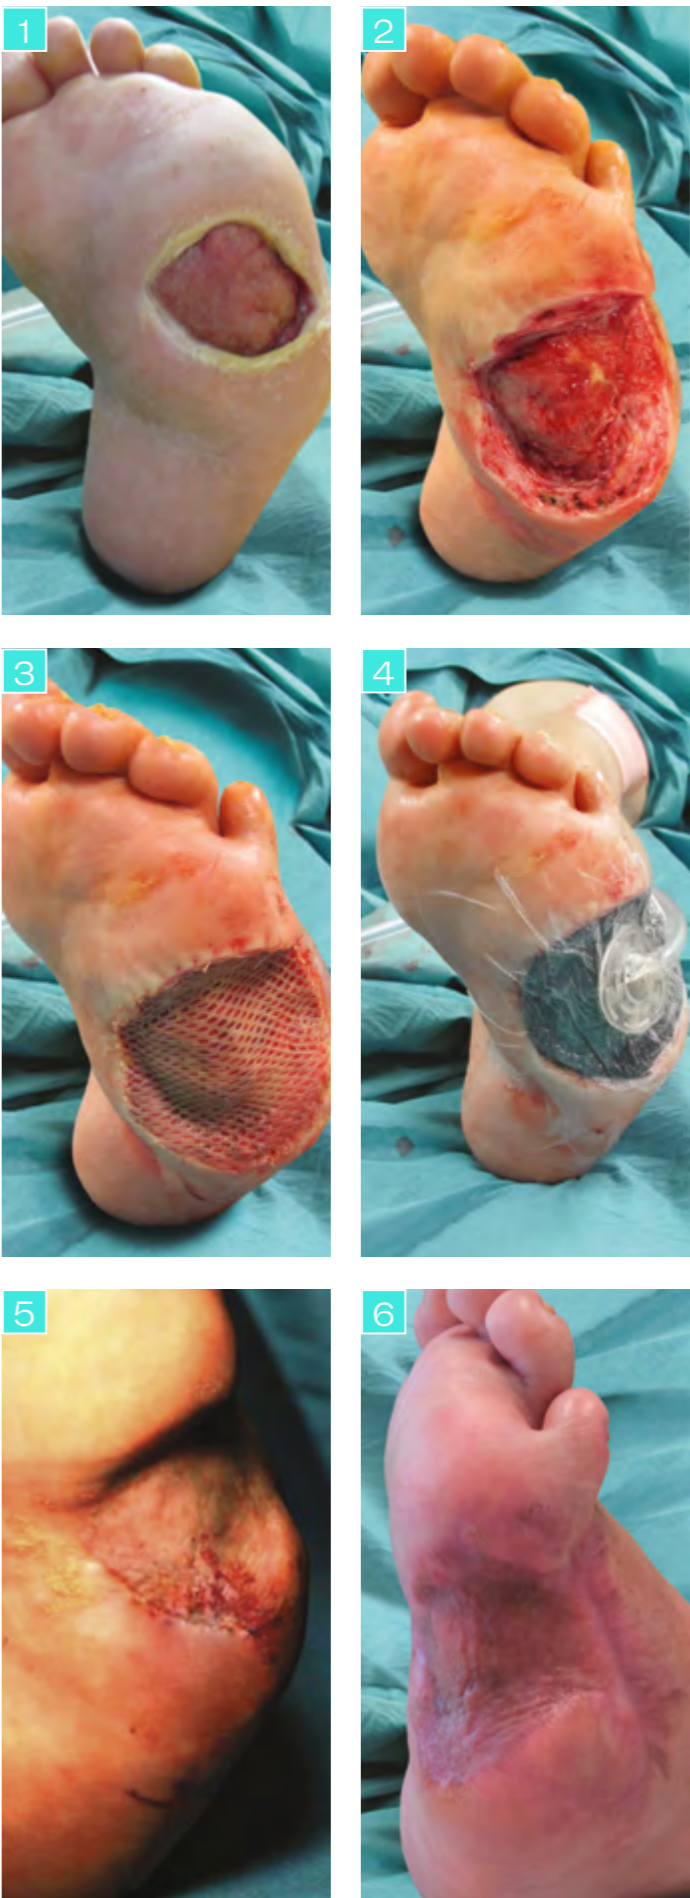
Chronic mixed ulcer in diabetic patient

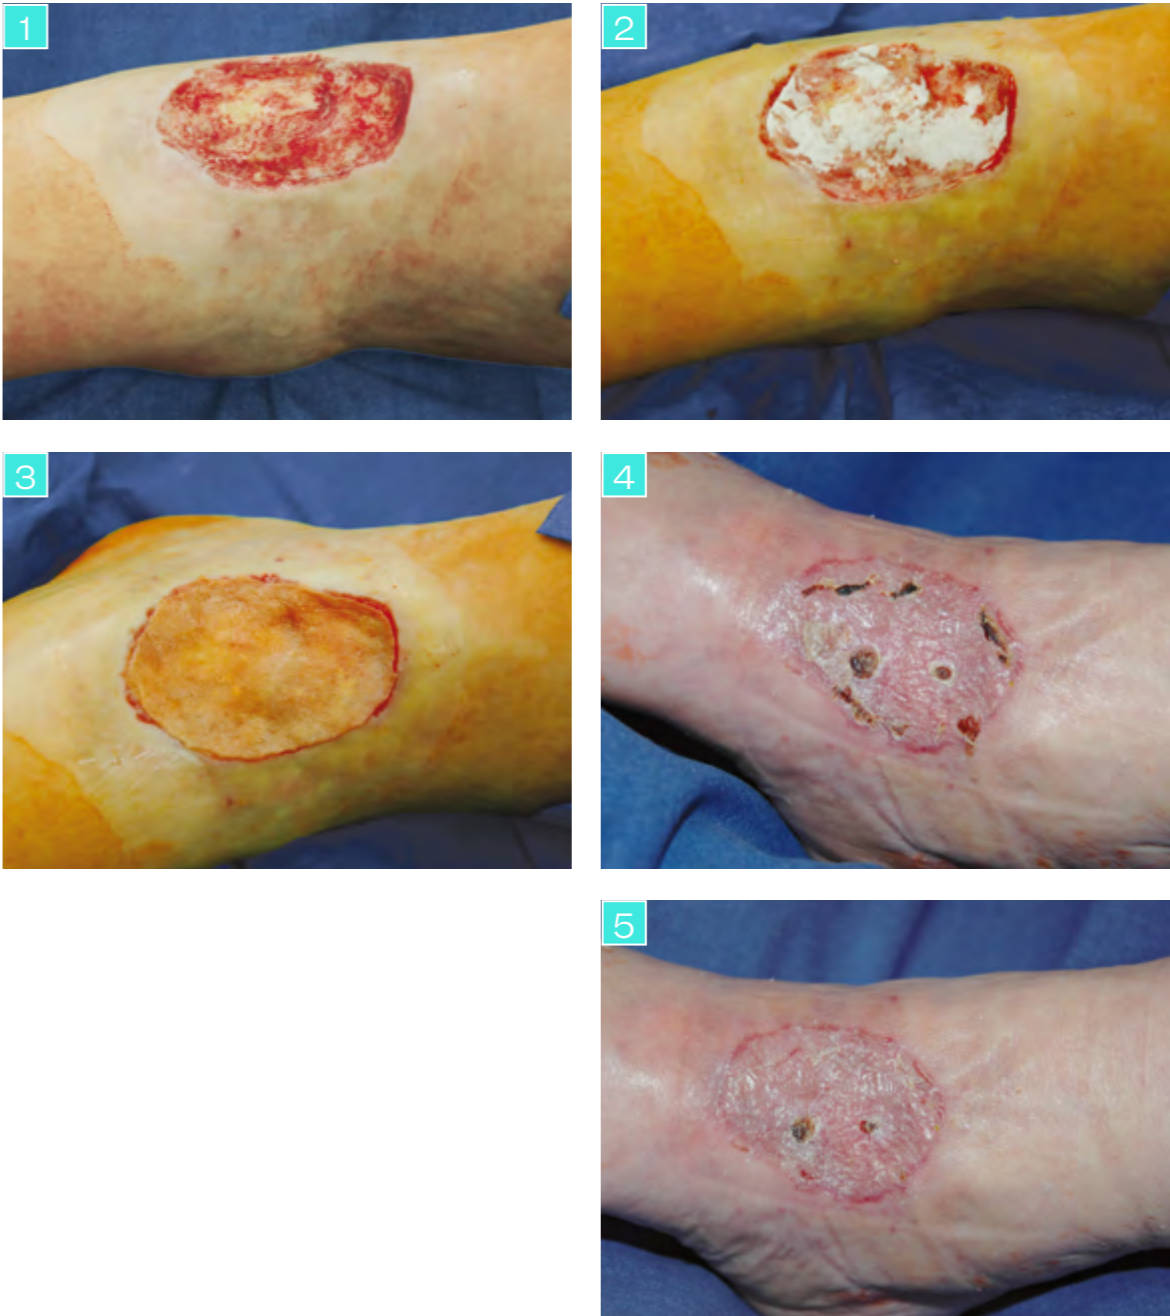
* Courtesy of M. Öhlbauer, MD, Murnau, Germany

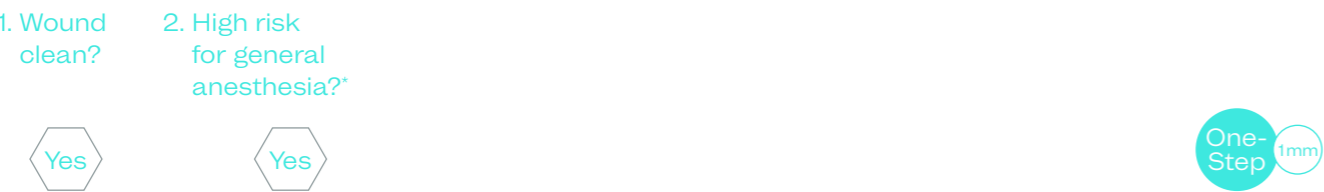
A 70-year-old patient suffered from an ischaemic stroke at home. He was found 4 days later lying on the floor unable to move and had developed large pressure ulcers of the left thorax and the lateral side of the left knee. After cardiopulmonary stabilisation at the intensive care unit, operative debridement of the necrotic tissue exposed both knee capsule and rib cartilage.

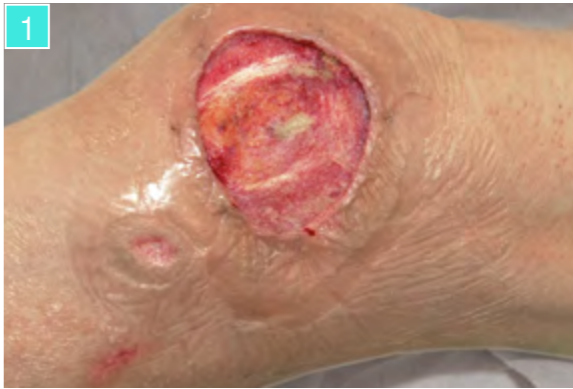
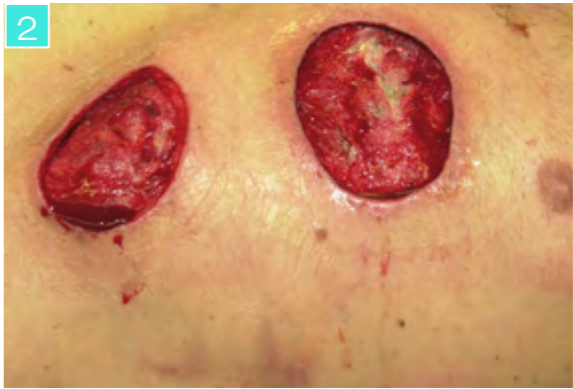
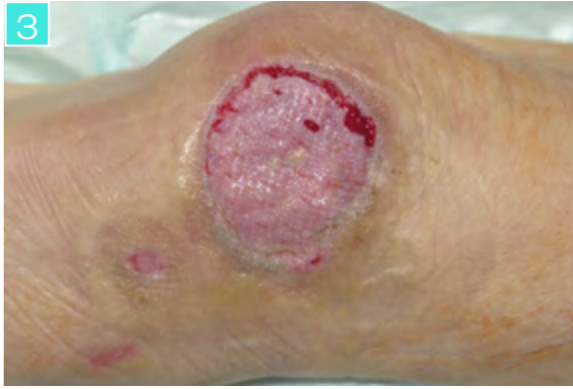
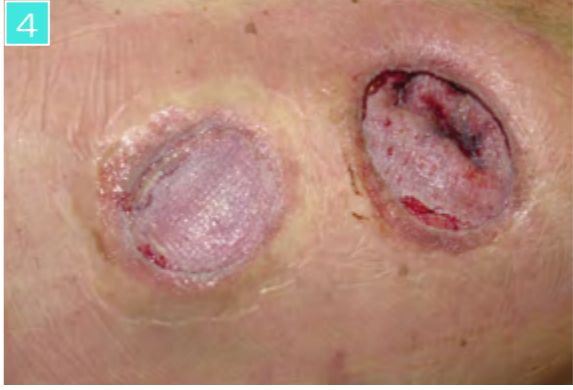
* Courtesy of M. Öhlbauer, MD, Murnau, Germany

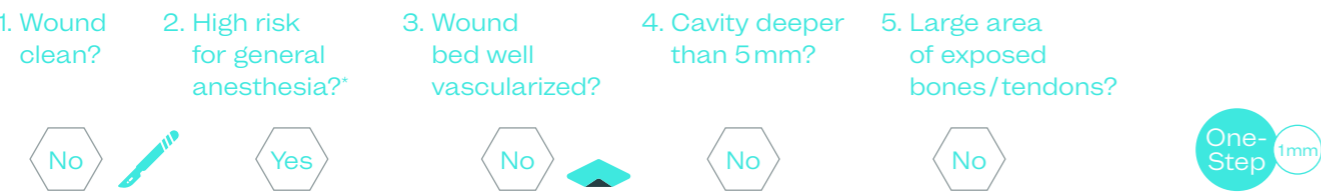
An 81-year-old male patient presented with a squamous cell carcinoma in the left popliteal fossa. The ulceration was growing already for 5 years.

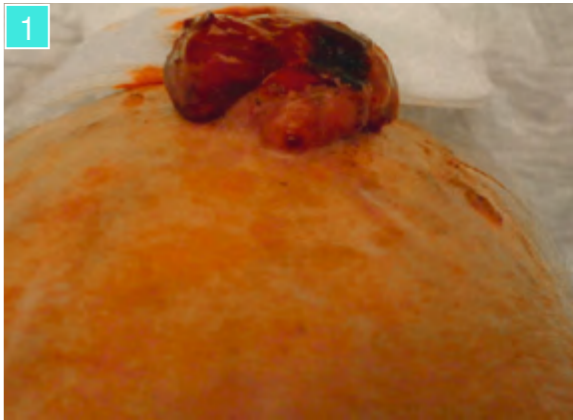
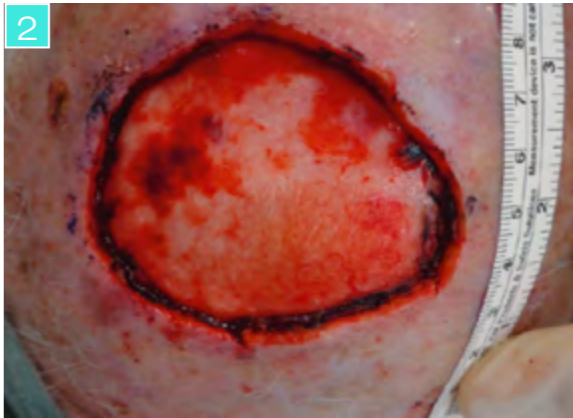
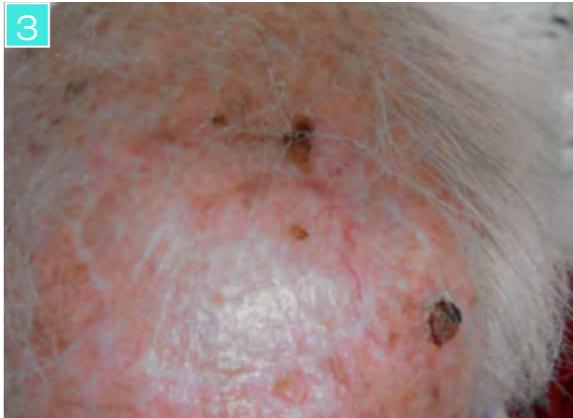
* Courtesy of V. Wedler, MD, Frauenfeld, Switzerland

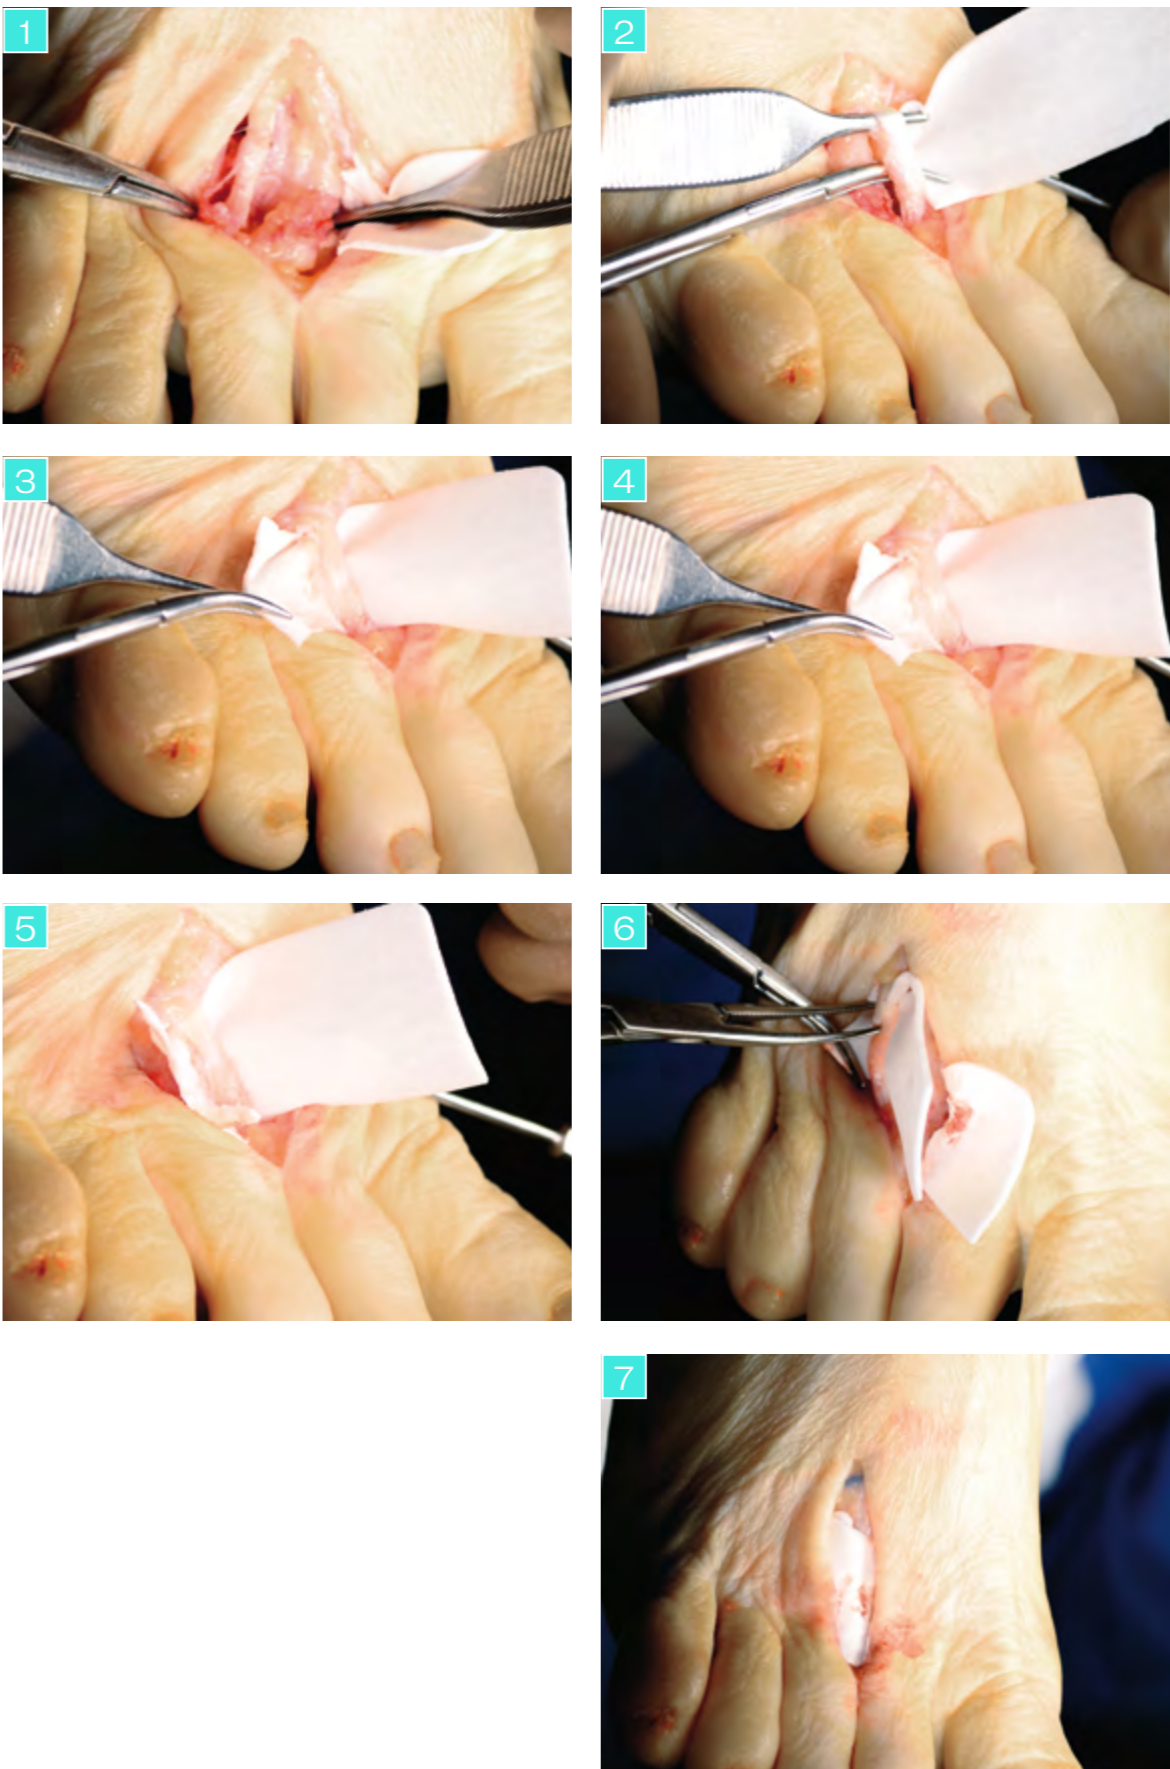
* Courtesy of U. Graf, MD, Zurich, Switzerland

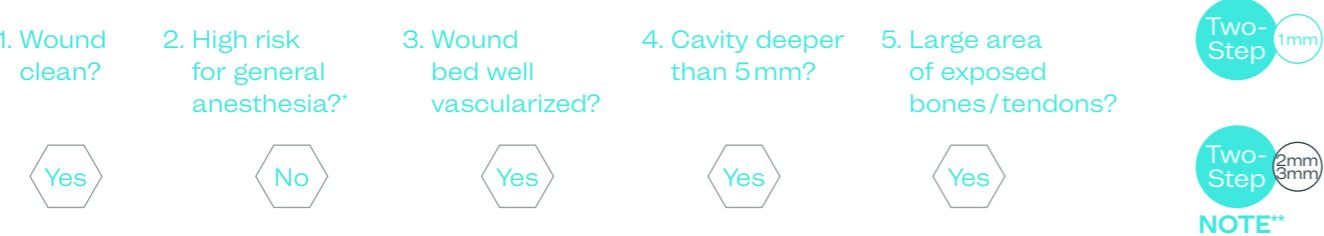
Consecutive patient underwent female-to-male affirming surgery. On the preoperative day, the flap was drawn on the non-dominant hand and an Allen test was performed to confirm vascular support from the ulnar artery. Under a tourniquet, the flap was raised distally to proximally and care was taken to meticulously clip all vessel branches. The radial sensory nerve (asterisk Fig. 1) was identified, dissected, and spared. The flap was raised in a subfascial plane and care was taken to include the proximal sensory nerves, veins and axial pedicle.

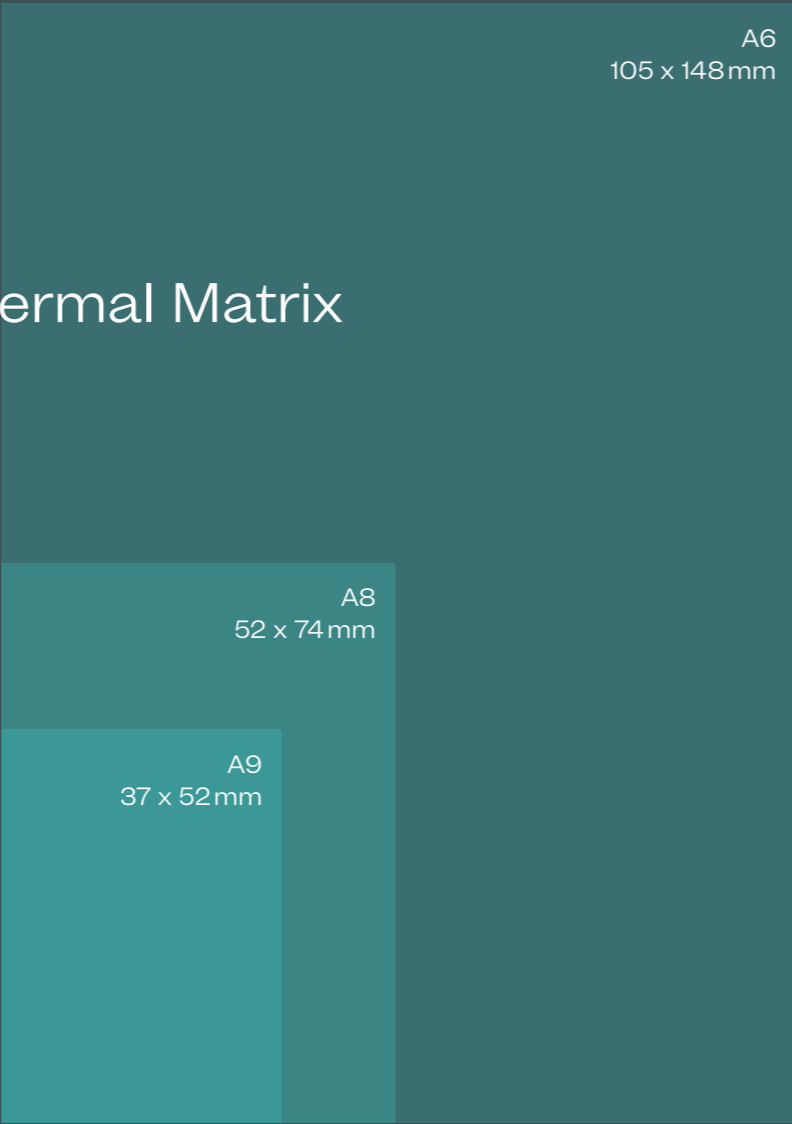
All product and company names are trademarks ™ or registered ® trademarks of their respective holders. Use of them does not imply any affiliation with or endorsement by them.
