National Trail Surfaces Study

Final Report

February 2014

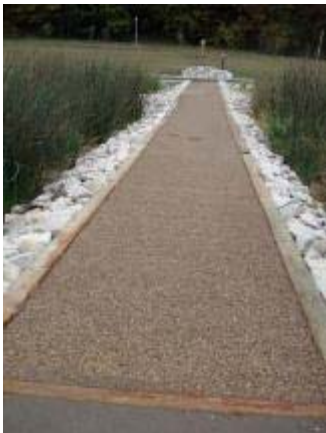
Photo 11 Klingstone amber color has started to fade. October 19, 2007.

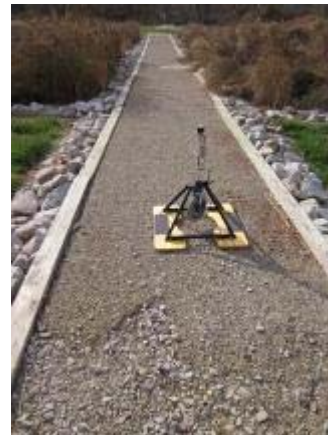
Photo 16 Klingstone at beginning of trail segment has started to wash out. November 22, 2011.

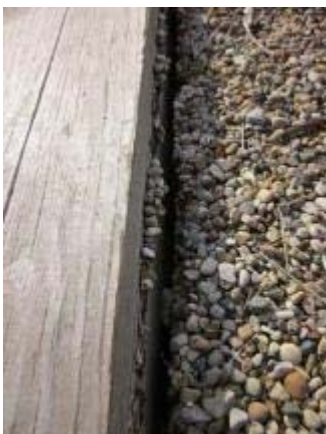
Photo 17 Klingstone surface has started to recede from timber edging. November 22, 2011.

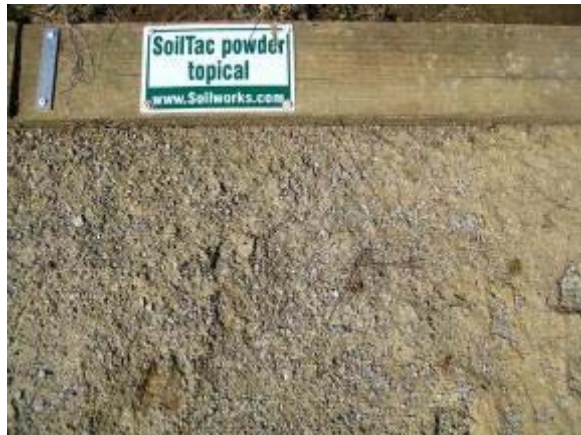
limestone aggregate. The stabilizer has a penetration depth of 1/8 inch. As with the other three Soiltac surface applications, the first signs of change for this surface came after the first heavy rainfall at the March 2008 testing. After the rain, the stabilizer formed a solid paper-thin elastic layer on top of the surface. It should be noted that runoff was a problem onto this surface from the adjacent earth mound that was not controlled by constructed drainage. The surface was soft under foot and showed footprints. Like the other Soiltac Topical application, this segment never seemed to firm up. The same guidance is recommended for the Soiltac Powder Topical application as the Soiltac Liquid Topical application. Upon the advice of the stabilizer company, topical applications should not be utilized to stabilize trail surfaces, but are to be utilized when dust control and erosion is necessary. It can be applied to mix-in stabilizers during the installation and during maintenance to help achieve a more firm and stable surface.

Photo 21 Soiltac Powder Topical has formed a solid paper-thin layer after a heavy rainfall. March 13, 2008.

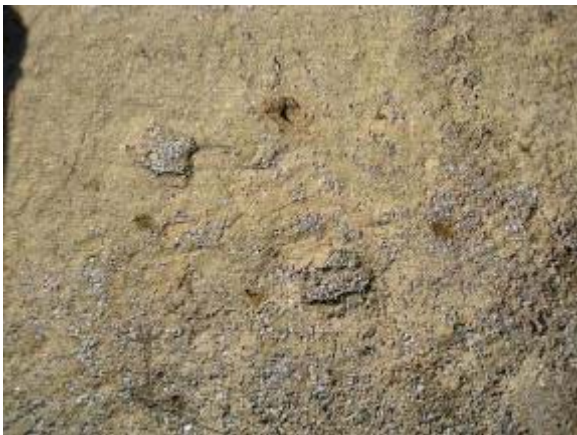
Photo 22 Soiltac Powder Topical was soft under foot and showed footprints. March 13, 2008.

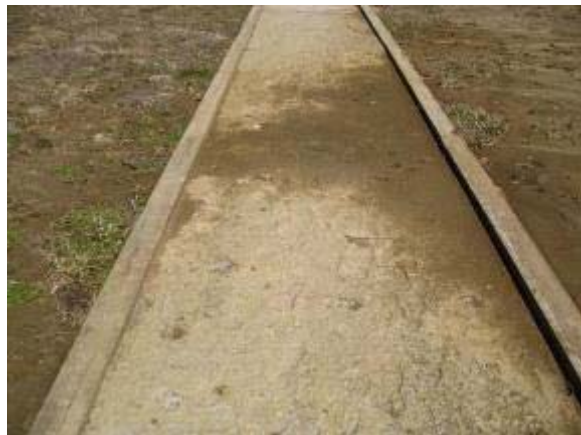
Photo 23 Soiltac Powder Topical with runoff from adjacent landscape. March 13, 2008.

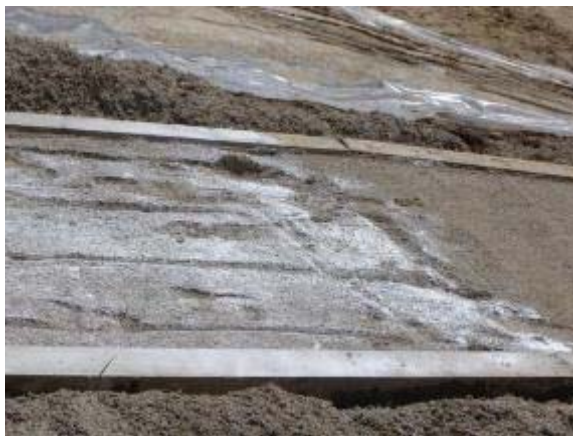
Photo 29 Soiltac Powder Mix-In is applied to a base of 2 inches of native soil. June 27, 2007.

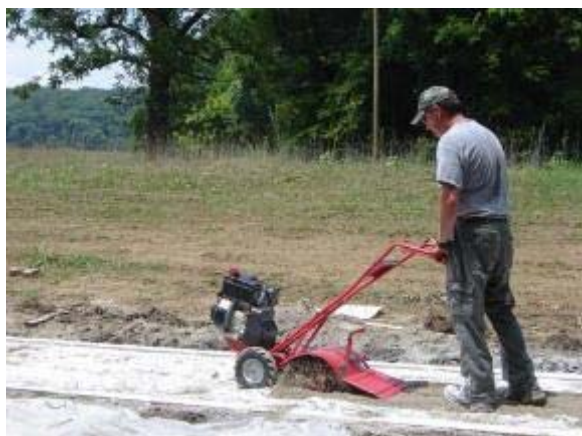
Photo 30 Soiltac Powder Mix-In is tilled into the 2 inch base of native soil. June 27, 2007.

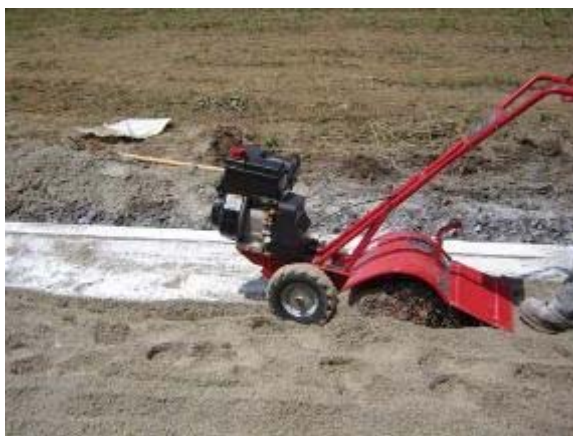
Photo 31 Soiltac Powder Mix-In has a penetration depth of 4 inches. June 27, 2007.

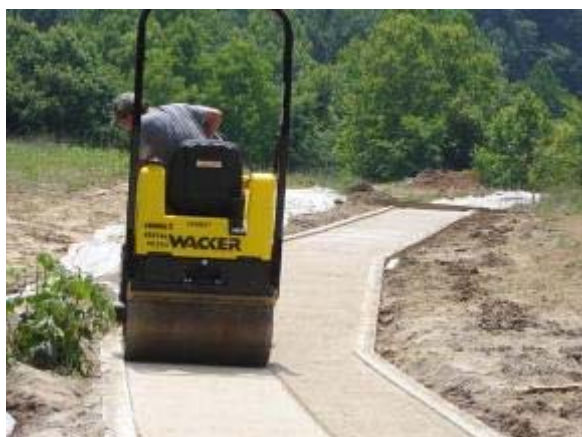
Photo 32 Soiltac Powder Mix-In is smoothed and compacted. June 27, 2007.

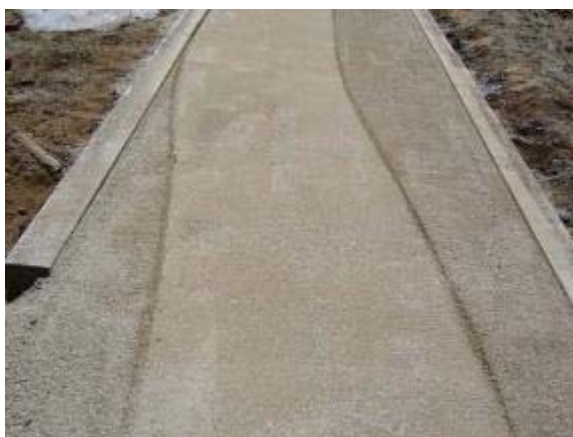
Photo 33 Soiltac Powder Mix-In is smoothed and compacted. June 27, 2007.

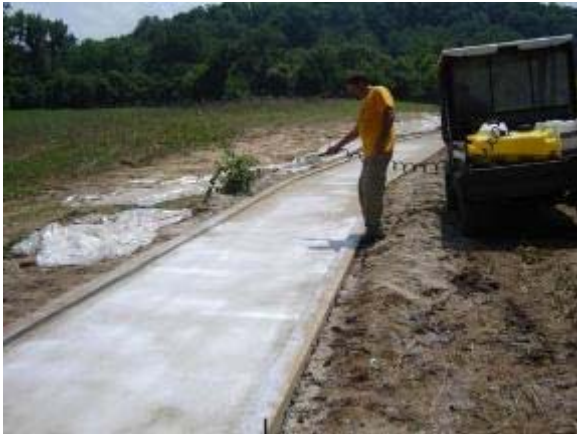
Photo 34 Soiltac Powder Mix-In is sprayed to seal the surface. June 27, 2007.

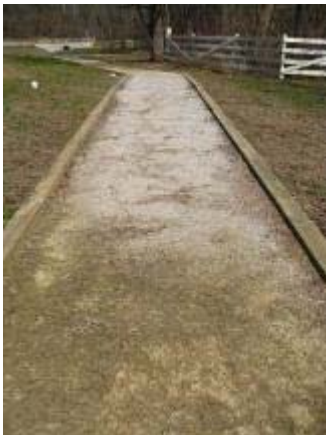
Photo 38 Soiltac Powder Mix-In almost two years after installation. March 17, 2009.

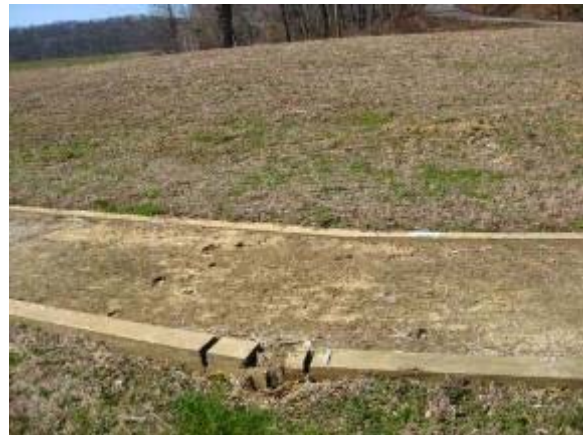
Photo 39 Soiltac Powder Mix-In does not have a constructed drainage mechanism considered appropriate for trail construction. March 17, 2009.

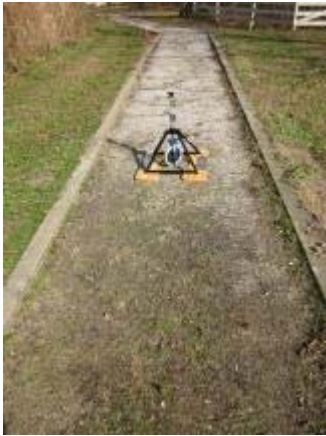
Photo 40 Soiltac Powder Mix-In showed only minor evidence of softening at the end of the study. November 2, 2011.

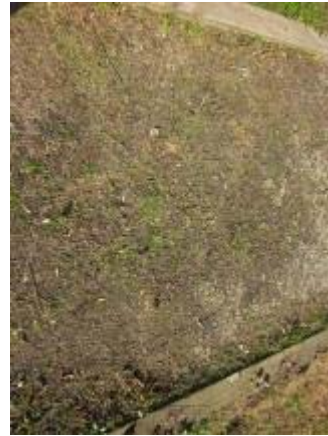
Photo 41 Soiltac Powder Mix-In trail segment with water crossing would soften and then return to natural surface state. November 2, 2011.

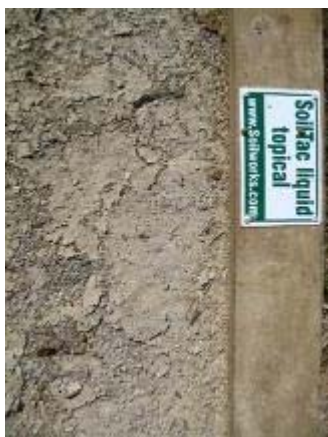
Photo 45 Soiltac Liquid Topical trail segment showed change after a heavy rainfall. March 13, 2008.

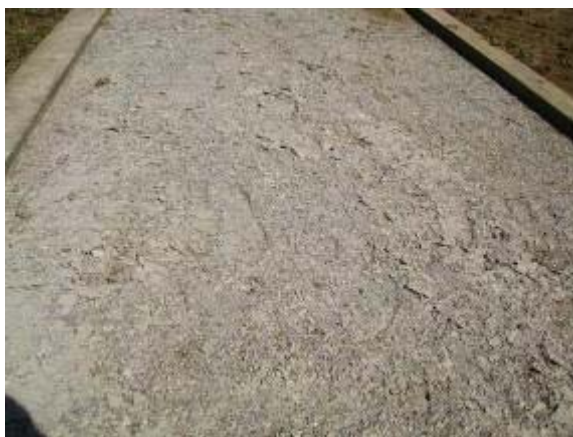
Photo 46 Soiltac Liquid Topical trail segment became soft under foot. March 13, 2008.

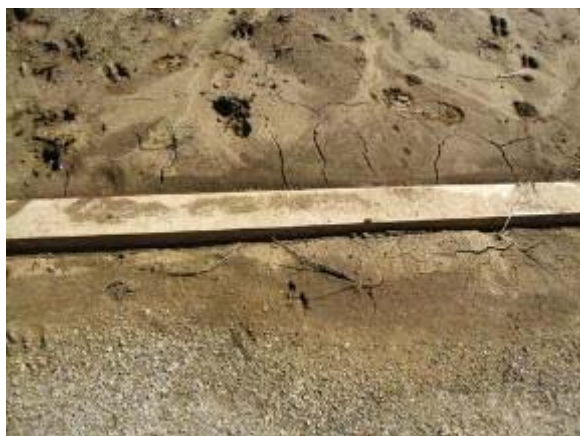
Photo 47 Soiltac Liquid Topical trail segment showed signs of runoff. March 13, 2008.

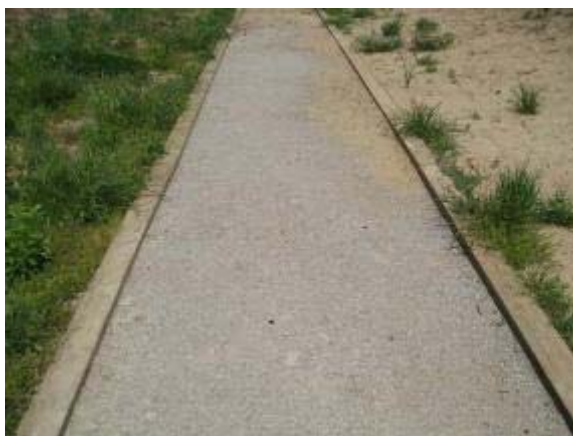
Photo 48 Soiltac Liquid Topical trail segment remained soft where water had pooled. May 6, 2008.

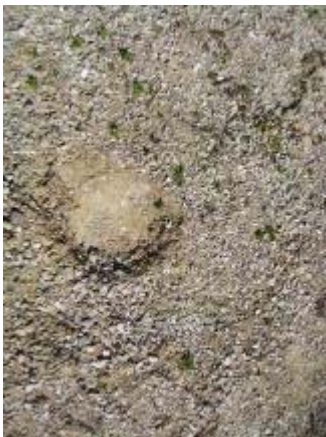
Photo 51 Soiltac Liquid Topical trail segment showed footprints. March 17, 2009.

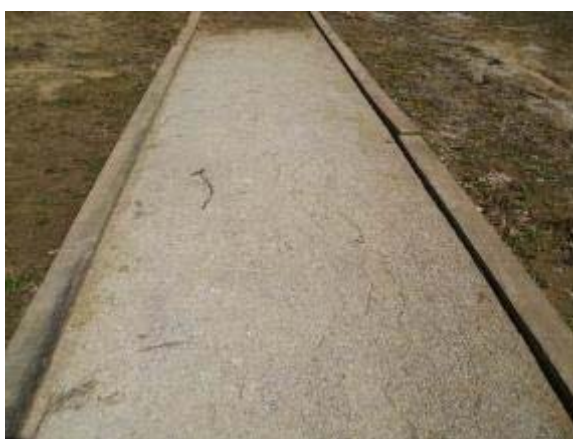
Photo 64 Soiltac Liquid Mix-In trail segment was only slightly soft under foot, showing footprint indentations. March 13, 2008.

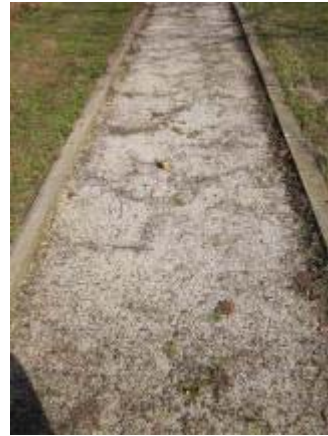
Photo 68 Soiltac Liquid Mix-In performed better than its topical application counterpart. November 2, 2011.

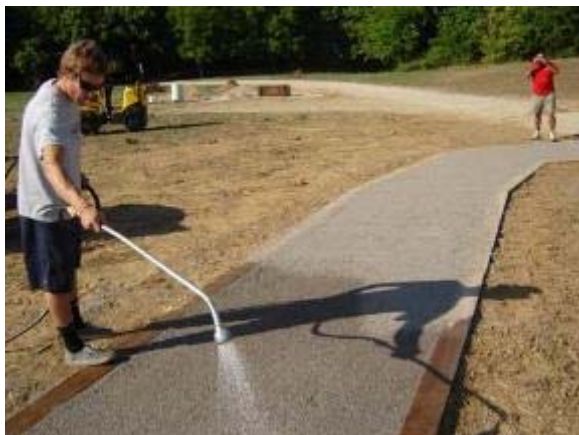
Photo 73 Stabilizer trail segment is prepared. June 21, 2007.

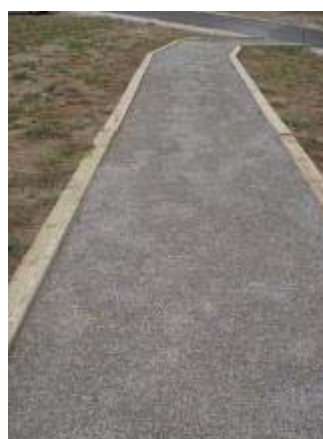
Photo 78 Stabilizer trail segment shows loose fines at
top of surface. October 19, 2007.

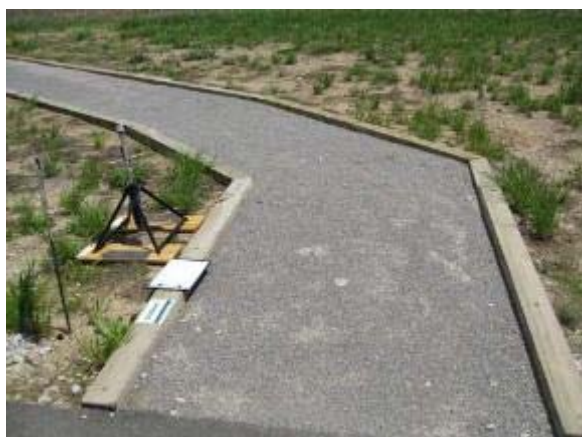
Photo 83 Stabilizer trail segment more than a year after installation. May 6, 2008.

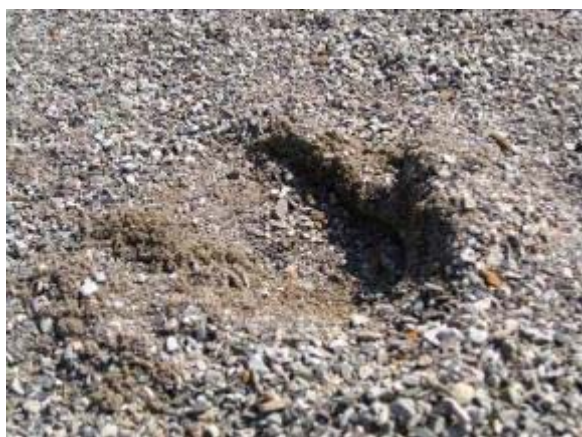
Photo 85 Stabilizer trail segment shows gullies created in surface from runoff. March 17, 2009.

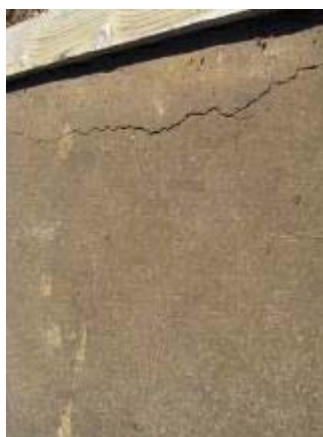
Photo 99 StaLok trail segment was noted for repairing itself. March 13, 2008.

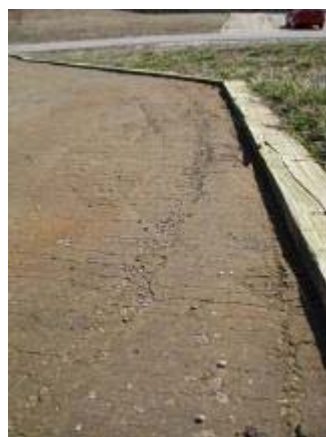
Photo 103 StaLok trail segment previously shown with marks had repaired itself. March 17, 2009.

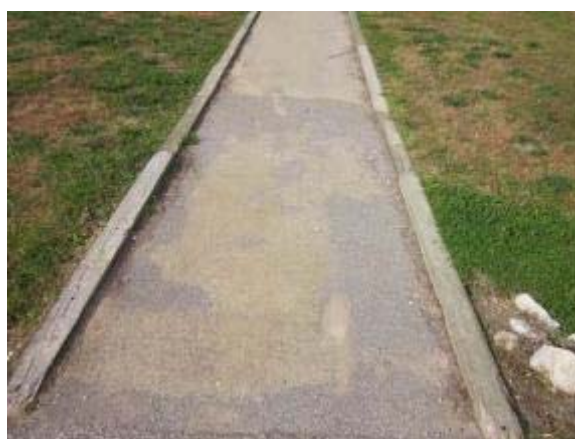
Photo 107 StaLok trail segment with pooling of water. November 2, 2011.

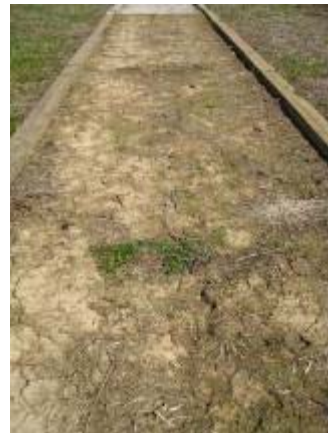
Photo 119 Polypavement trail segment almost two years after installation shows top layer of stabilizer and remaining surface returned to its natural soil base. March 17, 2009.

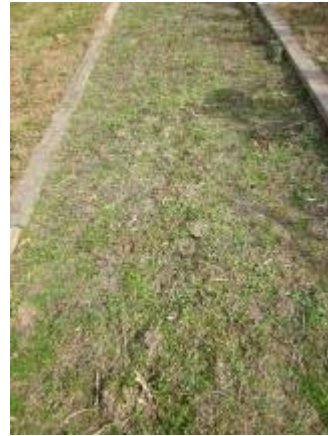
Photo 121 Polypavement trail segment overgrown with vegetation. November 2, 2011.

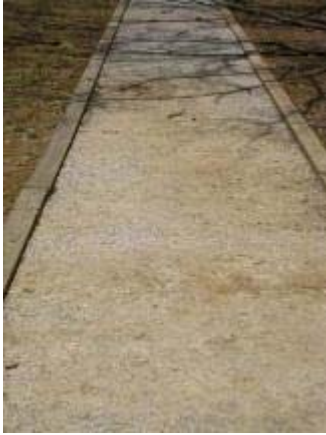
Photo 128 Three Quarter Inch Minus Limestone trail segment where water pooled after rain. March 13, 2008.

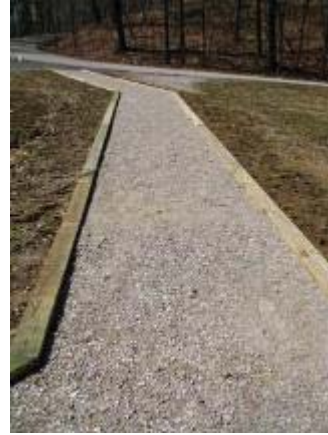
Photo 129 Three Quarter Inch Minus Limestone trail segment where water pooled after rain. March 13, 2008.

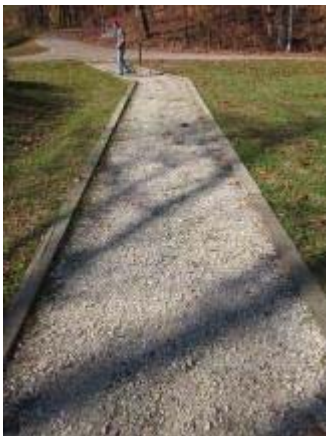
Photo 132 Three Quarter Inch Minus Limestone trail segment showed prevalence of larger fines working their way to the surface. November 2, 2011.

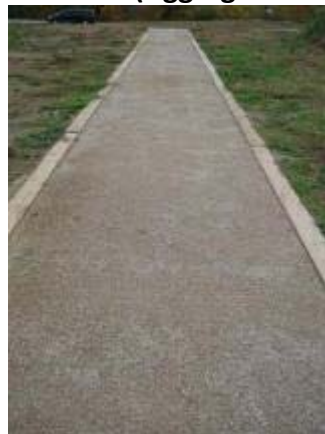
Photo 140 Three Quarter Inch Minus Base and Quarter Inch Minus Top Limestone trail segment maintained itself in dry temperatures. October 19, 2007.

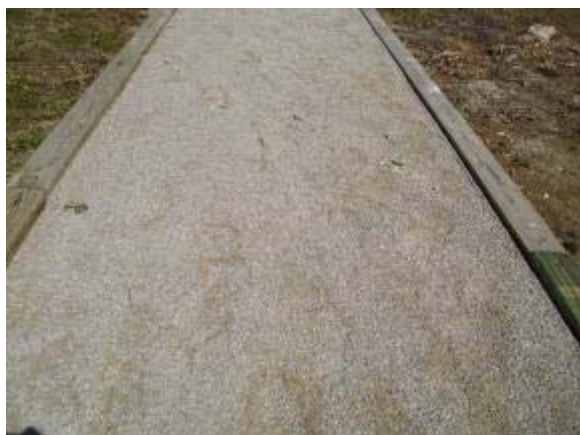
Photo 141 Three Quarter Inch Minus Base and Quarter Inch Minus Top Limestone trail segment after heavy rain. March 13, 2008.

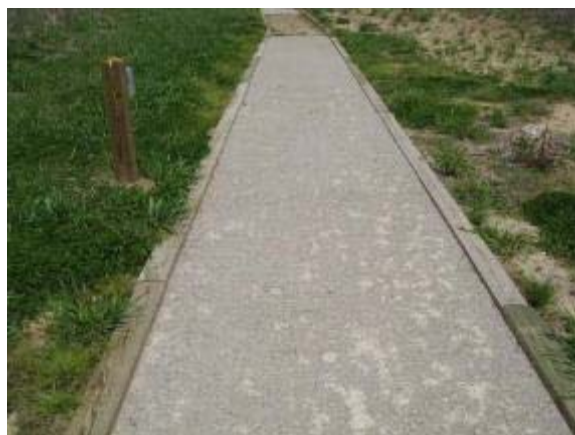
Photo 142 Three Quarter Inch Minus Base and Quarter Inch Minus Top Limestone trail segment firmed back up more quickly than the ¾ inch surface. May 6, 2008.

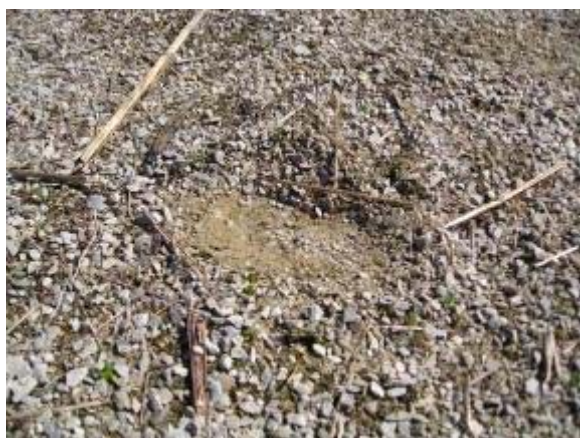
Photo 143 Three Quarter Inch Minus Base and Quarter Inch Minus Top Limestone trail segment showed signs of footprints after heavy rain. March 17, 2009.

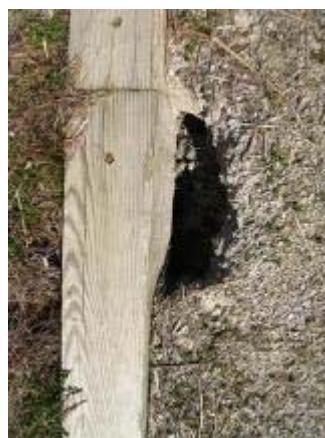
Photo 144 Three Quarter Inch Minus Base and Quarter Inch Minus Top Limestone trail segment after heavy rain. March 17, 2009.

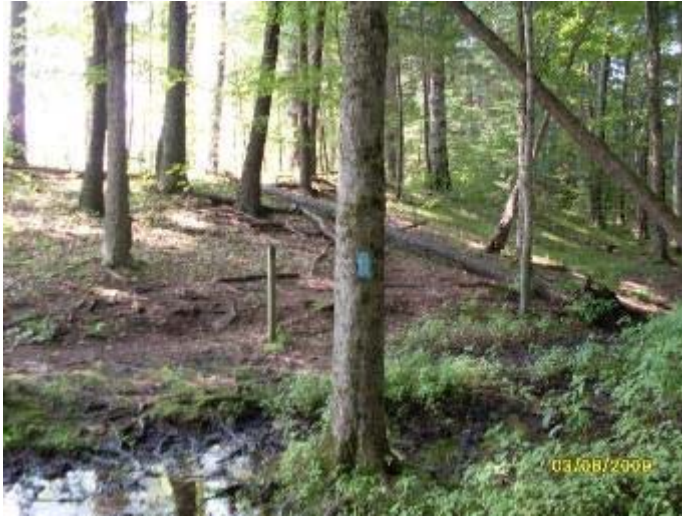
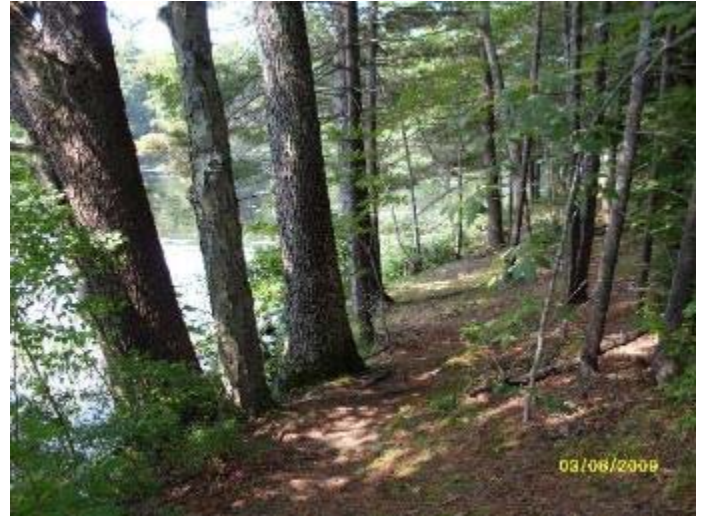
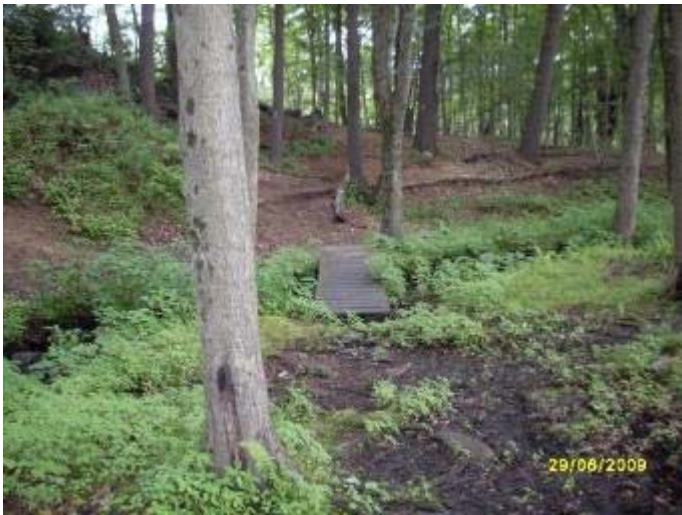
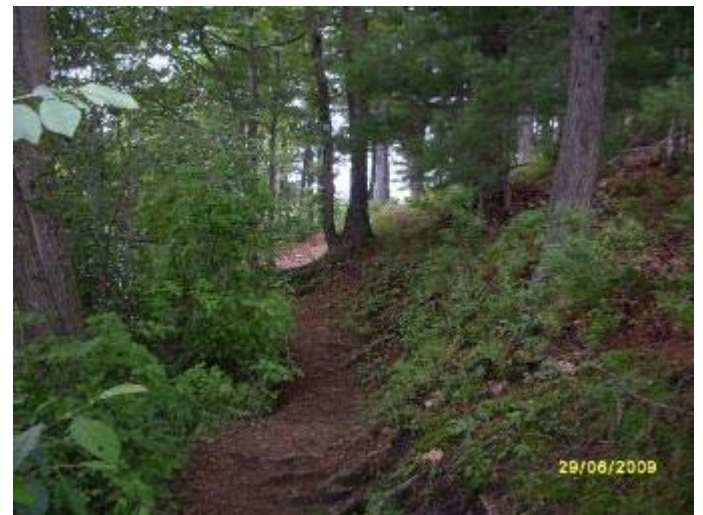
Massachusetts

Natural/native soil—not recommended surface

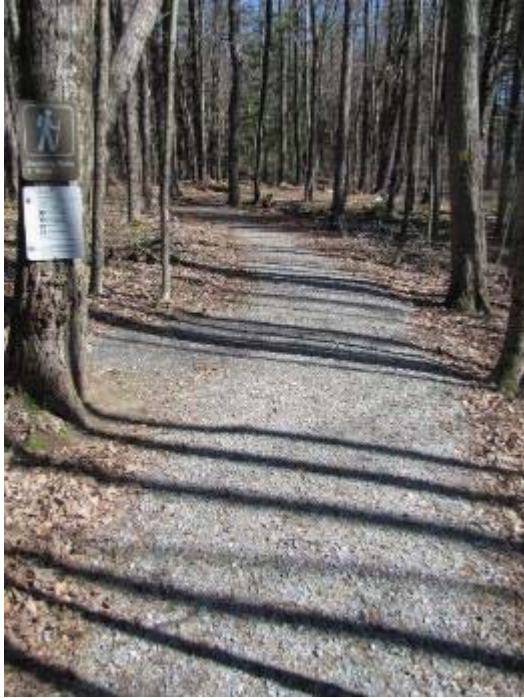
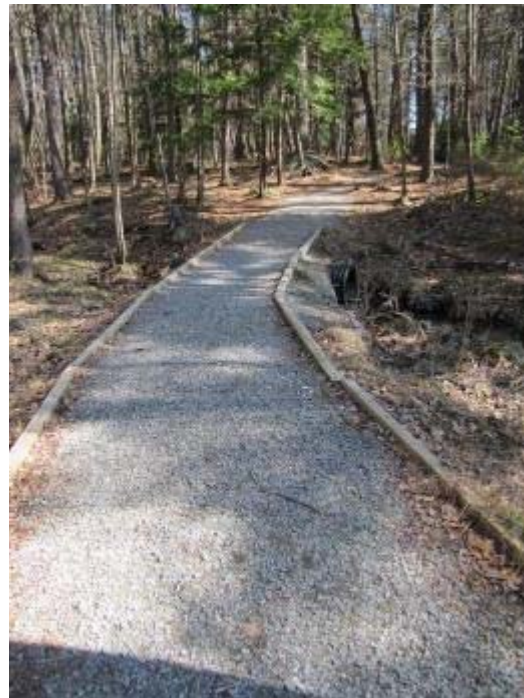
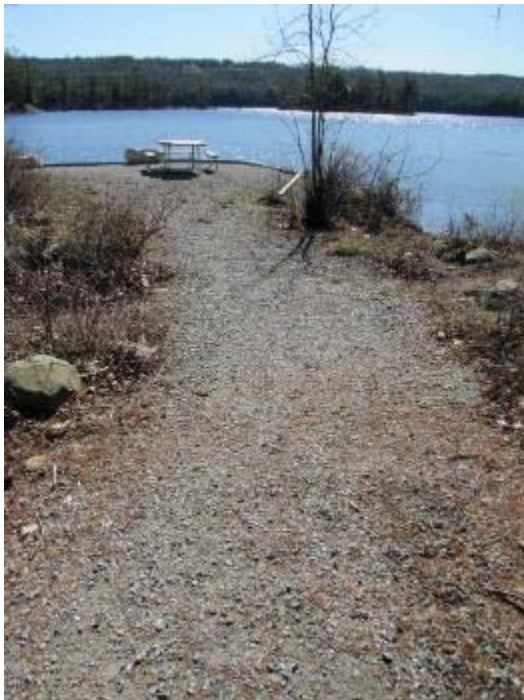
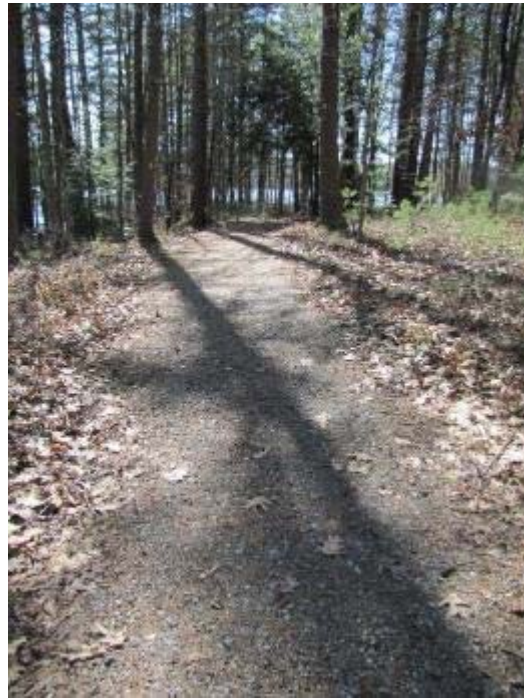
Massachusetts

Dense grade gravel—not recommended surface. Note respondent indicated with smaller fines this would be a good surface
